GENERAL INFORMATION

Identification number:	2007015
Classification:	Serious incident
Date, time ¹ of occurrence:	5 March 2007, 10.27 hours
Location of occurrence:	Amsterdam Schiphol Airport
Aircraft registration:	G-EZIP
Aircraft model:	Airbus A319
Type of aircraft:	Passenger aircraft
Type of flight:	Scheduled passenger service
Phase of operation:	Take-off
Damage to aircraft:	None
Number of crew:	Two
Number of passengers:	Not known
Personal injury:	None
Other damage:	None
Lighting conditions:	Daylight

SUMMARY

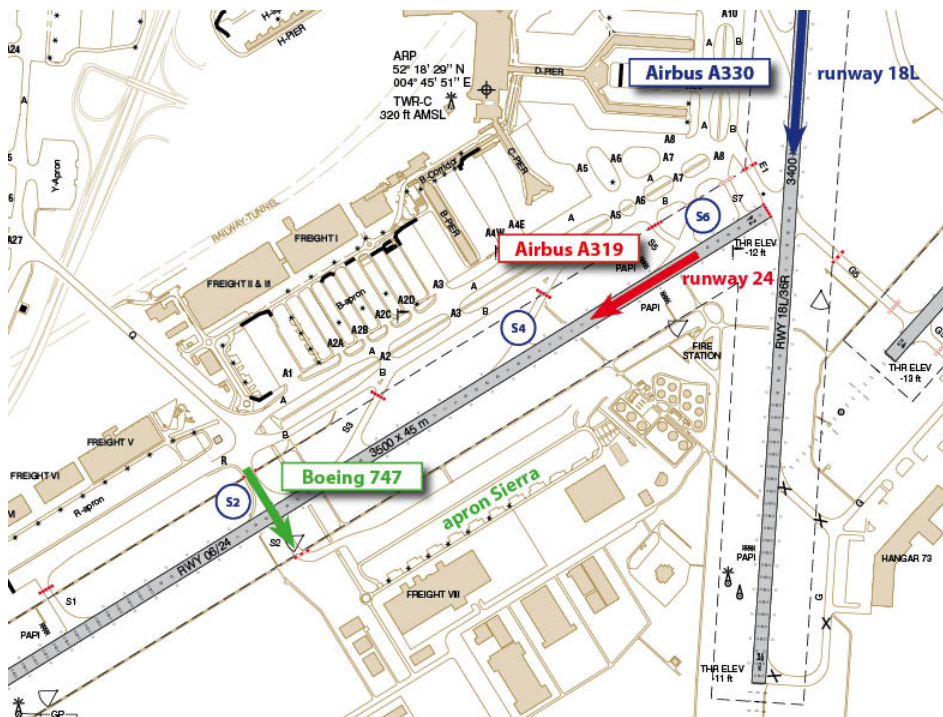
A Boeing 747 had to cross runway 24 at intersection S2, beyond the middle of runway, in order to park on apron Sierra. See illustration 1.

Illustration 1: runways 18L and 24 in use as departure runway
