**Inadvertent loss of altitude during
approach**

Sikorsky S-61N, PH-NZG, Waddenzee near Den
Helder, 30 November 2004

The Hague, August, 2007 (project number 2004215)

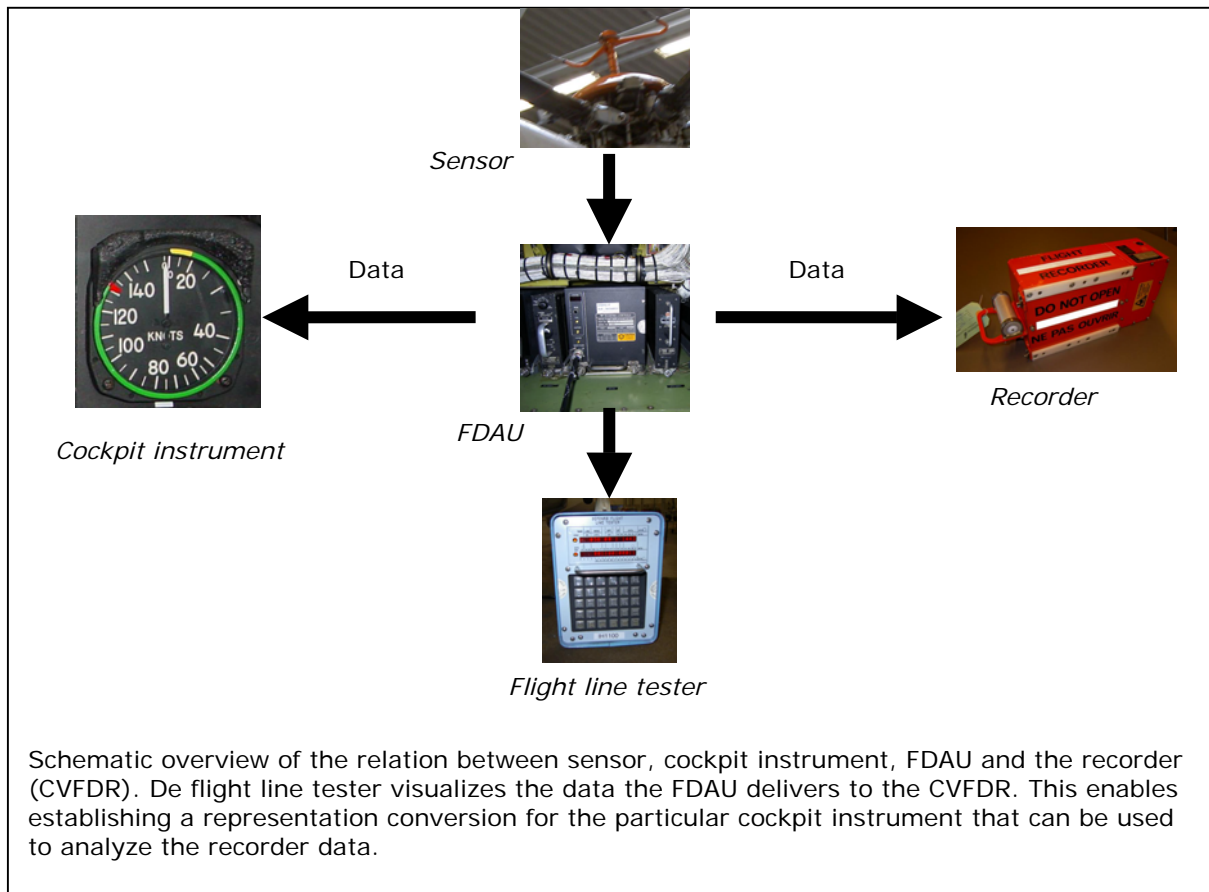
Parameter	Problem	Conclusion
IAS	Sensor recorded lower values then required by documentation	Conversion incorrect
Radio Altitude	Sensor recorded the altitude change, however the conversion was not linear as required by documentation	Conversion incorrect
Yaw rate gyro	Sensor failed to operate during GTP test	Defect
Lateral Cyclic	Sensor range larger than required	Defect, conversion incorrect
Longitudinal Cyclic	Deflection of cyclic was outside range of sensor	Defect
Tail rotor pedal	Sensor range larger then required	Defect
Collective Pitch	Deflection reversed. Sensor range differed	Defect, conversie incorrect
Heading	Conversion in original documentation of Teledyne incorrect, SNH had the correct conversion	Conversion unclear
ILS	Visual representation to pilot not matching up with conversion	Conversion incorrect
OAT	Conversion in original documentation of Teledyne incorrect, SNH had correct conversion	Conversion unclear

Landing gear in transit	Discrete reversed, wiring connected incorrectly	Conversion incorrect
Engine #1 Bleed air valve	Discrete reversed, wiring connedted incorrectly	Conversion incorrect
Engine #2 Bleed air valve	Discrete reversed, wiring connedted incorrectly	Conversion incorrect

- To develop legislation, in cooperation with the European Aviation Authorities, providing for mandatory maintenance of flight recorder equipment on a structural basis and for verification of its operation and the validity of data, in accordance with the ICAO recommendation.
- To record the agreements made with companies as a result of audits and inspections properly and strictly verify the compliance with these agreements in order to observe incomplete- or non compliance in a timely manner.
