GENERAL INFORMATION

Identification number:	2007037
Classification:	Serious incident
Date, time ¹ of occurrence:	19 April 2007, 23.17 hours
Location of occurrence:	Rotterdam Airport
Aircraft registration:	PH-HRK
Aircraft model:	Piaggio P.180 II Avanti
Type of aircraft:	Twin engine turbo propeller aircraft
Type of flight:	Charter
Phase of operation:	Landing
Damage to aircraft:	Minor
Cockpit crew:	Two
Passengers:	One
Injuries:	None
Other damage:	None
Lighting conditions:	Darkness

SUMMARY

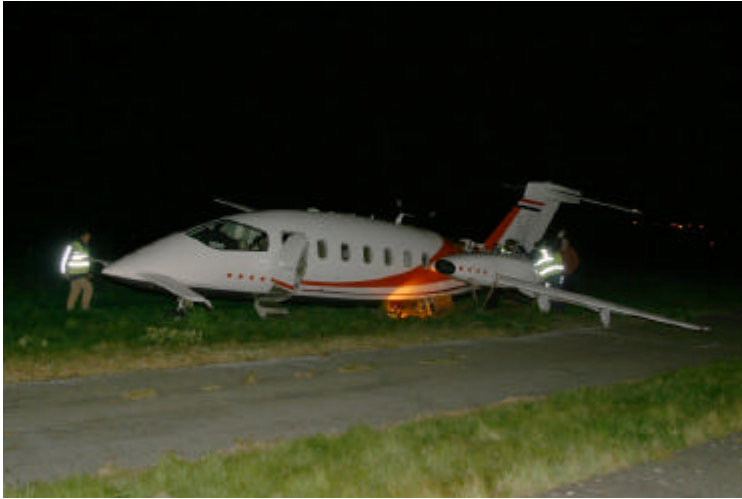
The captain informed air traffic control of the runway departure and secured both engines. After inspection of outside conditions and absence of engine fire, the first officer evacuated the passenger. The aircraft suffered damage to the rim of the left-hand main landing gear and the left-hand propeller blades. No one was injured.

Illustration 1: PH-HRK after the runway excursion
