GENERAL INFORMATION

Identification number:	2007088
Classification:	Serious incident
Date, time ¹ of occurrence:	11 September 2007, 18.57 hours
Location of occurrence:	Near Stolwijk
Aircraft registration:	PH-SVT
Aircraft model:	Apex Robin DR400/135CDi
Type of aircraft:	Single engine propeller aircraft
Type of flight:	Training flight
Phase of operation:	Landing
Damage to aircraft:	Severe damage to engine
Cockpit crew:	Two
Passengers:	One
Injuries:	None
Other damage:	None
Light conditions:	Daylight

SUMMARY

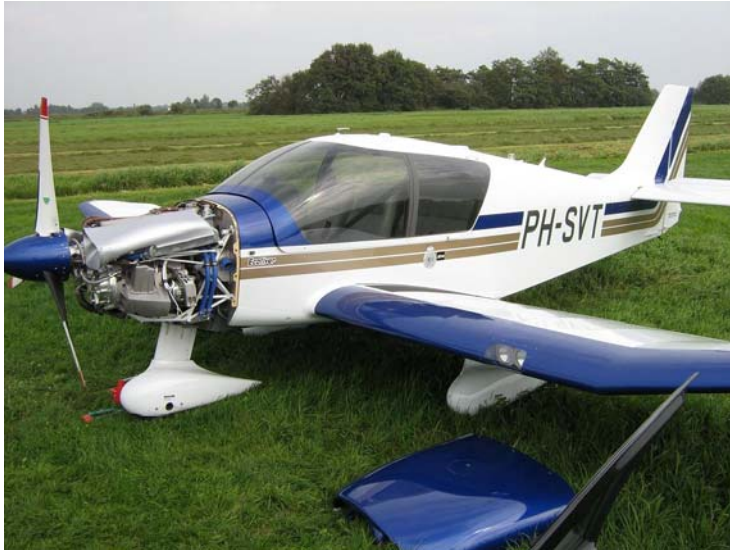
Figure 1: PH-SVT after the emergency landing with the engine cover removed for investigative purposes

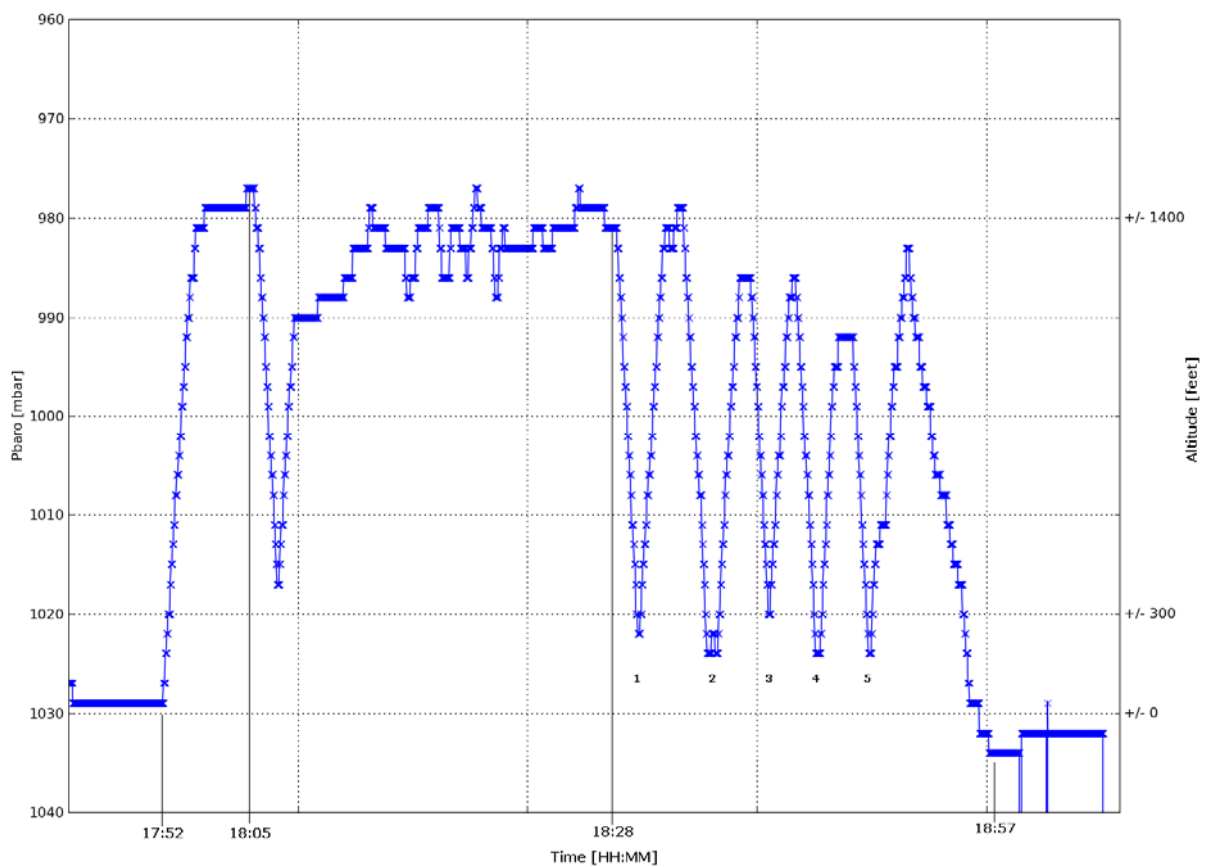
Figure 2: the barometric pressure (Pbaro) and altitude during the flight

At 18.05 hours a descent was made from 1400 feet to approximately 300 feet. Starting from 18.28 hours the barometric pressure showed five descents with the engine at idle (load 0 %). After each of these descents a load of 100% was selected and the altitude increased to approximately 1000 till 1400 feet.

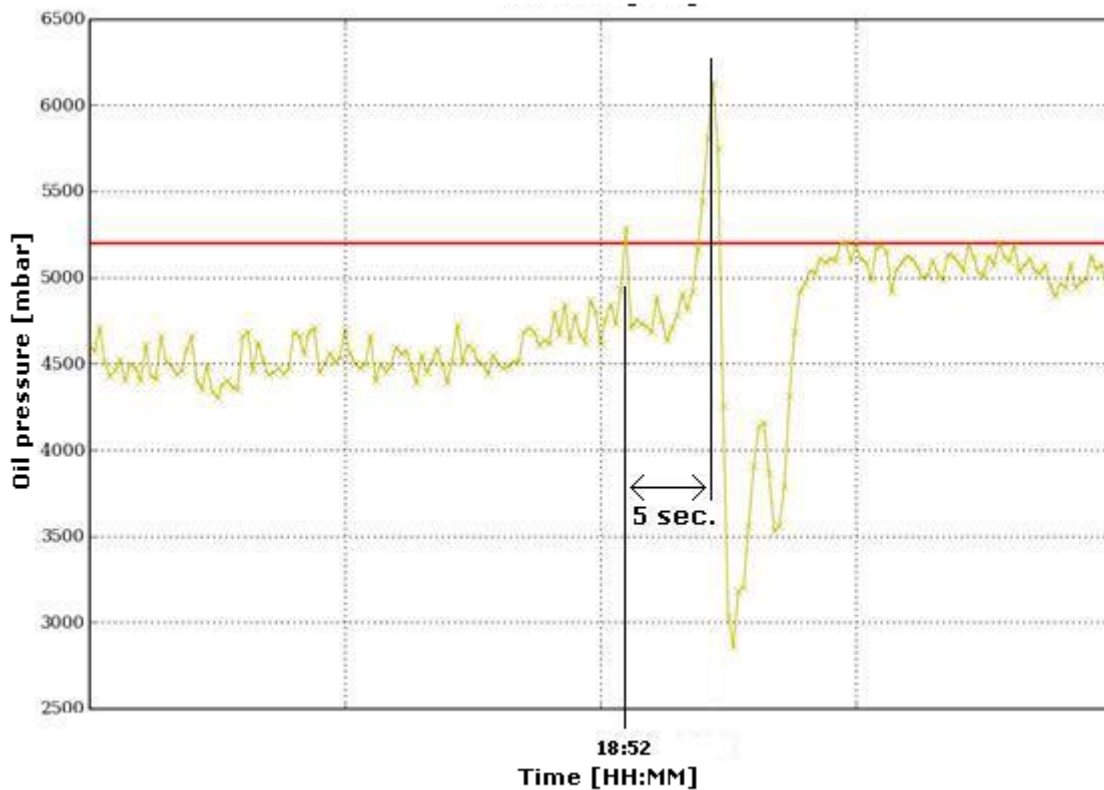
At 18.49 hours a climb with 100% load was ongoing. At 18.52 hours an oil pressure of 5286 mbar was recorded, which exceeded the limit of 5200 mbar, prescribed by the manufacturer. See figure

3. Next the pressure dropped to below 5200 mbar and five seconds later the recorded oil pressure was 6133 mbar. After this the oil pressure continued to drop to 2865 mbar. A few seconds later the oil pressure stabilized between 5000 and 5200 mbar.

Figure 3: oil pressure (yellow) and the limit specified by the manufacture (red)

After the oil pressure spike and drop the manifold pressure (MAP) and engine revolutions (RPM) did not return to the previous stabilized limits. The RPM settled below 2000 RPM and declined over a period of time. The MAP stabilized at approximately 1500 mbar. Both the MAP and RPM indicated that a load of 60% was produced, however a load of 100% was selected. At 18.55 hours the FADEC recorded a switch to ECU B but no changes in engine parameters were recorded. The barometric pressure increased over time and at 18.57 hours a barometric pressure of 1034 mbar was recorded when the aircraft was on the ground and the engine shutdown.

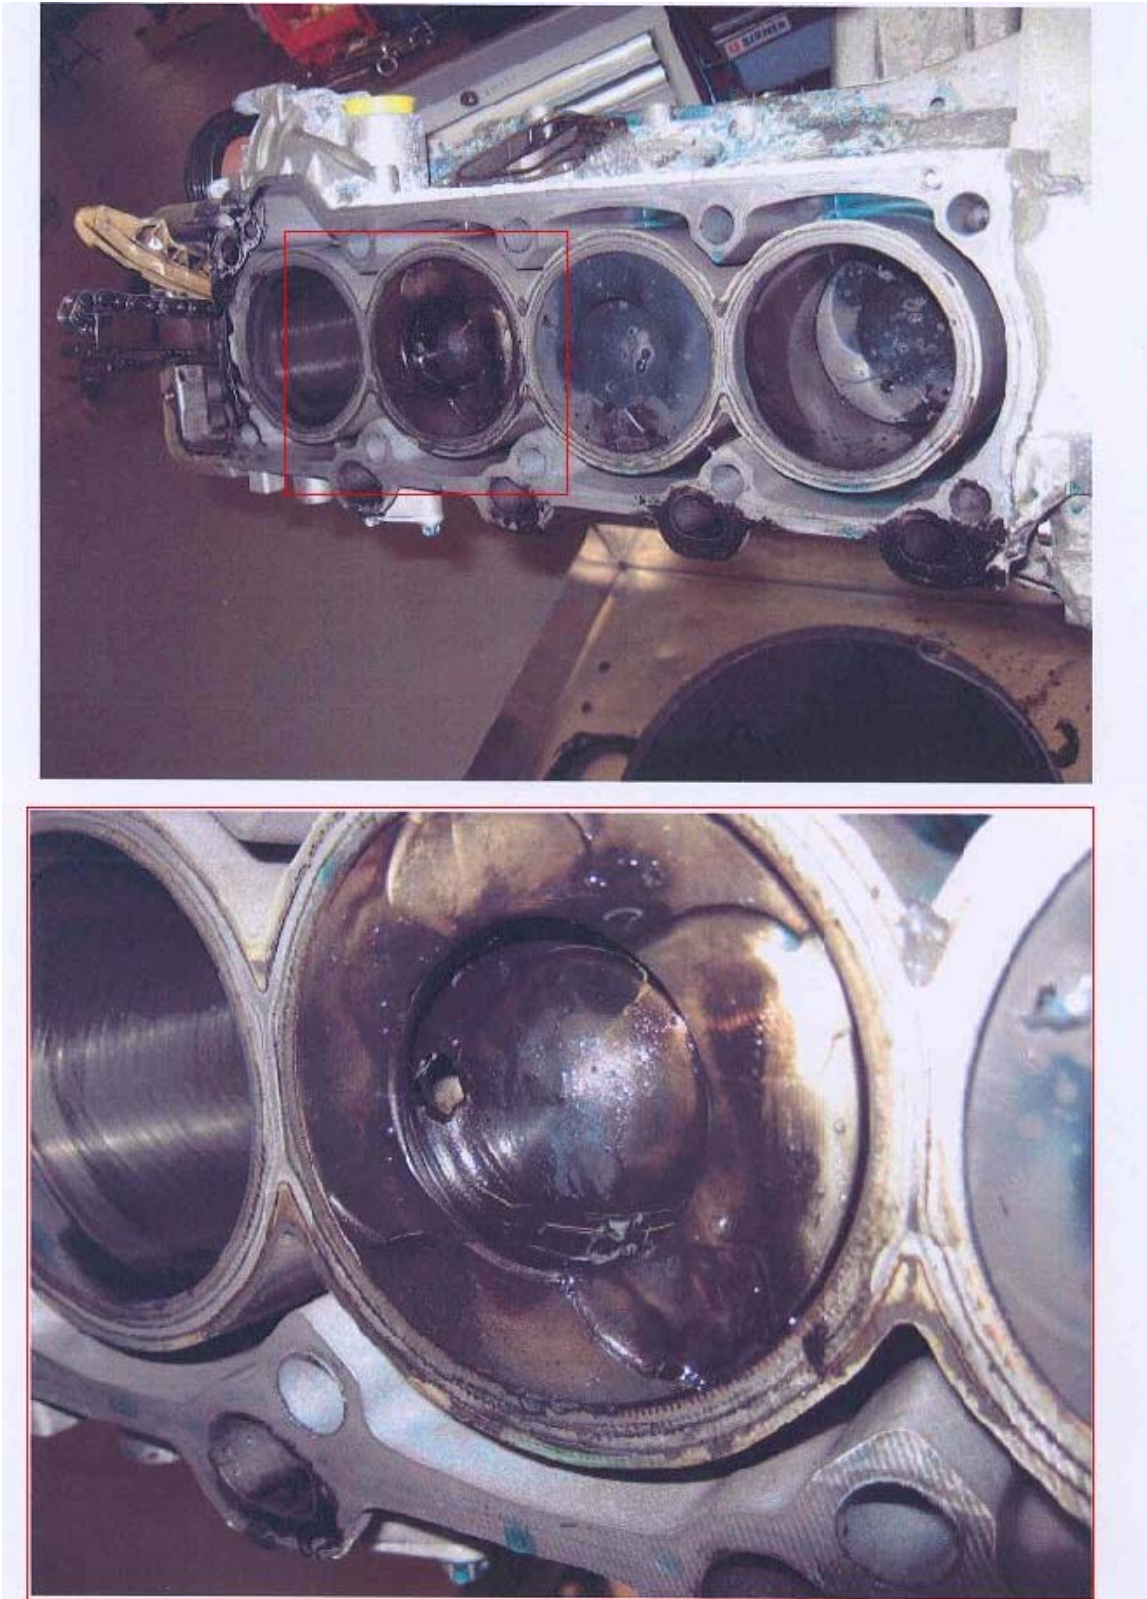
- Severe damage on cylinder/piston number 2. A hole in the piston head was detected on the cylinder with reduced compression. The hole in the piston head had a diameter of approximately 5 millimetre. Moreover, sever scratches were found on the contact surface of the cylinder and piston (figure 4).
- The oil nozzle of cylinder number 2 and number 3 were found (figure 5).

Due to the lack of clearance between the oil nozzle and the hollow in the piston skirt, the oil nozzle pipe and the oil nozzle connected on it were stressed during each cycle. As a consequence the oil nozzle pipe cracked and the oil cooling of the piston head was interrupted. The thermal overstress lead to mechanical damage of the piston. Hence the compression of the cylinder was reduced and an in-flight loss of power occurred.

Figure 4: view of engine teardown during investigation (top) with detail of hole in the piston (bottom) (source: BFU)

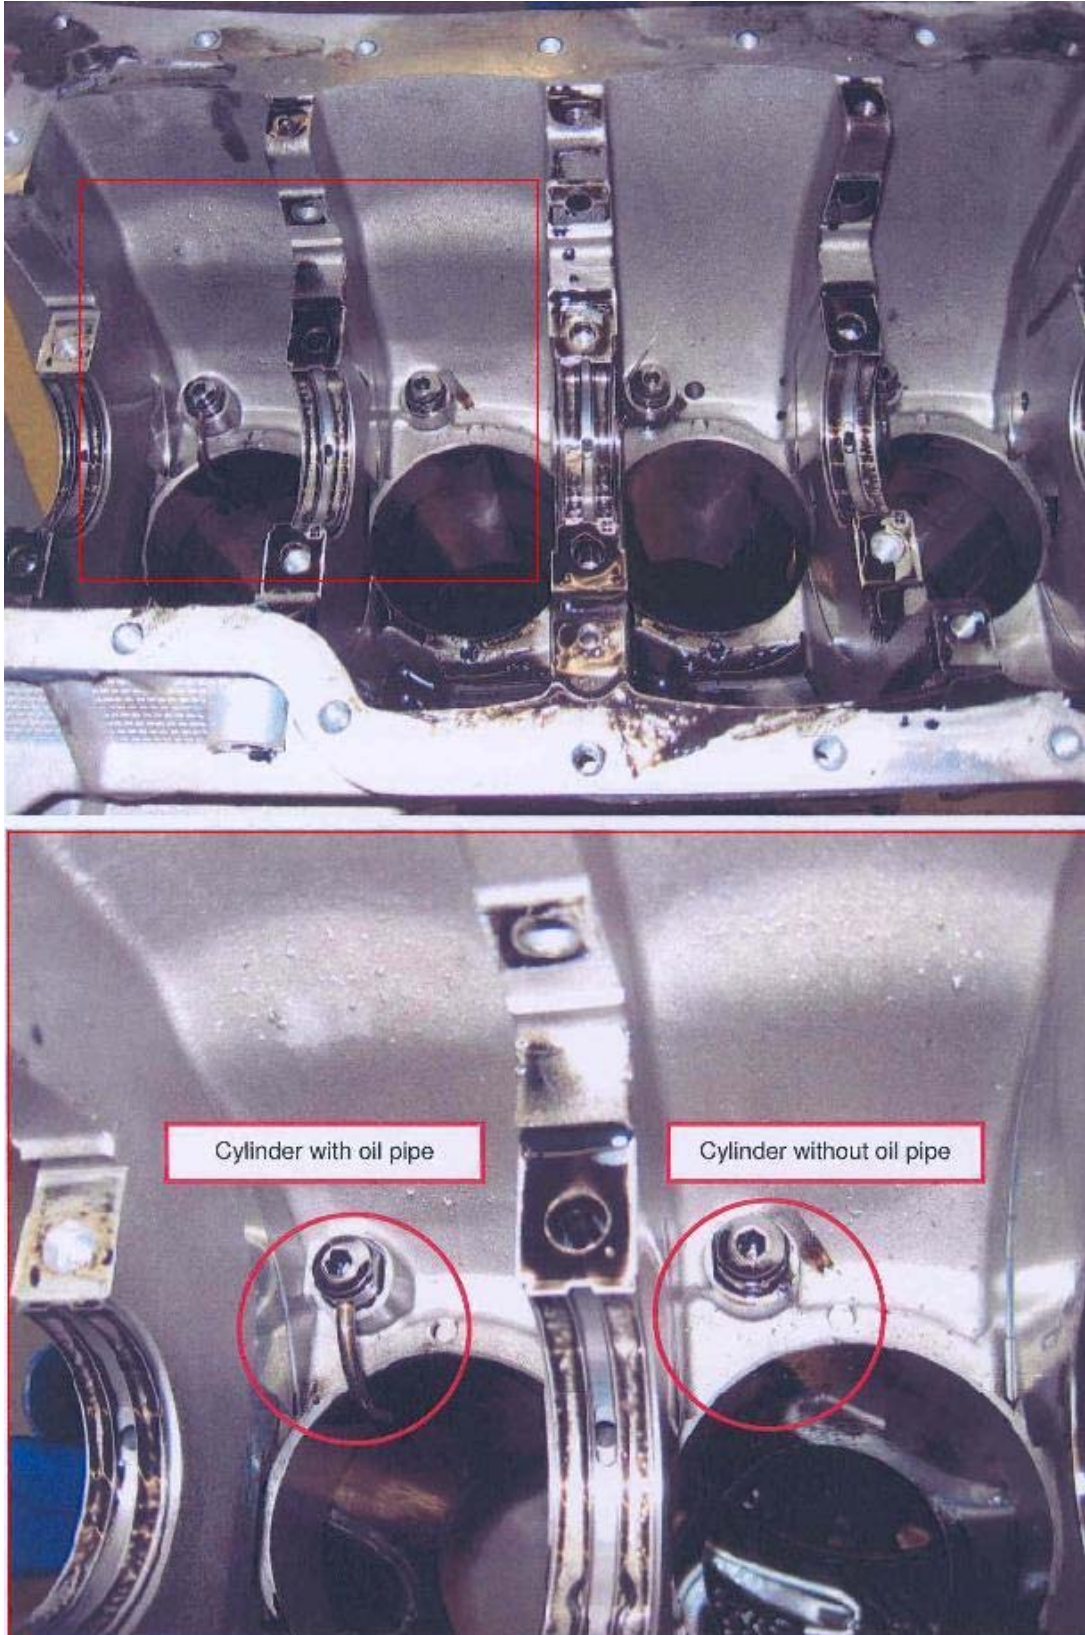
The engine pistons are cooled by oil which is fed to the bottom of the piston heads. The cooling oil is fed by an oil line which ends with a nozzle. The investigation showed that on two of the four cylinders the oil nozzle in the lower housing was broken. These broken nozzles were found in the lower housing of the engine. One oil nozzle pipe was scrunched. On further investigation a contact pattern mark on the hollow of the piston was identified. This hollow is designed to allow sufficient clearance between the oil nozzle and the piston.

The probable cause of the engine malfunction was thermal overstress of the piston as a result of reduced cooling. The piston received insufficient oil because of a broken oil nozzle. The nozzle was broken due to inadequate clearance between the oil nozzle pipe and the piston.

Figure 5: view of engine teardown during investigation (top) with detail of oil pipe nozzles (bottom: cylinder with and without oil pipe) (Source: BFU)

On February 22nd 2008 a Service Bulletin⁶ was published by Thielert Aircraft Engines GmbH, see appendix 1. This Service Bulletin was directed to inspect the engine for broken oil nozzles. Also during each 100 hour regular engine inspection it is now mandated to check the oil nozzles for anomalies. The production process of the oil nozzle has also been modified.
