LOSS OF PART OF TAILFIN

Occurrence:	2007091
Classification:	Serious incident
Date, time ¹ of occurrence:	11 September 2007, 09.17 hours
Place of occurrence:	North Sea, 30 NM north of Den Helder Airport, the Netherlands
Aircraft registration:	OY-HSL
Aircraft model:	Eurocopter EC155B1
Type of aircraft:	Helicopter
Type of flight:	Passenger flight
Phase of operation:	Cruise
Damage to aircraft:	Serious, partial loss of tailfin
Number of crew:	Two
Number of passengers:	Nine
Injuries:	None
Other damage:	None
Lighting conditions:	Daylight

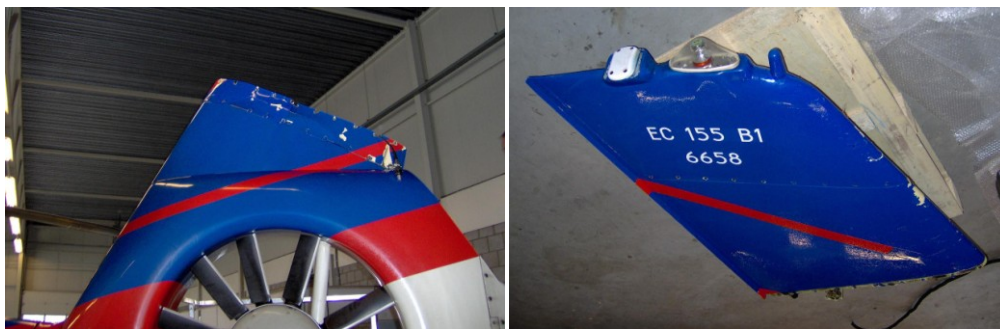
Figure 1: The lower part of the tailfin (left) and the separated upper part of the tailfin (right).

A few days after the event the upper part of the tailfin washed ashore at the island of Terschelling and was recovered. The lower part of the tailfin was inspected and a fatigue crack was found on the forward fitting. Inspection of the aft fitting showed a failure which was indicative of overload. Analyses of the fractures make it probable the forward fitting failed first whereby the upper part of the tailfin ripped, overloading the aft fitting. In day to day operations, the hinge system was not used for parking the helicopter in the hangar.

- The loss of the upper tailfin part was probably caused by a fatigue crack on the forward attachment fitting of the lower part of the tailfin.
- Due to the failure of the forward attachment fitting, the separation of the upper part of the tailfin caused an overload of the aft attachment fitting.

Eurocopter published a safety bulletin on 28 September 2007 asking for a repetitive inspection on all EC155 helicopters every 55 flight hours. For the Eurocopter models AS365N1, N2, N3 and AS 366G1 this was for every 110 flight hours³. This Safety Bulletin was endorsed by an EASA Emergency Airworthiness Directive (AD) 2007-0259-E published on 2 October 2007.

During application of the required repetitive inspections two other cases of cracks, in the forward lower fitting were discovered. As a result of further investigations, EASA issued AD 2007-0259-R1 in February 2010 superseding AD 2007-0259-E. This latest AD removed the repetitive inspection for the SA365, AS365 and SA366 helicopters, modified the time requirement for initial inspection, and specified the inspection area. The manufacturer developed a Design Change⁴ of the forward fitting, increasing the resistance of the attachment fittings (hinges) between the fairing and the vertical fin. This Design Change was approved by EASA in July 2010. The Design Change is implemented in helicopters delivered since July 2010. At time of publication of this report (May 2011) a proposed AD is under publication for retrofitting the whole EC155 fleet with the new fitting design. The introduction of this new design will remove the 55 hour inspection interval.

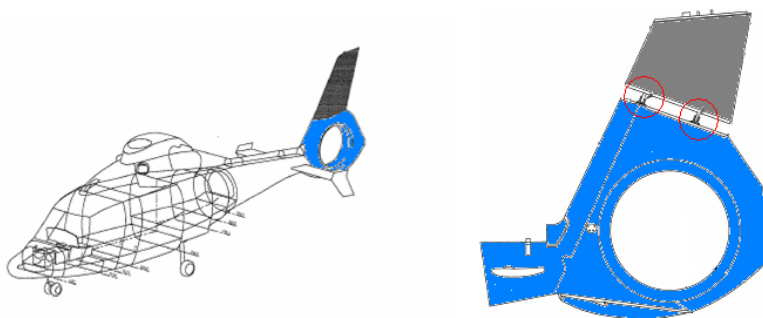
Figure 2: Schematic overview of the EC155B1 helicopter with a coloured tailfin, consisting of a lower tailfin part (light blue) and an upper tailfin part (grey). The two attachment fittings are circled in red.
