Occurrence:	2007096
Classification:	Serious incident
Date and time <sup>1</sup> :	27 September 2007, 15.55 hours
Location of occurrence:	Amsterdam Schiphol Airport (EHAM)
Aircraft registration:	B-2428
Aircraft model:	Boeing 747-412F
Type of aircraft:	4-engine cargo aircraft
Type of flight:	Commercial cargo flight
Phase of operation:	Landing
Damage to aircraft:	Bottom of the right outboard engine plating damaged
Flight crew:	Three
Passengers:	None
Injuries:	None
Other damage:	None
Lighting conditions:	Daylight

The right outboard engine of the aircraft touched the ground during landing. As a result of this the bottom of this engine was damaged.

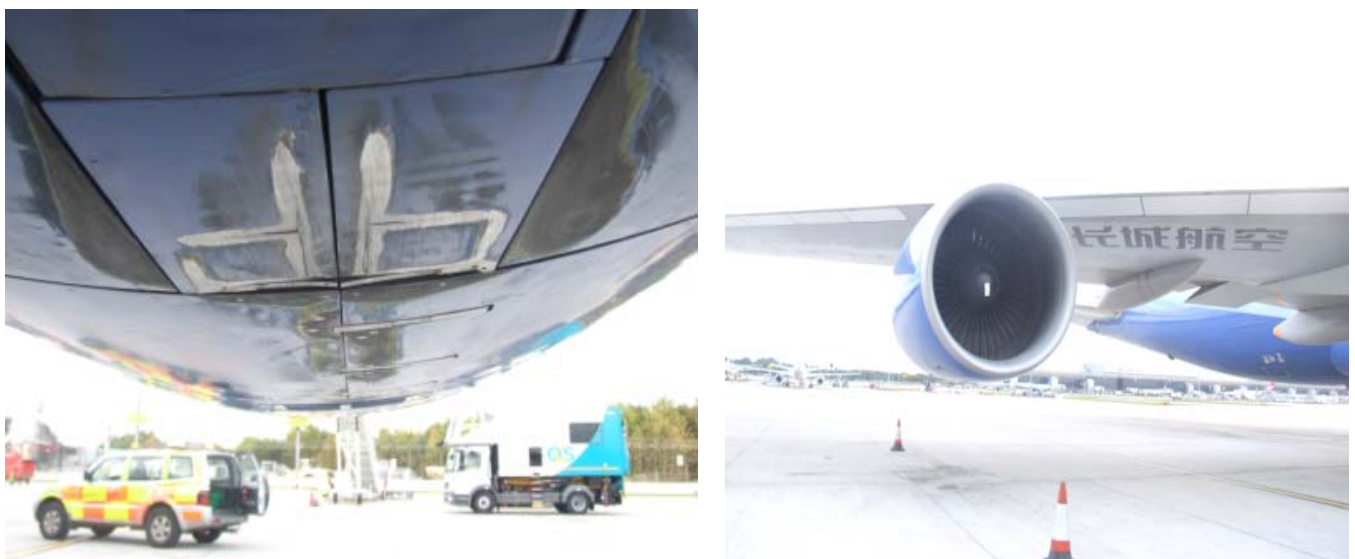
After the landing at Manchester, maintenance personnel discovered damage to the bottom of the right outboard engine plating. The British Air Accidents Investigation Branch (AAIB) was informed about this by the airport authorities and they started an investigation.

*Figure 1: damage to the bottom of engine 4*

In view of the FDR analysis, the damage found in Manchester to the plating of engine 4 was most probably caused during the landing at Schiphol. It is unclear why during the visual inspections of the aircraft the damage was not discovered.

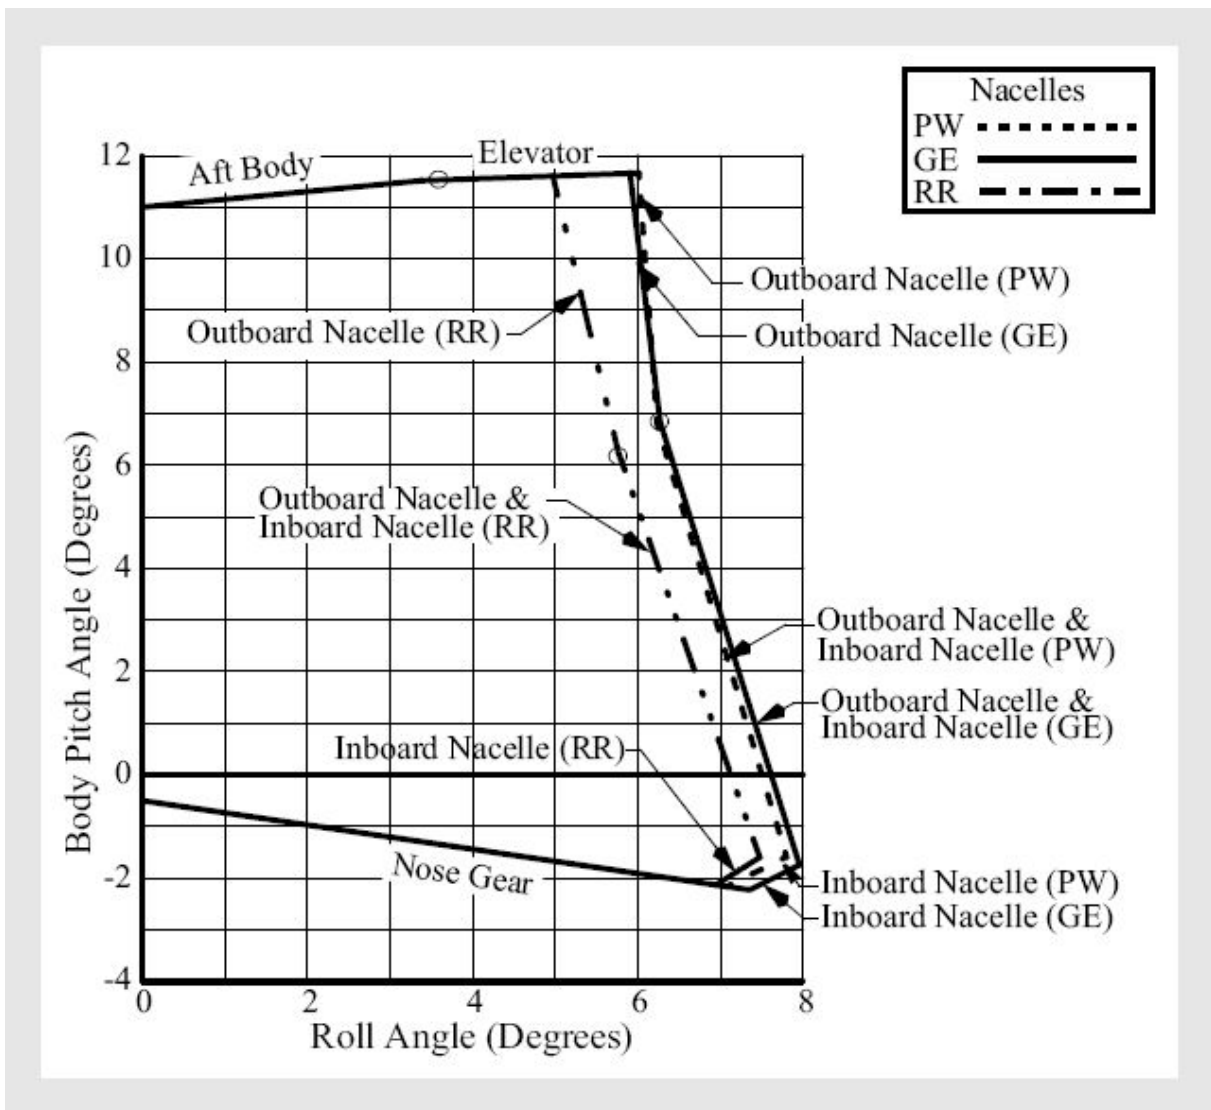
Figure 2: ground contact angles – normal landing (PW = Pratt & Whitney engines)

Although it has not been investigated whether all parameters for the conditions of a 'normal' landing situation were met, based on figure 2 it is probable that the right engine touched the runway immediately after the landing. The data of all other landings that were available on the FDR showed pitch and roll values that remained within the limits of figure 2. It is unclear why the damage was not observed by the maintenance crew or during the inspection by one of the crew members prior to the next flight.

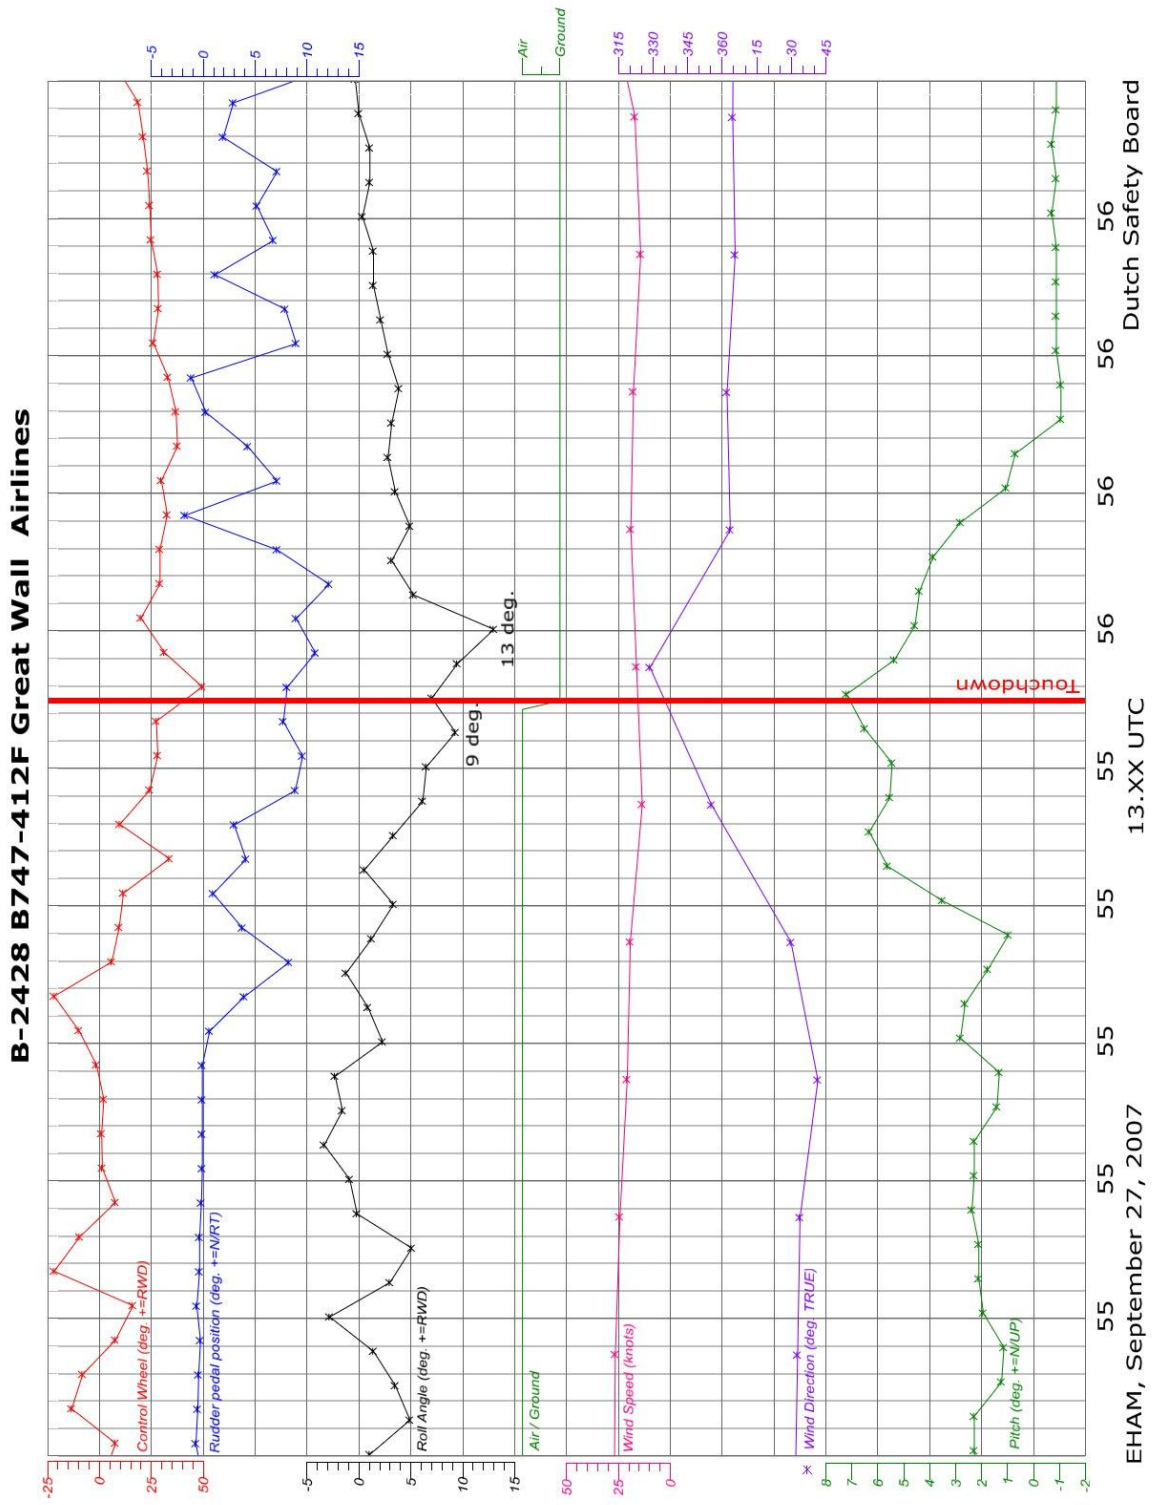
The following data emerged as well as other data from the analysis of the FDR. Up to approximately 13 seconds before the landing at Schiphol, the wind recorded on the FDR was 034 degrees with a speed of approximately 25 knots. As from this moment, the wind started to shift to 329 degrees while the wind speed dropped to 15 knots. Just before the landing, the aircraft started to roll to the right with a roll angle up to 9 degrees as a result of steering inputs of the pilot. Immediately after the main wheels touched the ground, the roll angle reached a maximum of 13 degrees with a pitch of 7 degrees nose up.

Figure 3: relevant FDR parameters
