The Dutch Safety Board

Occurrence #:	2004089	Classification:	Serious incident
----------------------	----------------	------------------------	-------------------------

Date of the occurrence:	14-06-2004	Flight crew:)
Place of the occurrence:	Amsterdam (EHAM)	Cabin crew:)
Aircraft registration:	EP-IBA) Total:	250
Aircraft model:	Airbus A300-600	Passengers:)
Aircraft type:	Passenger aircraft		
Type of flight:	Scheduled flight	Injuries:	None
Phase of operation:	Taxiing		
Damage to aircraft:	Substantial	Lighting conditions:	Daylight

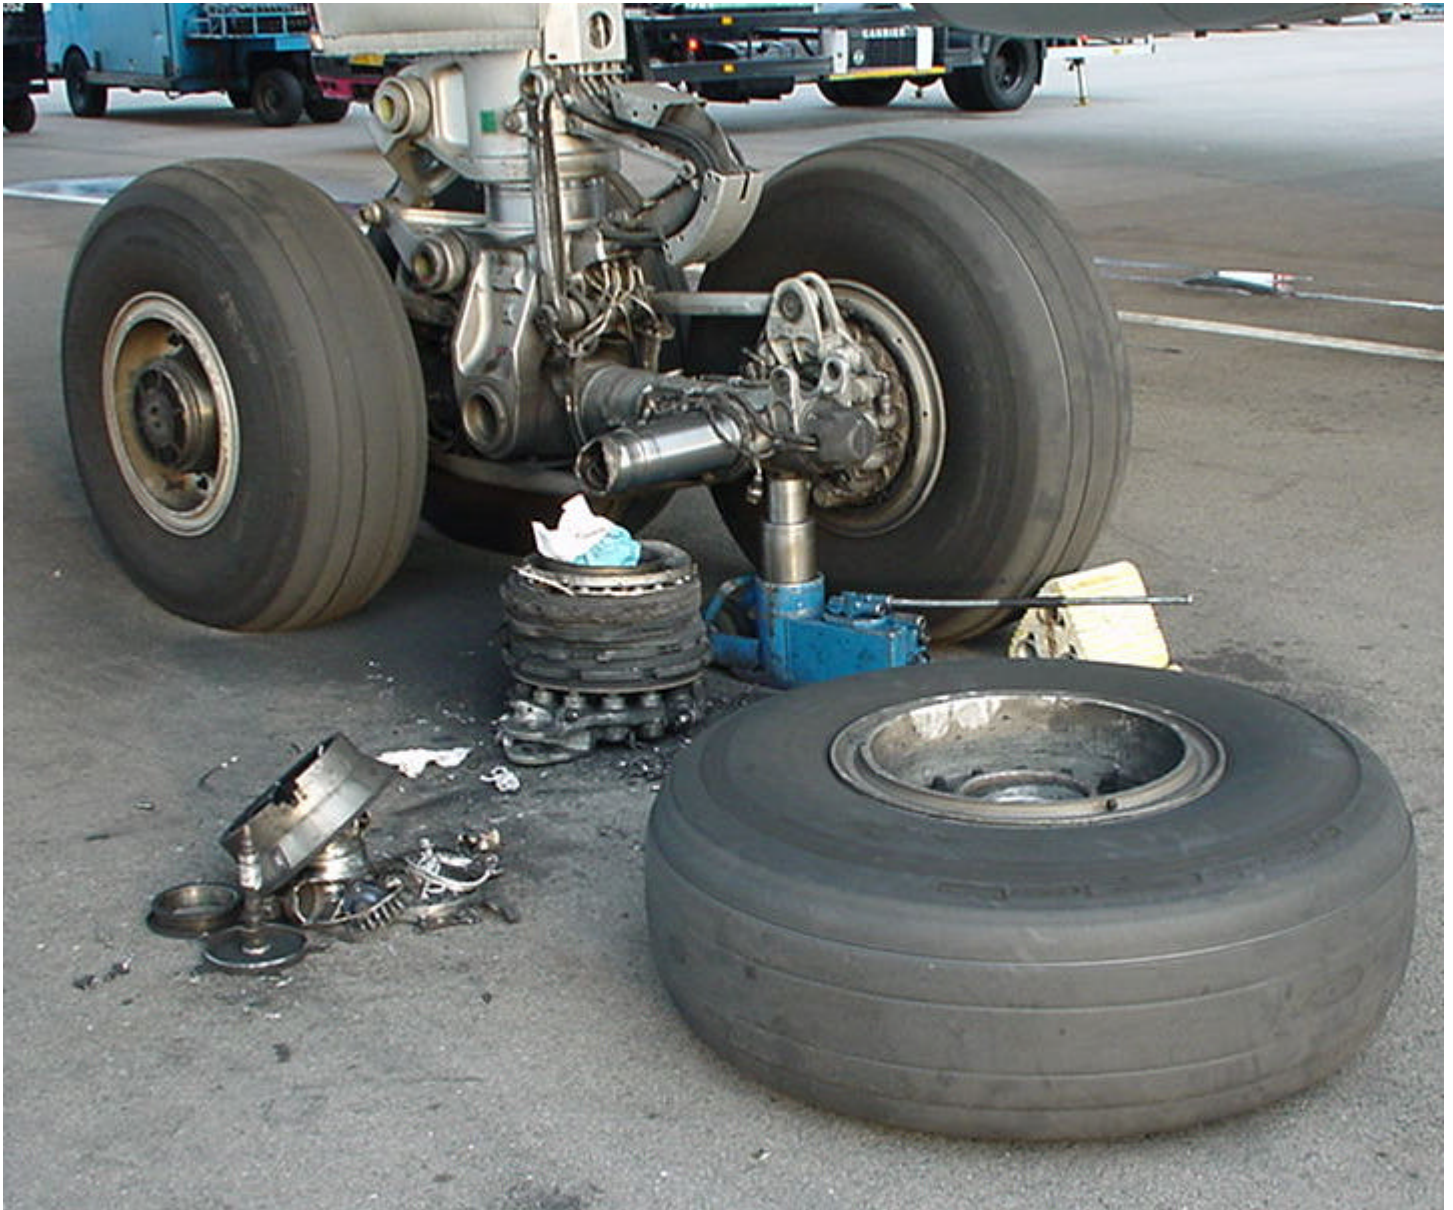
Shortly afterwards IRA 764 reported to the Air Traffic Control (ATC) heating on the left wheel brake and requested the brake to be checked by their own (on board) ground mechanics. This was at first refused because first the fire brigade had to check the supposed overheated break of the Left Hand (LH) Main Landing Gear (MLG). Therefore ATC requested IRA 764 to switch off their engines. Only after several request and demands IRA 764 was willing to do so. A visual inspection was carried out by the on board ground mechanics and a ground mechanic of a local maintenance company. A misalignment of wheel no. 5 was observed. After been towed back to the parking area removal of the wheel revealed that the axle and axle sleeve were sheared off. The tire had not been deflated.

- The root cause of the wheel axle rupture is an overheating which led to spreading of cadmium plating within the steel, making it fragile to rupture. Metallurgical investigations performed on the axle show an obvious cadmium embrittlement within the base material leading to a crack initiation and then an intergranular propagation leading to final static rupture. Overheating of the axle is a consequence of bearing overheating.

- The bearing failure would be the only overheating source identified in the wheel and brake system.
- Rollers and races were not retrieved; root cause of the roller bearing seizure will remain undetermined (lack of lubrication, corrosion, over torque, excessive wear).
