The Dutch Safety Board

Occurrence #: 2005159 **Classification:** Serious incident

Date of occurrence:	09-12-2005	Cockpit crew:	2
Place of occurrence:	Rotterdam Airport (EHRD)	Cabin crew:	0
Aircraft registration:	EC-HZH	Passengers:	0
Aircraft model:	Fairchild SA227-AC Metro III		
Airline company:	Aeronova	Injuries:	None
Type of aircraft:	Passenger/cargo aircraft		
Type of flight:	Ferry flight		
Phase of operation:	Landing		
Damage to aircraft:	None	Lighting conditions:	Daylight

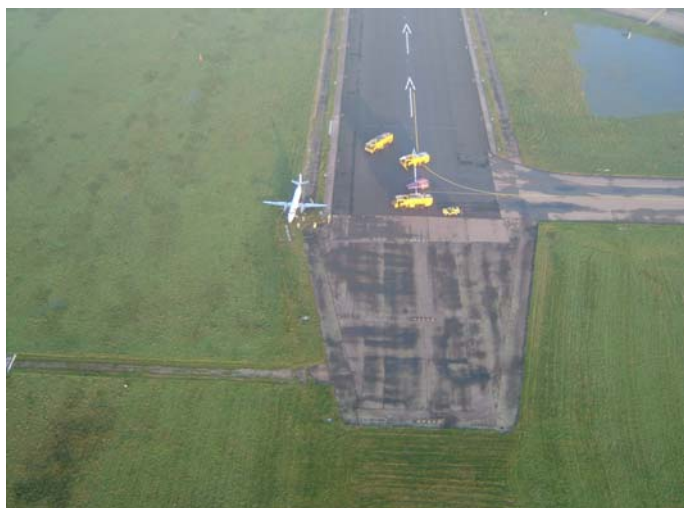
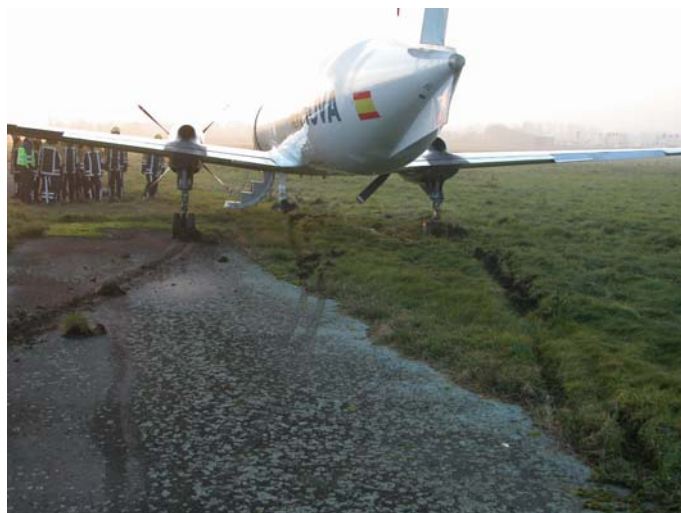
The wind at the time of the occurrence was 050 degrees with 6 knots, visibility 6,000 meters with some haze. Control of four aircraft coming from the northeast with destination Rotterdam was handed over from Amsterdam Area Control Centre to Rotterdam Approach. Initially runway 06 was in use for landing. On request of the crew of at least one incoming aircraft and because of the light wind, Rotterdam Approach changed the landing runway to runway 24 to enable a straight-in approach. OVAT42 was the first in sequence and was cleared with heading and descend instructions to 2,000 feet for an instrument landing system (ILS) approach. The first officer was pilot flying (PF). The air traffic controller got concerned about the (high) approach altitude the aircraft was flying. At four nautical miles from touchdown the altitude was approximately 1,600 feet (derived from radar data) while it should be around 1,200 feet. The air traffic controller asked the crew if they could manage the approach, which was confirmed. The captain took over the controls of the aircraft when they were flying near the outer marker. The aircraft touched down at about one third of the available runway length. At the end of the runway the aircraft veered to the right and came to rest in the grass near the threshold of runway 06. Both occupants left the aircraft without injuries. The aircraft was not structurally damaged.

EC-HZH near threshold runway 06 (source: Airport Authorities Rotterdam Airport)

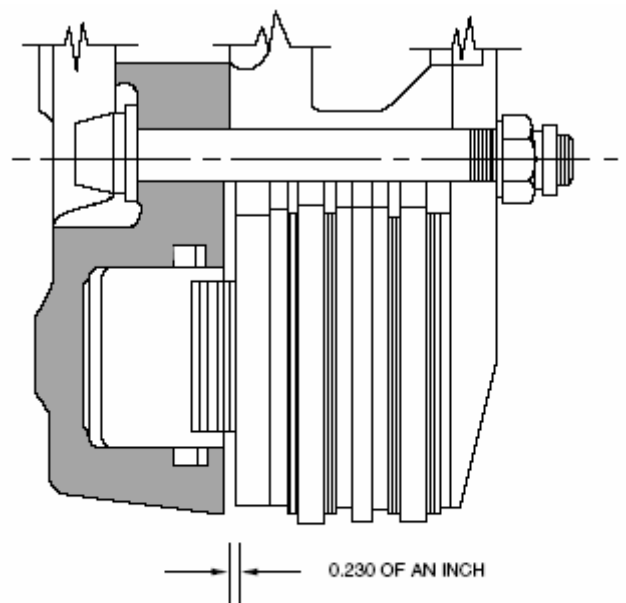
- No hydraulic failures were detected.
- All brake units showed normal wear and tear marks.
- All brake units had been subject to overheating.
- Two brake units were worn beyond inspection limits. The units were respectively 0.1 and 0.3 mm beyond the maximum wear limit of 5.8 mm (0.230 inch).
- None of the brake units showed signs of glazing.

It is unknown when the overheating occurred but it is not unlikely that it happened during the incident flight. The result of overheated brakes is brake fade, the same amount of force at the pedal no longer provides the same amount of deceleration. The excessive heat decreases the relative coefficient of friction between the friction material and the disks.

Although two of the four brake units were worn slightly beyond limits, it is unlikely that the braking action was significantly affected by this.

According to the operator the brakes are checked every 75 flying hours during a service check inspection. The inspection of the brakes consists of a visual check for hydraulic leaks and a dimensional check of the gap between the housing and the pressure plate. If a brake fails the dimensional check it must be removed for maintenance. The last time this inspection was performed was on 13 November 2005, less than a month and about 15 flying hours before the incident flight. During the last inspection the brakes were signed off as serviceable.

REMOVE BRAKE FOR MAINTENANCE WHEN
DIMENSION FROM HOUSING TO THE PRESSURE
PLATE IS 0.230 OF AN INCH OR GRATER,
Brake Unit (copy of maintenance manual)
