DUTCH SAFETY BOARD

Occurrence number: 2007028

Classification: Accident

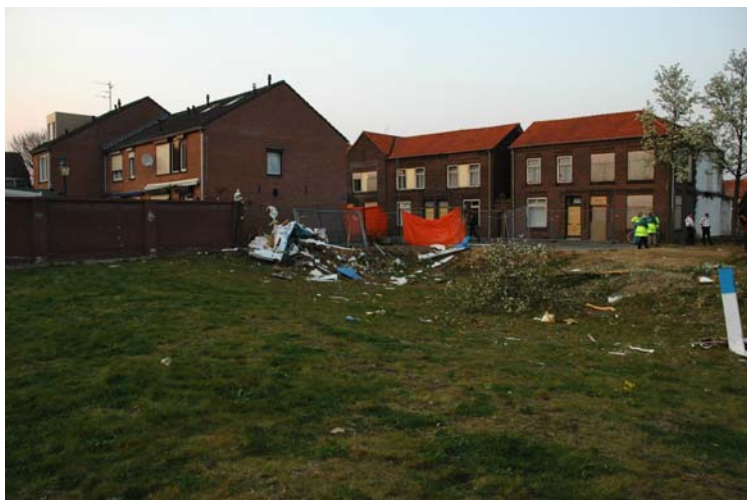
Figure 2: The accident site

The location at which the D-KDBV came to rest is an undeveloped open terrain within a residential area. The size of the terrain is estimated to be 200 meters by 100 meters. The terrain is surrounded by buildings at all sides. The aircraft approached from a southerly direction. Before it crashed the D-KDBV touched a tree which broke off. Subsequently the aircraft came to rest at the north side of the terrain against a bank of earth. Debris from the aircraft was dispersed and for the main part had ended up against the fence of a house. This house was damaged slightly as a result of the accident.

performed aerobatic manoeuvres on purpose, overhead the build-up area, is very unlikely. Furthermore it is unlikely that the pilot did try to execute an emergency landing on the open terrain; it appeared from the broken tree that the D-KDBV approached the terrain in a steep angle of descent. Furthermore the location of this tree is, with a view to the direction of flight, at the final part of the terrain. If the pilot would have attempted to make an emergency landing he would have the aircraft approach the terrain under a smaller angle of descent and the pilot would have attempted to land the aircraft at the beginning of the terrain.
