Factual information

Occurrence:	2006086	Classification:	Serious incident
Date occurrence:	17-07-2006	Flight crew:	3
Place occurrence:	Amsterdam Airport Schiphol (EHAM)	Passengers:	0
Aircraft registration:	N516MC	Injuries:	0
Aircraft model:	Boeing 747-200F	Lighting conditions:	Daylight
Aircraft type:	Freighter aircraft		
Type of flight:	Scheduled cargo flight		
Phase of operation:	Take-off		
Damage to aircraft:	Major

Synopsis

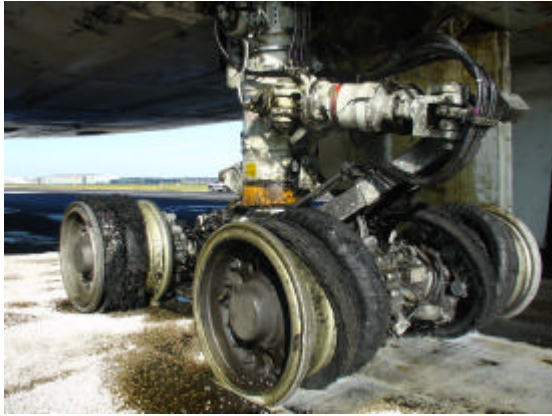
Illustration 1: Left hand body gear

Remnants from tires and wheel rims were found on the departure runway 36L. After landing, the left-hand body gear (LHBG) tires were found ruptured and the aft wheel assemblies were fractured. All thermal plugs⁵ of the left-hand wing gear (LHWG) and right-hand body gear (RHBG) had released the tire pressure. Parts of the flap system of the left wing and parts of the fuselage were found damaged. During the take-off from runway 36L and the landing on runway 06 the aircraft damaged both runways substantially, due to the wheel flanges contacting the runways.

During the take-off roll involving a relatively high take-off weight, the effects of previous or current underinflation/overdeflection were most likely the cause of the rupture of the #8 tire (aft inboard) followed by rupture of the #7 tire (aft outboard) due to the resulting overload (and possibly pre-existing internal damage due to being operated in an underinflated/overdeflected condition). Tire #6 (forward inboard) may have then failed due to foreign object debris (FOD) from the #7 and/or #8 wheels and tires. Tire #5 (forward outboard) may have also been damaged by FOD, and would have been subjected to overload following the deflation of tire #6.

The Board is of the opinion that the cause of the occurrence is that one or both of the two aft tires of the LHBG were operated in an overdeflected/underinflated condition at some point and may have had pre-existing damage, before the occurrence flight.

The combination of tire underinflation damage, the high take-off weight and the long taxi distance caused failure of these tires during the take-off roll. This was later followed by fracture of the wheel rims. Consequently the forward inboard tire failed. The forward outboard tire failed during the landing due to effects from FOD and/or overload.

The Board emphasizes the importance of correctly checking the tire pressures during the pre-flight inspection.

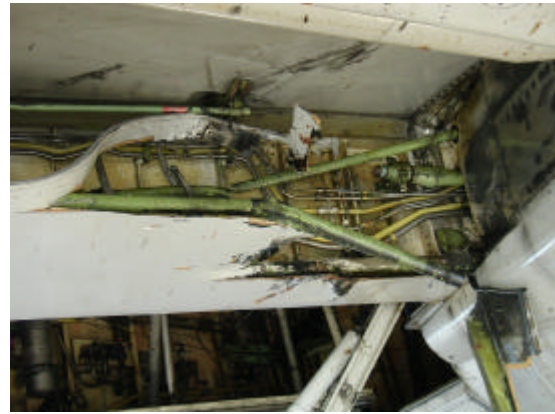
Illustration 2: Damaged parts of the flap system

During take-off from runway 36L the aircraft experienced rupture of the aft tires on the left-hand body gear (LHBG), followed by damage to the wheel rims and one forward tire. The flap system and the fuselage were damaged by the wheel rim and tire fragments. The damaged flap system caused a flap asymmetry and roll moment. The crew dumped fuel and returned to the airport. During landing on runway 06 the remaining forward tire of the LHBG ruptured. Both runways were damaged substantially by the LHBG wheel flanges rolling on the runways.

At 3,000 feet after the flaps were retracted to 10 degrees, a deflection of the control wheel was required to keep the wings level. The captain stated that aircraft systems notified an asymmetrical inboard flap problem. The indicated left inboard flap position was 5 degrees while the indicated right inboard flap position was 10 degrees. Both indicated outboard flap positions were 10 degrees. The flaps were reset to 20 degrees and the asymmetric flap checklist was performed. The crew decided to climb to 10,000 feet, kept the flaps at 20 degrees and depressurized the aircraft anticipating a possible pressurization problem.
