Factual information

Occurrence :	2007083	Classification:	accident
Date occurrence:	29-08-2007	Flight crew:	1
Place occurrence :	De Kooy Airport (EHKD)	Passengers:	1
Aircraft registration:	F-GSHG	Injuries:	0
Aircraft model:	Fouga Magister CM-170	Lighting conditions:	daylight
Aircraft type:	training jet aircraft		
Type of flight:	training flight		
Phase of operation:	landing		
Damage to aircraft:	severely damaged

Synopsis

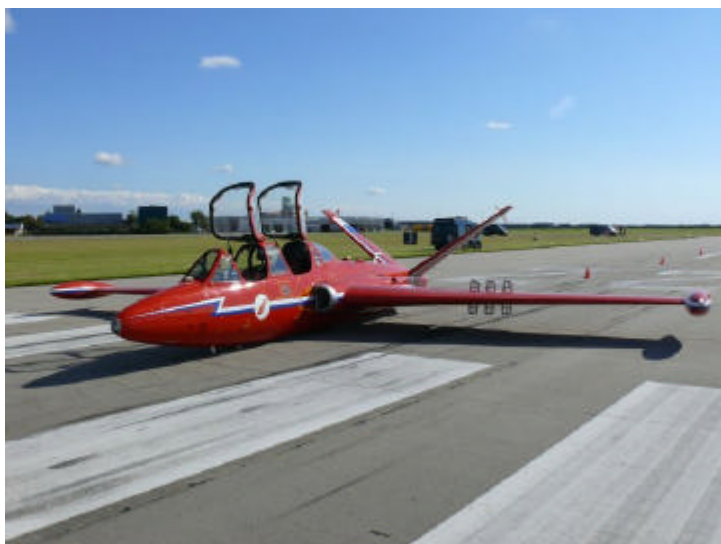
F-GSHG after the accident

- *the fuselage belly was damaged severely from the front cockpit up to the tailfin;*
- *in this belly several connectors, hydraulic hoses and fuel lines were damaged;*
- *damage was found on the right main gear and gear door;*
- *differences were found in the landing gear lever position between the front and rear cockpit.*

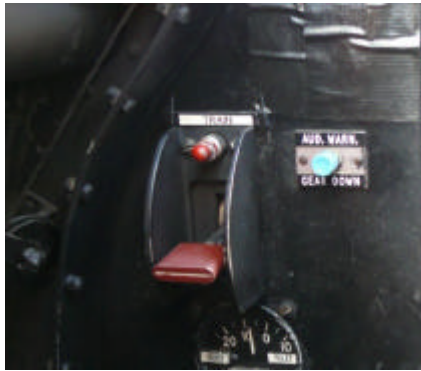
Gear lever Fouga Magister

According to the Board the most likely scenario is that during the flare the aloud spoken check "flaps 15" by the captain, was interpreted as a command by the passenger. In his confusion because this was not briefed, he accidentally took the gear lever for the flap lever and selected this up.

- during the flight and during a part of the pattern, the passenger was instructed by the captain to operate the controls and levers;
- the statement of the passenger shortly after the accident that "I was busy with my flaps when the gear retracted";
- the passenger was not quite familiar with the Fouga Magister;
- the similarity of the shape of the gear lever of the Fouga Magister with the flap lever in aircraft the passenger was used to fly in (Cessna and Beechcraft);
- the gear levers were found in the "up" position and in a position between "up" and "down".

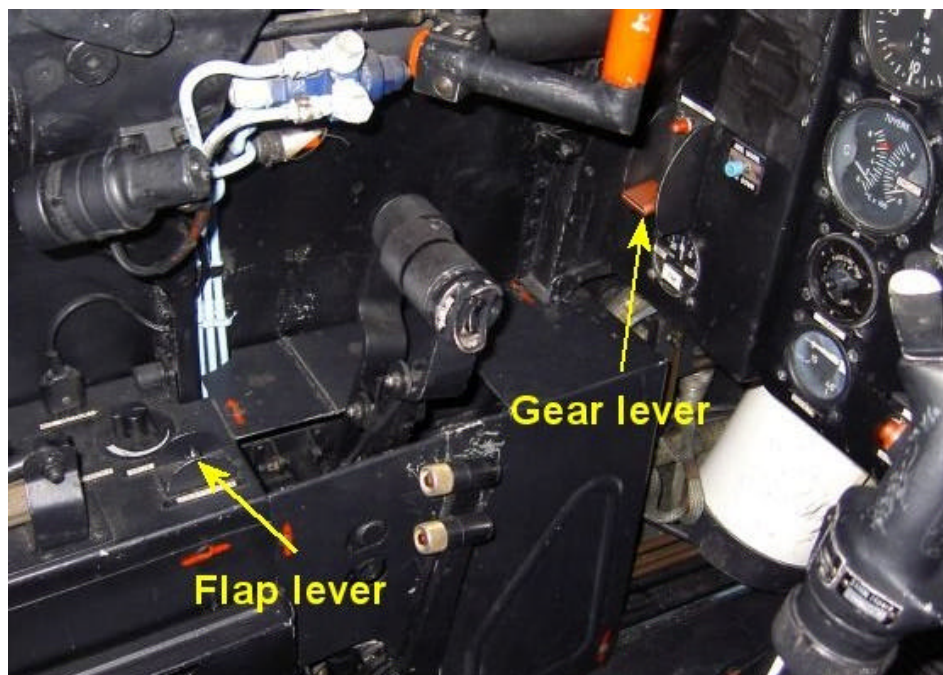
Position of the gear lever and flap lever in the F-GSHG aft cockpit.

It is most likely that the aft gear lever was lifted at the same moment the left main gear strut was fully extended at the moment the aircraft pitched up which enabled the gear lever to be manually moved to the upward position. Since no technical defects were found and the override buttons were not used, this would be the only technical possibility for the gear to retract. The damage of the right main gear and right hand gear door demonstrates that the aircraft had a small bank angle to the right upon gear retraction.
