GENERAL INFORMATION

Identification number:	2008031
Classification:	Accident
Date, time ¹ of occurrence:	31 March 2008, 12.07 hours
Location of occurrence:	Rotterdam Airport (EHRD)
Aircraft registration:	PH-KIS
Aircraft model:	Christen A-1 Husky
Type of aircraft:	Single engine piston
Type of flight:	Banner towing
Phase of operation:	Taxi-in
Damage to aircraft:	Heavily damaged
Cockpit crew:	One
Passengers:	None
Injuries:	None
Other damage:	None
Light conditions:	Daylight

SYNOPSIS

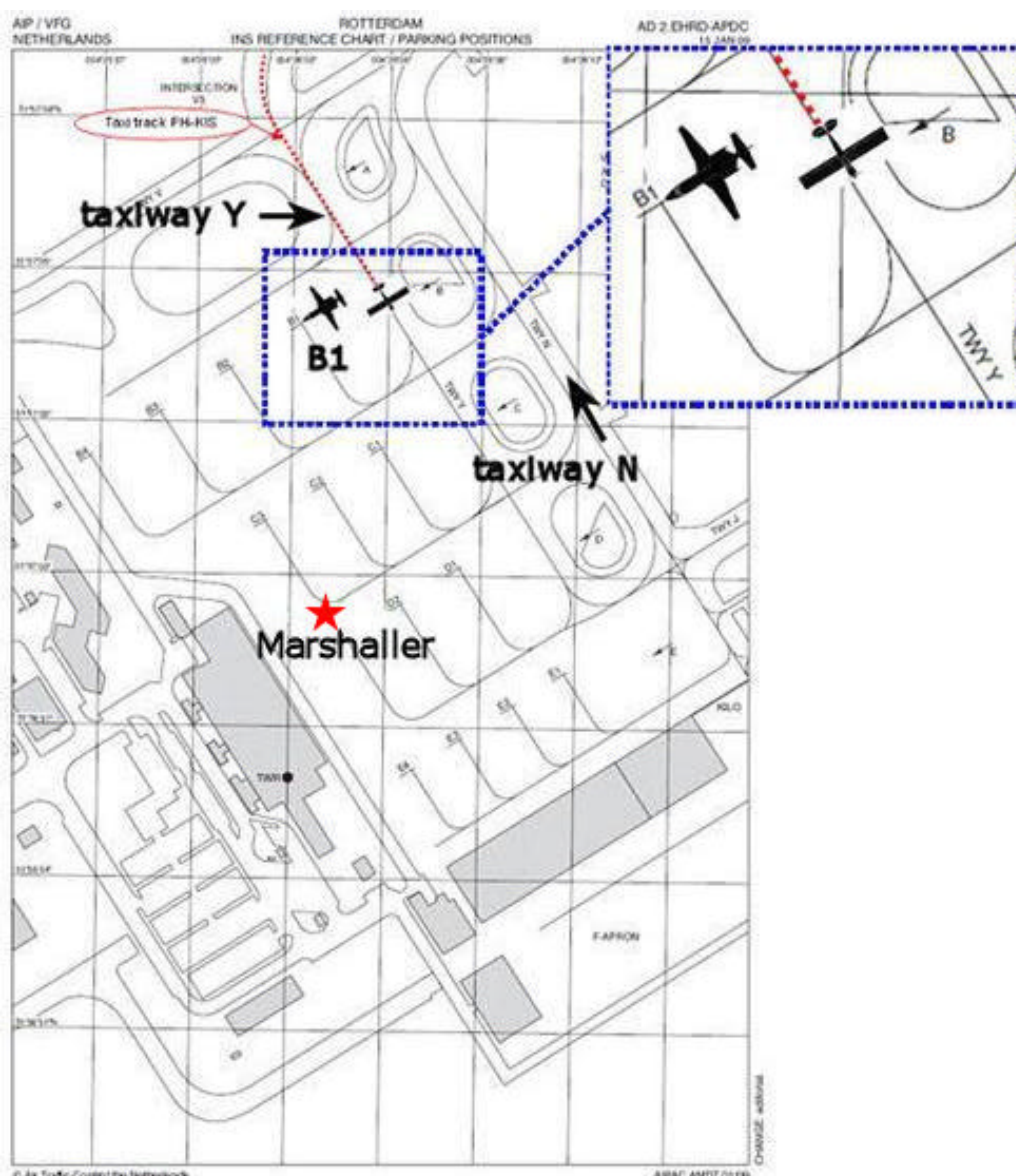
Figure 1: Situation oversight

Rotterdam Airport uses several designated parking stands to accommodate aircraft, which can be reached by taxiways Yankee or November (see figure 1).

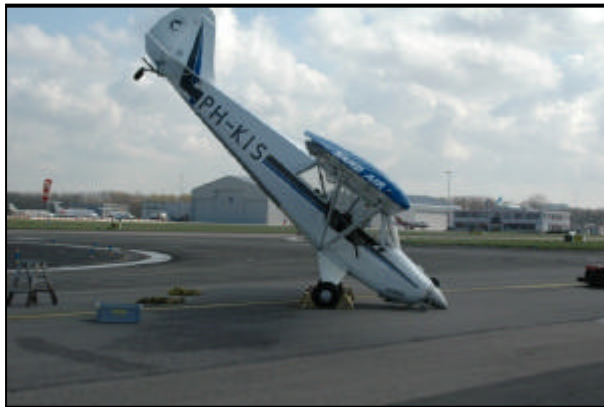
The aircraft was blown over by jet blast when it taxied behind a Cessna Citation which was performing an engine test run. The aircraft came to a rest with its nose down and the tail pointing upwards. Damage was inflicted to the left wingtip, propeller and engine. The pilot was not injured.

Figure 2: PH-KIS after the accident

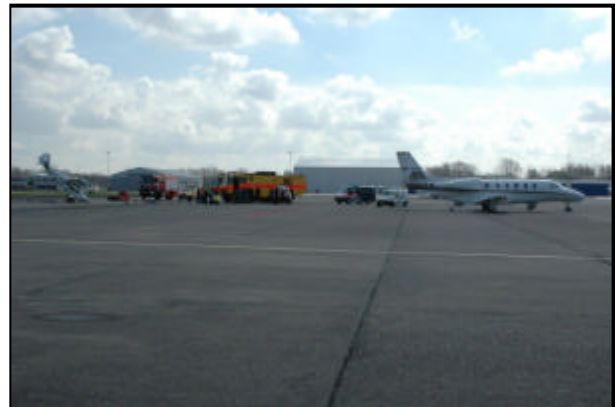
Figure 3: Situation after the accident
