GENERAL INFORMATION

Identification number:	2007038
Classification:	Accident
Date, time ¹ of occurrence:	29-04-2007, 17.23 hours
Location of occurrence :	Texel Airport (EHTX)
Aircraft registration:	D-ERPW
Aircraft model:	Cessna 182Q
Type of aircraft:	Single engine propeller aircraft
Type of flight:	Cross-country
Phase of operation:	Landing
Damage to aircraft:	Damage to nose gear, propeller, engine and engine cowling
Cockpit crew:	One
Passengers:	One
Injuries:	None
Other damage:	None
Lighting conditions:	Daylight

Structural damage after landing short of the runway.

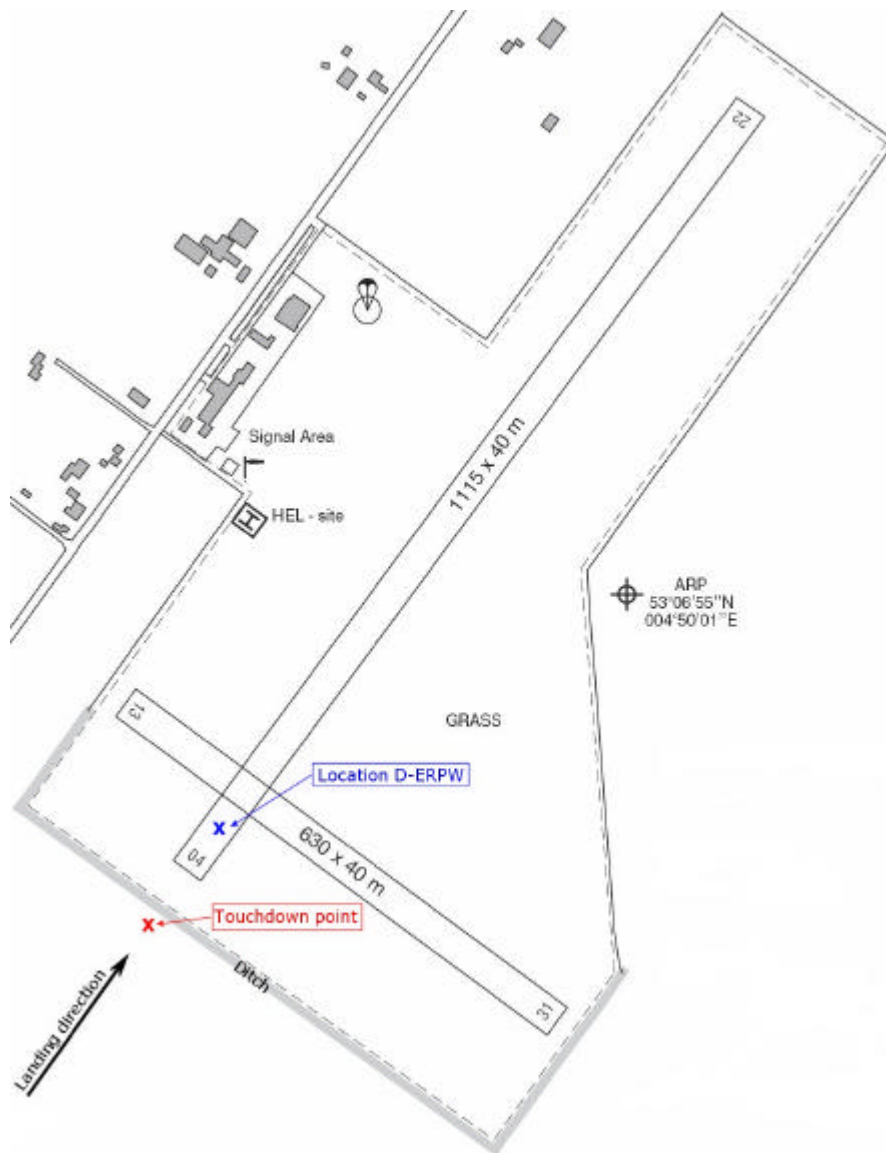
Figure 1: Situation at the time of the accident at EHTX

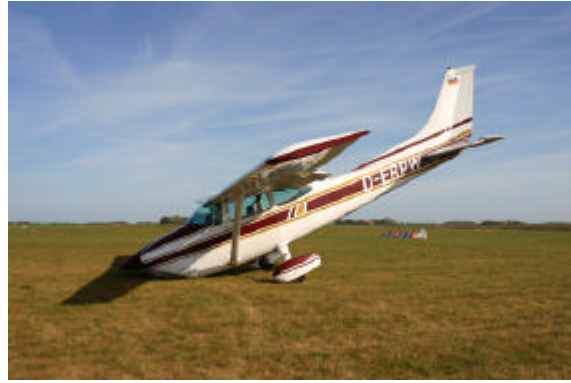
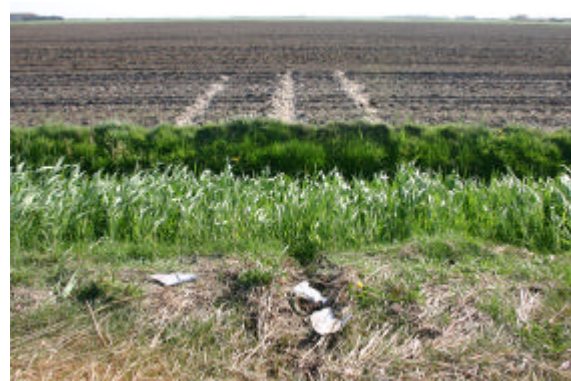
The aircraft with registration D-ERPW had departed from Borkum airport (EDWR), Germany for a cross-country flight to Texel airport (EHTX), the Netherlands. On board were the pilot and a passenger. At EHTX runway 04 was in use and the wind at the time of the occurrence was 040 degrees with 20 to 30 knots. The visibility was more than 10 kilometres. When arriving in the circuit the pilot declared his intentions for landing to Texel Radio. According to the aerodrome manager on duty the runway in use, circuit direction, wind direction and wind speed were reported to the pilot. According to the pilot the final approach was flown with an indicated airspeed of 80 knots and 30 degrees flaps. In front of runway 04 at EHTX there is a farmland. The farmland and the aerodrome are separated by a small waterway (ditch). The aircraft touched down at the farmland approximately 5 meters in front of the waterway. Markings in the farmland indicated that all three wheels had touched the ground. At the rim of the waterway the nose gear was ripped off the fuselage and the aircraft slid over the ditch. The aircraft finally came to a standstill 67 meters inside the aerodrome boundary. Both occupants left the aircraft without injuries. Besides the aircraft's nose gear the propeller, engine and engine cowling were found damaged.

According to the statement of the pilot the aircraft encountered a downdraft on short final. The Safety Board is of the opinion that the accident was caused by misjudgement of the (wind) situation. At the time of the occurrence the wind speed was unsteady with wind gusts up to 30 knots.

Photographs 1-4: D-ERPW after the accident (provided by aerodrome manager EHTX)
