Identification number:	2008078
Classification:	Serious incident
Date, time ¹ of occurrence:	12 July 2008, 20.10 hours
Location of occurrence:	Near Lekkerkerk, the Netherlands
Aircraft registration:	PH-SVU
Aircraft model:	Apex Robin DR400/135CDi
Type of aircraft:	Single-engined propeller aircraft
Type of flight:	Training flight
Phase of operation:	Landing
Damage to aircraft:	Serious
Number of crew:	Two
Number of passengers:	One
Injuries:	None
Other damage:	None
Lighting conditions:	Daylight

SUMMARY

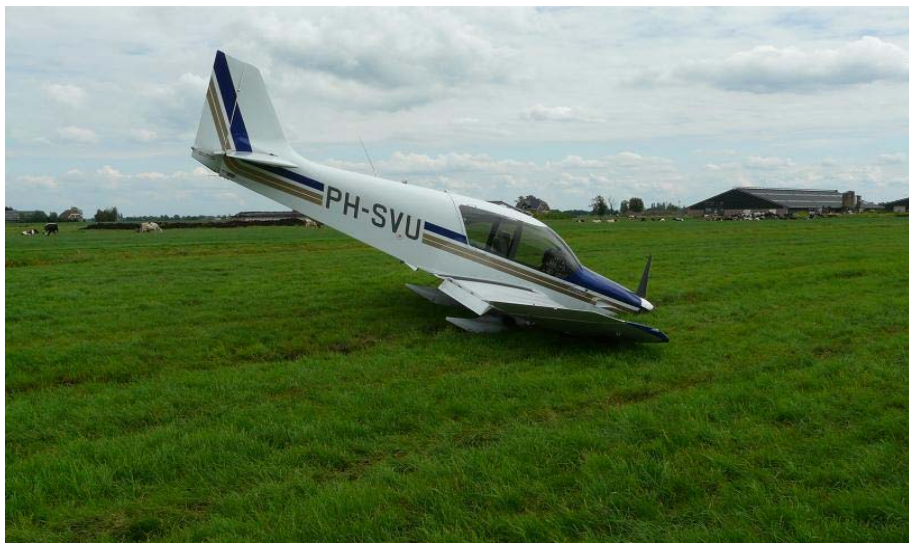
The instructor and student pilot conducted a training flight from Rotterdam Airport (EHRD) under visual flight rules. The aircraft carried one passenger. After having entered the low flying area between Rotterdam and Gouda and flying at an altitude of approximately 1400 feet, the instructor reduced engine power for an emergency landing exercise. Sometime after that, both engine control system warning lights started to flash and the engine stopped. Subsequently the instructor decided to execute an emergency landing in a meadow. During the landing manoeuvre the right hand wheel of the main landing gear entered a ditch, causing the aircraft to turn over right and nose over into the ditch whereupon it came to a stop. The aircraft was seriously damaged. The occupants could leave the aircraft uninjured.

Figure 1: PH-SVU after the emergency landing

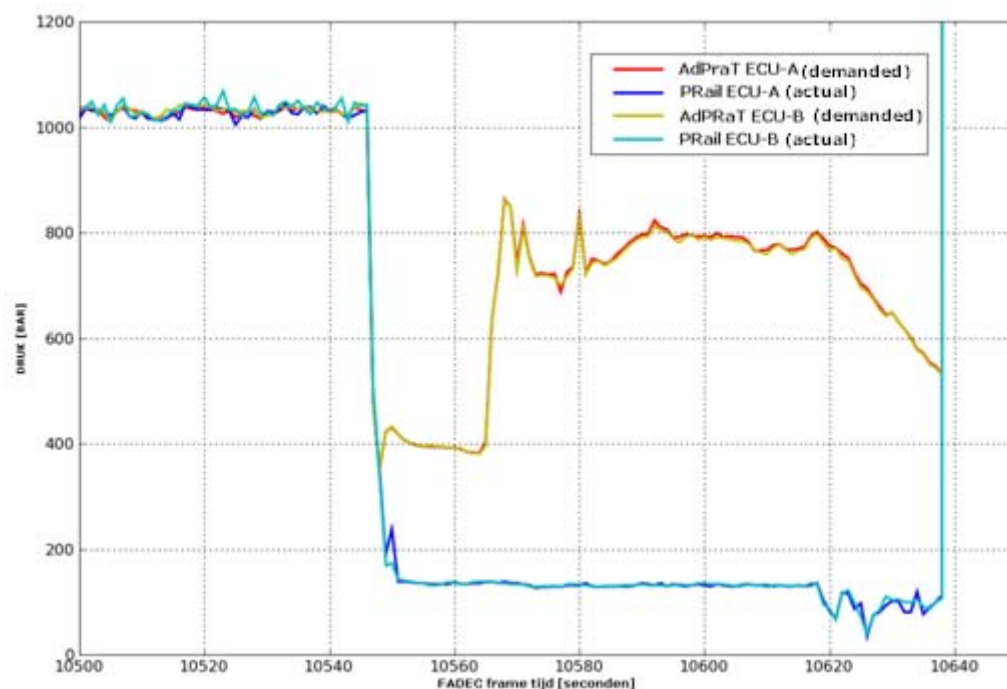
Figure 3: demanded ('AdPrat') and actual common-rail pressure ('PRail') during the last 140 seconds of the incident flight

identical. These differences in value between the demanded and actual common-rail pressure are shown in figure 3.

Analysis of the data further indicated that the demanded pressure was in accordance with the engine power selected by the pilot. According to the engine manufacturer, the actual rail pressure appeared to be in line with the wind mill effect of the propeller, indicating that the engine did not supply any power.

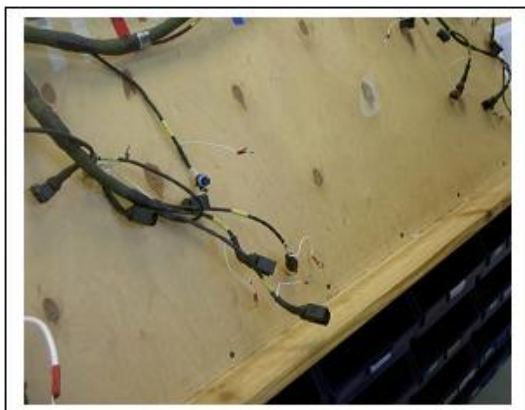
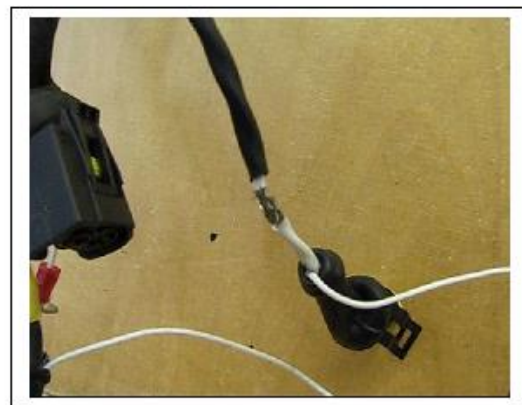
Figures 4 en 5: wiring harness on installation board (left). Detailed picture of “VRail” cable (right)

Subsequently the attention was focussed on the original wiring harness of the incident aircraft. Extensive examination of the harness learned that part of the wiring (regulating cable) inside the connector to the common-rail pressure control valve (“VRail”), was uncovered and insulation material was missing. To facilitate the examination, the wiring harness was connected to an installation board, and an acceptance test procedure was started (figures 4 and 5). When electrical power was applied to the “VRail”, sparks appeared and a short-circuit was found. No further deficiencies were found in the wiring-harness cables.

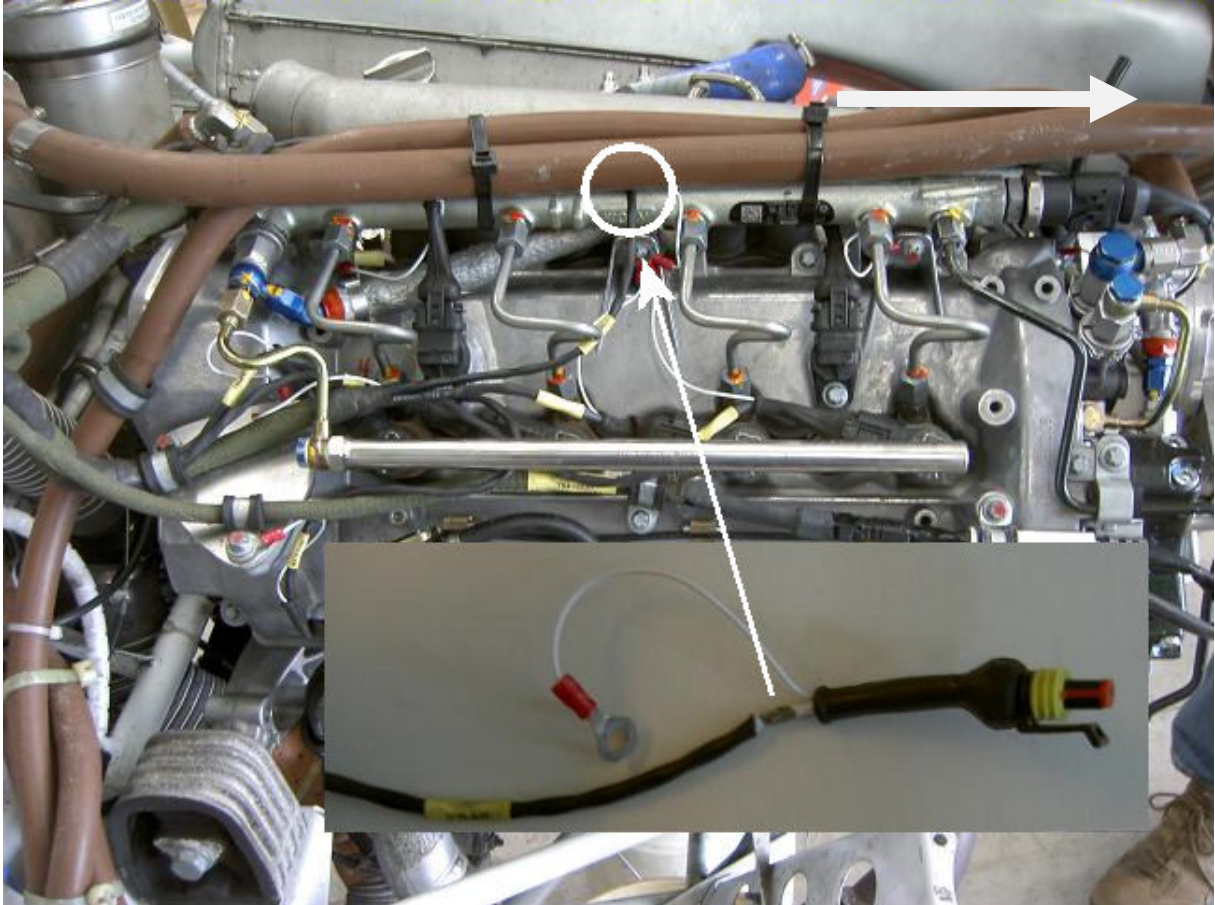
Figure 6: view of right side of engine

The white circle in figure 6 shows the position of the "VRail" cable being guided over the engine. The detailed picture shows the "VRail" wiring as found during the investigation. Part of the insulation material is missing and the wiring is uncovered.

short-circuit. Analysis of the "VRail" wiring indicated that the failure probably was caused by chafing, caused by a kind of wear-through; see figure 6.

It is concluded that cable chafing of the "VRail" wiring probably caused an electrical short-circuit, resulting in the normal electrical power supply to the rail pressure control valve to be interrupted. This caused the engine to stop operating. The chafing was very likely caused by the installation method of the wiring, in combination with normal engine vibration during flight.

The European Aviation Safety Agency (EASA) is recommended to:
revise the certification requirements for the TAE-125-01 diesel engine design, with the emphasis being put on the fail-safe principle being applied to an individual engine component, as well as to the complete power plant system including its electronic failure mode.
