GENERAL INFORMATION

Occurrence:	2008123
Classification:	Accident
Date and time ¹ of occurrence:	25 October 2008, 17.00 hours
Place of occurrence:	Near Otterlo, the Netherlands
Registration:	PH-ATN
Aircraft model:	Cameron Z-350
Type of aircraft:	Hot air balloon
Type of flight:	Commercial passenger flight
Phase of operation:	Inflation of balloon
Damage to aircraft:	None
Operating crew:	One
Number of passengers:	Fifteen
Injuries:	One seriously-, five slightly injured
Further damage:	None
Lighting conditions:	Daylight

SYNOPSIS

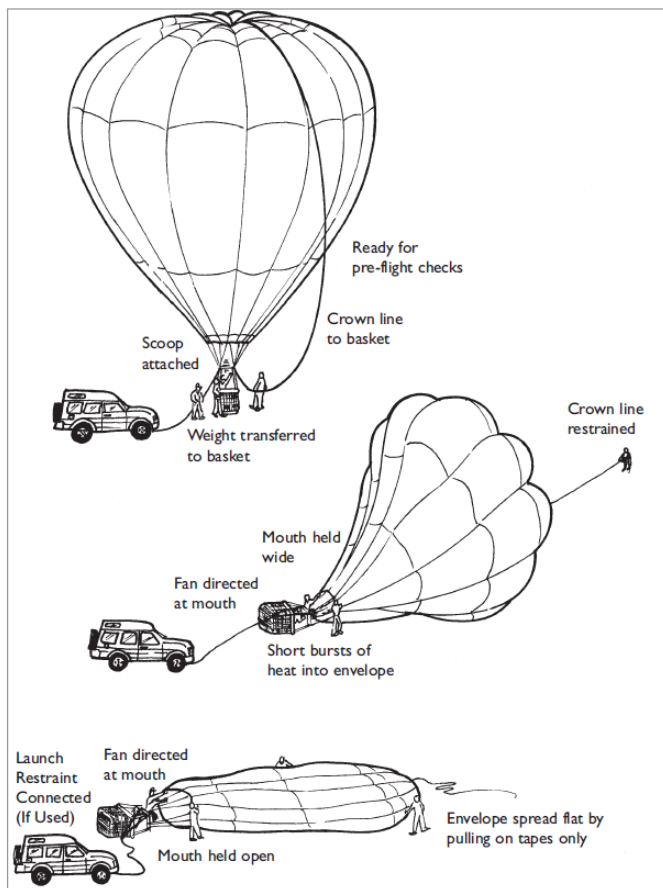
Figure 1: inflation procedure (source: Cameron Balloons Hot Air Balloon Flight Manual)

With regard to utilisation of the launch restraint the flight manual is ambiguous. In figure 1 the text "If Used" is shown in brackets below the depiction of "Launch Restraint". This implies that utilisation of the restraint is voluntary and is left to the judgement of the balloon operating crew.

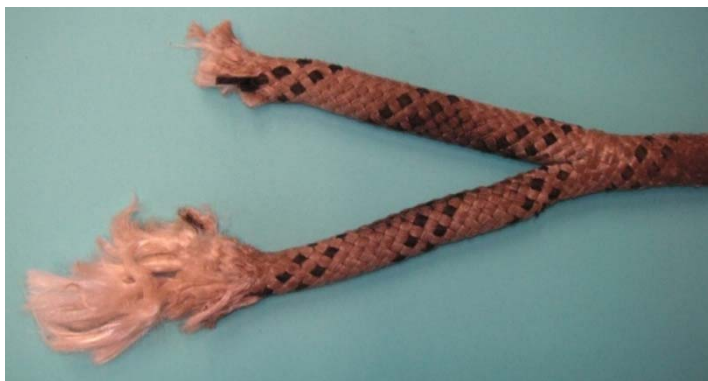
The rope has been subjected to further investigation by the manufacturer. It appeared that the rope was of the Marlowbraid type and had a diameter of 14 mm. The rope met the specification of this product. It had failed at an unusual spot by a tensile force, but without an extremely high tensile stressing being exerted. The failed loop of the launch restraint is shown in figure 2.

The manufacturer states that during regular tensile tests the rope did not fail at the back side of the loop, as did occur during the accident with the PH-ATN. By splicing the rope in order to weave the loop, a weak spot is created at a distance of approximately 40 cm from the loop. The rope normally will fail at that spot first and at a high tensile stressing.

Furthermore the manufacturer states that the normal picture of the tips of a failed rope show traces of transient high temperatures, caused by fibres being melted together. The results of the tensile test with the new rope were in compliance with this picture, but the rope involved in the accident with the PH-ATN did not show a similar merging. This suggests that the rope had failed at a considerably lower tensile stressing.

The investigators that inspected the rope state that the condition of the rope showed a frequent utilisation, which undoubtedly has contributed to a reduction of the tensile strength of the rope.

Figure 2: failed loop of the launch restraint

This accident has been caused by the failure of the launch restraint during inflation of the hot air balloon. The tension causing the failure of the restraint has not been extremely high. The bending diameter of the karabiner used was too small, causing a reduction in the normal tensional strength of the rope. Furthermore the absence of information regarding age and utilisation history of the launch restraint prevents verification of compliance with the desired standard.

- The balloon manufacturer is investigating the possibility to change the karabiner and the rope connection to prevent chaffing of the rope in the karabiner.
- The manufacturer supplied restraint ropes are now marked with the maximum breaking load, date of manufacture, serial number and part number.
- The practice of pre-loading passengers is commonplace throughout the ballooning world. The balloon manufacturer has no objection to this practice. The flight manual guidance on this subject is being updated.

- Describe univocal use of the launch restraint;
- Guarantee the necessary strength of the launch restraint at all times;
- Protect passengers for any risk during inflation of the hot air balloon.

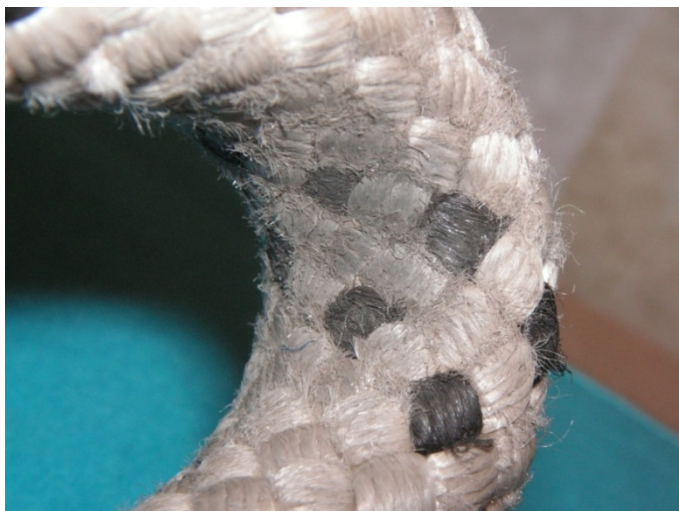
at the back side of the loop being affected because the threads of the rope will be compressed. Figure 3 shows the degree of wear of the launch restraint in the loop at the other end. A tensile test with a new rope, connected to a ring with a bending diameter of approximately 10 mm, showed that then the rope failed at the backside of the loop indeed. By using the karabiner concerned, the tensile strength of the rope as a whole was reduced slightly.

Figure 3: wear in loop at other end of launch restraint

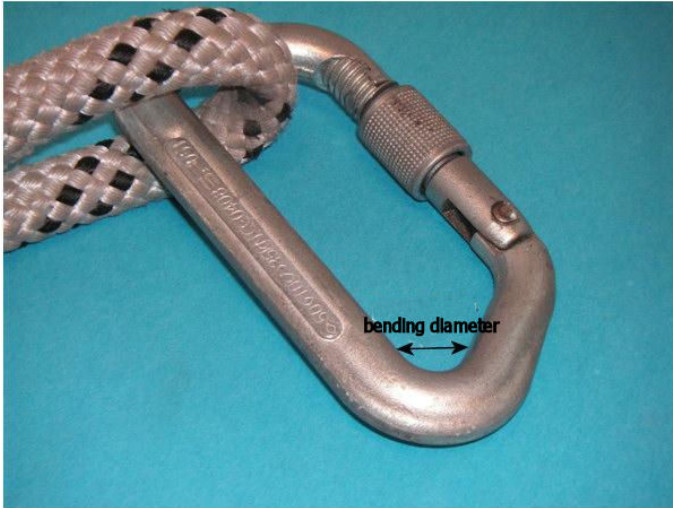
By using a karabiner (ref. to figure 4) with a bending diameter of approximately 10 mm, as used for the PH-ATN, the rope is folded around a diameter that is too small, causing the tensile strength

Figure 4: karabiner used in launch restraint
