GENERAL INFORMATION

Identification number:	2009008
Classification:	Serious incident
Date, time ¹ of occurrence:	29 January 2009, 16.17 hours
Location of occurrence:	Amsterdam Schiphol Airport
Aircraft registration:	G-JBIS
Aircraft model:	Cessna Citation II/C550
Type of aircraft:	Twin-engine jet aircraft
Type of flight:	Charter flight
Phase of operation:	Approach to runway 22
Damage to aircraft:	None
Cockpit crew:	Two
Passengers:	Two
Injuries:	None
Other damage:	None
Lighting conditions:	Daylight

SUMMARY

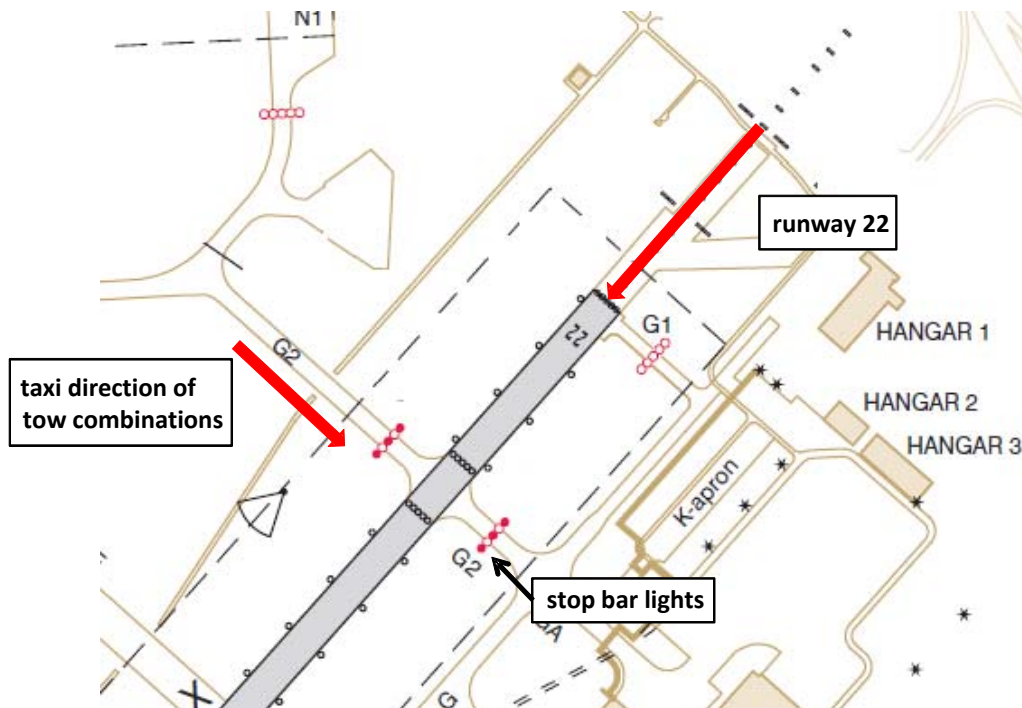
At 16.17 hours, the driver of a towing combination with a Boeing 737, with call sign BDD, requested permission over the runway channel⁶ to cross runway 04-22 at G2. See figure 1. The tower assistant verified the position of BDD and asked the runway controller whether permission could be granted. The runway controller answered affirmatively and switched off the stop bar lights. The tower assistant then granted permission to BDD, upon which the vehicle crossed the runway. Approximately one minute later, BDD reported that runway 04-22 was clear again. The stop bar lights were turned on again automatically. Half a minute later, another towing combination with an Airbus 330, with call sign AOA, called in on the radio. This combination also wished to cross runway 04-22 at G2. The driver asked permission to cross runway 22, after which the stop bar lights were turned off. The tower assistant gave a clearance and without stopping the driver of AOA drove onto runway 22. The driver of AOA stated that he had seen an aircraft in the approach phase to runway 22, but because the stop bar lights were switched off, he was under the impression that the aircraft was not flying towards runway 22 but was on the approach to a different runway.

Figure 1: intersection of runway 22 with taxiway G2 at Amsterdam Schiphol Airport
