## TAXIWAY EXCURSION

Number incident:	2009062
Classification:	Incident
Date, time <sup>1</sup> incident:	2 August 2009, 14.36 hour
Location incident:	Maastricht Aachen Airport
Registration of aircraft:	PH-AAY
Type of aircraft:	Airbus A320 – 232
Type of operation:	Commercial passenger flight
Phase of flight:	Taxi-out
Damage to aircraft:	Minor
Number of crew:	Two cockpit crew, four cabin crew
Number of passengers:	58
Personal injuries:	None
Other damage:	Runway edge light
Light conditions:	Daylight

During a 90° right turn an Airbus A320 ran off the left side of a taxiway while taxiing at Maastricht Aachen Airport towards the runway. An intermittent failing main landing gear down and locked sensor caused the sensor to lose its near position. This resulted in the deactivation of the hydraulic pressure to the nose wheel steering hydraulic module, leaving the crew with no control over the nose wheel steering. The only way to steer the airplane was by differential braking.

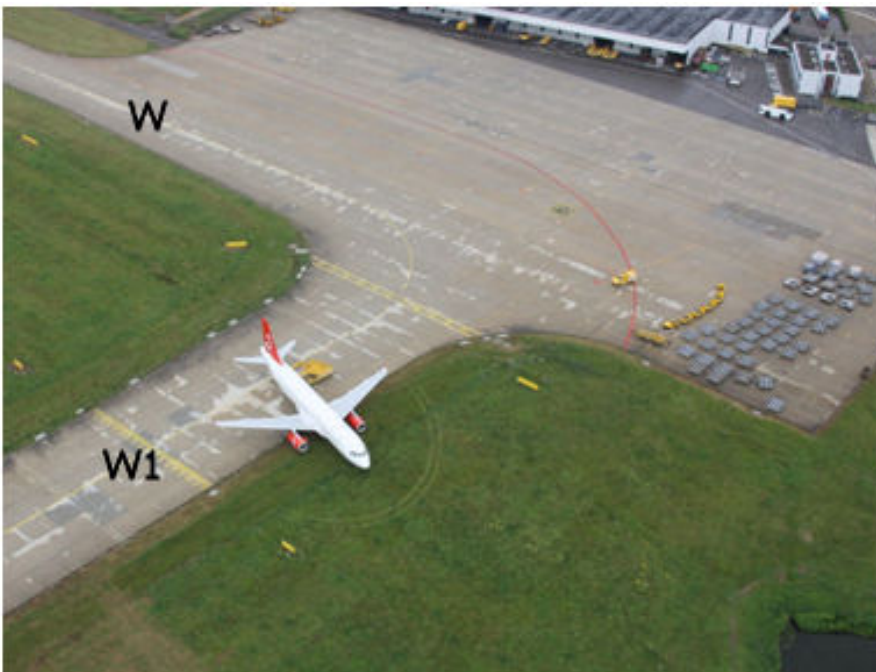
The aircraft was parked on the A apron. At 14.33:57 hours PH-AAY started to taxi to the runway 21 via the W taxiway. At the start of the turn towards the W1 taxiway the ground speed was approximately 18 knots.<sup>2</sup> At 14.36:16 hours a 90 degrees right turn towards the runway was initiated by the captain using the steering hand wheel. After completing approximately a ¾ right turn, the aircraft lost the nose wheel steering. An effort was made to reset the anti-skid and nose wheel steering. However, the nose wheel steering remained inoperative. The crew used differential braking, with more pressure on the left pedal, trying to steer the aircraft. Thereafter the aircraft ran-off the taxiway at the left side at an angle of approximately 30° with the taxiway edge. The left main gear sank 20 cm into the soft ground and came to a halt after 1 to 2 meters. The aircraft started to pivot to the left around the left main gear. The aircraft came to a standstill with the fuselage almost perpendicular to the taxiway with the right main gear just on the pavement edge. See picture 1.

The wheels of the left main gear sustained minor damage. A taxiway edge light was broken and the grass area next to the taxiway sustained some damage.

*Picture 1: aerial picture after the incident (source: Aviation police)*
