## GENERAL INFORMATION

Identification number:	2009073
Classification:	Serious incident
Date, time <sup>1</sup> of occurrence:	1 September 2009, 19.59 hours
Location of occurrence:	Amsterdam Schiphol Airport
Aircraft registration:	G-LEAA
Aircraft model:	Cessna 510 Mustang Citation
Type of aircraft:	Twin engine jet aircraft
Type of flight:	Charter flight
Phase of operation:	Lining up on runway 22
Damage to aircraft:	None
Cockpit crew:	Two
Passengers:	Not known
Injuries:	None
Other damage:	None
Lighting conditions:	Daylight

## SUMMARY

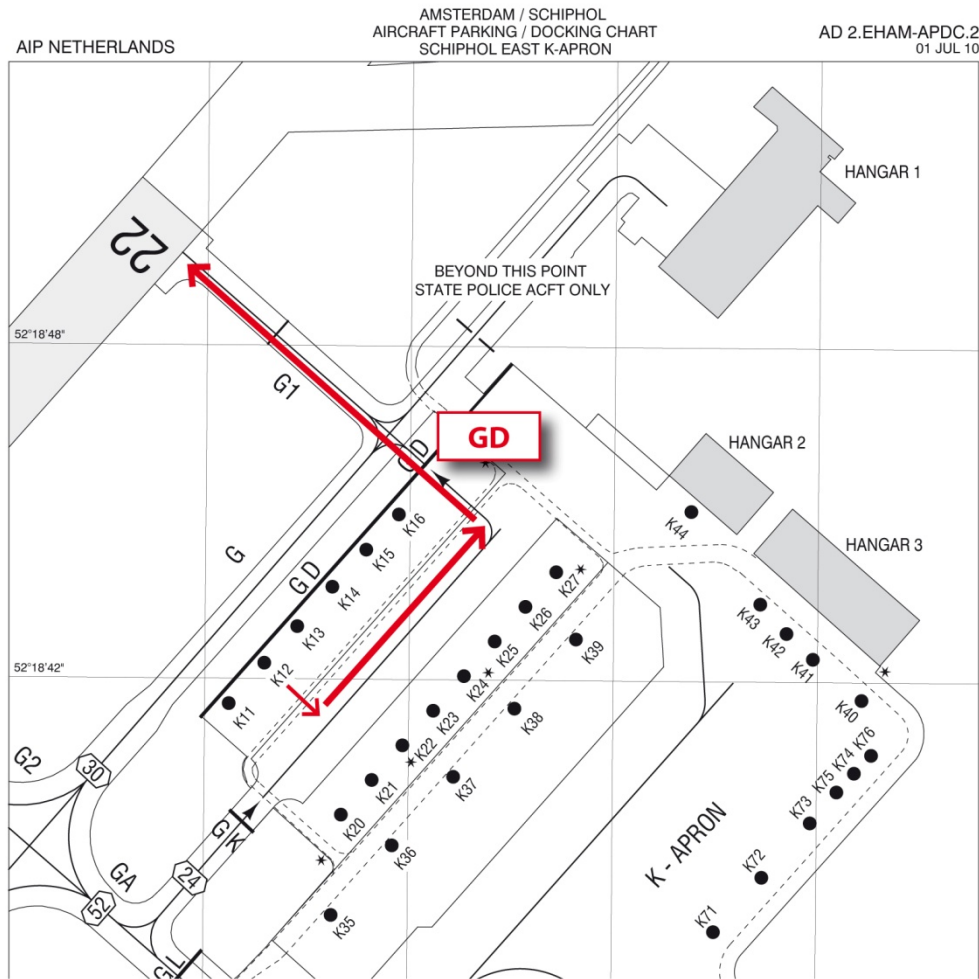
Figure 1: overview of K-apron, taxiway and start of runway 22 at Amsterdam Schiphol Airport

Procedures in the event of restricted visibility are in force at Amsterdam Schiphol Airport. The use of stop bars - red lights before a runway - is part of that. These stop bars are located on taxiway G1 (see figure 1) but were not switched on, because visibility was not restricted. The lights of the stop bars could not have served as a barrier to prevent the crew of G-LEAA from taxiing onto runway 22.
