LEFT MAIN LANDING GEAR COLLAPSED

Identification number:	2009076
Classification:	Accident
Date, time ¹ of occurrence:	9 September 2009, 11.16 hours
Location of occurrence:	Groningen Airport Eelde (EHGG)
Aircraft registration:	D-IIYY
Aircraft model:	Cessna 421
Type of aircraft:	Twin-engined propeller aircraft
Type of flight:	Charter flight
Phase of operation:	Landing
Damage to aircraft:	Serious
Cockpit crew:	Two
Passengers:	None
Injuries:	None
Other damage:	None
Lighting conditions:	Daylight

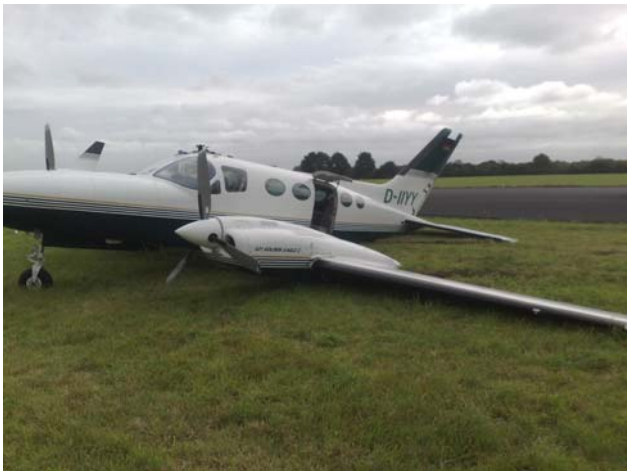
During the landing on runway 05 of Groningen Airport Eelde, the left main landing gear collapsed. The aircraft veered to the left and came to a standstill alongside the runway in the grass on its left wing. The left main landing gear had separated from the aircraft. Both crew members suffered no injuries.

Figure 1: D-IIYY after the accident

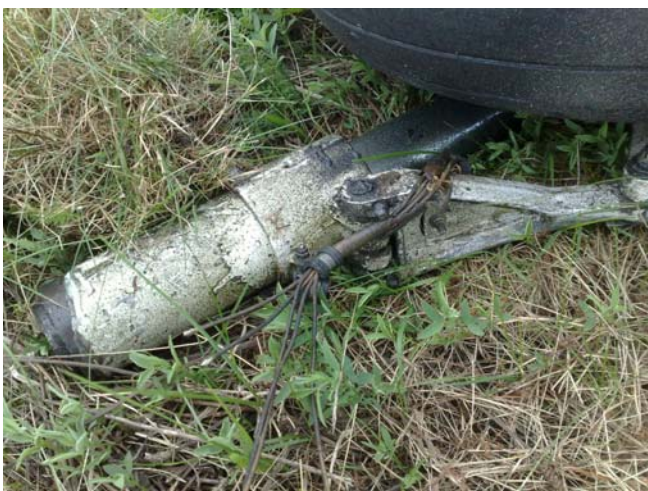
The initial damage assessment revealed that the outer tube of the left main landing gear had failed. The failed landing gear revealed crack growth in the landing gear outer tube which had weakened its strength. The crack might have been initiated by internal pitting corrosion that was observed on the outer tube. Eventually the load upon the outer tube during landing caused the tube to fail, resulting into a gear collapse.

Figure 2: the failed left main landing gear outer tube
