BRAKE PROBLEMS DURING LANDING

Incident number:	2010005
Classification:	Accident
Date, time ¹ of incident:	20 January 2010, 14.05 hours
Place of the incident:	Amsterdam Schiphol Airport
Registration:	CS-DXR
Aircraft type:	Cessna Aircraft Cooperation Citation 560 XLS
Aircraft category:	Twinjet
Flight type:	Ferry flight
Flight phase:	Landing
Aircraft damage:	Major
Number of crew:	Two
Number of passengers:	None
Personal injury:	None
Other damage:	Damage to airport infrastructure
Light conditions	Daylight

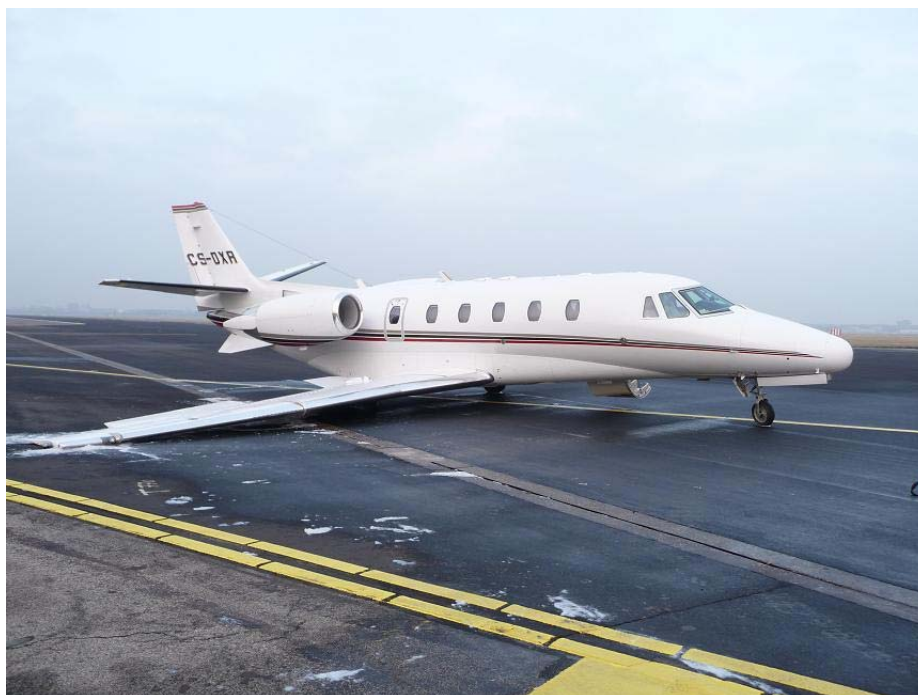
After landing the first officer wanted to commence with braking by pressing down on the foot pedals but this had no effect. The 'LO BRK PRESS' and 'ANTISKID INOP' warning lights illuminated in the cockpit. Next the first officer activated the emergency brake system whereupon the aircraft turned to the right. Steering the aircraft using the foot pedals did not affect the aircraft turning, whereupon the aircraft ultimately came via the grass alongside the runway to a halt on Runway 18L-36R (figures 1 and 2). The right wheel of the main landing gear collapsed to the aft, damaging the flaps and other wing surfaces. The aircraft was severely damaged as a result.

Figure 1: CS-DXR after landing on Runway 06. The aircraft came to a halt on Runway 18L-36R.

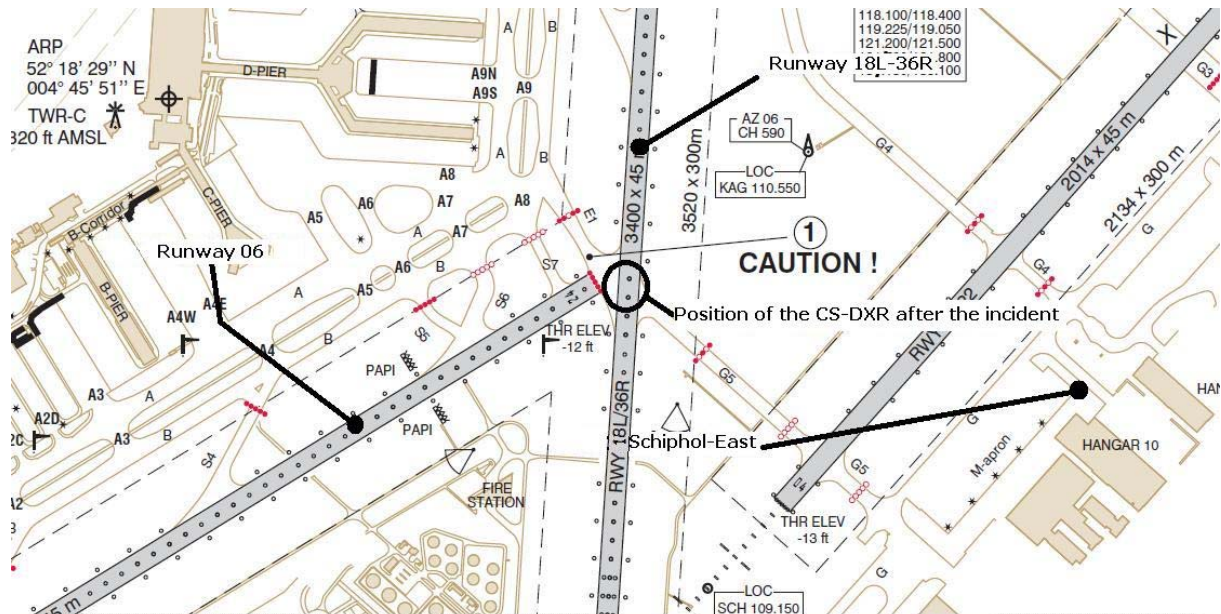
Figure 2: Position of the CS-DXR following the event.

Dutch Safety Board investigators were dispatched to the scene following the incident. The aircraft was found on Runway 18L-36R. The start of one skid mark was found on Runway 06, 765 metres from the aircraft. This skid mark ran across a manhole cover located in the grass alongside the runway. Impact marks were also found on the manhole cover. The marks ultimately lead to the strut of the right wheel that had collapsed backwards.

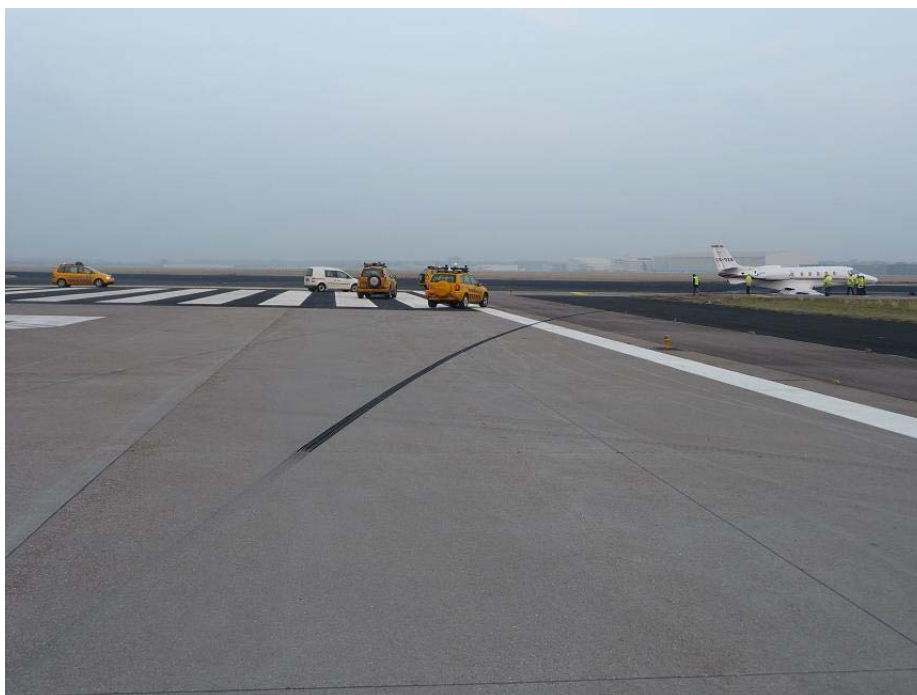
Figure 4: The CS-DXR after the event with the skid mark of the right main landing gear in the foreground.

Analysis of the skid marks showed that the brakes on the right side were in working order. No skid marks were found left of the runway centre line. The technical inspection therefore focused on the primary and secondary brake systems and the left main landing gear.

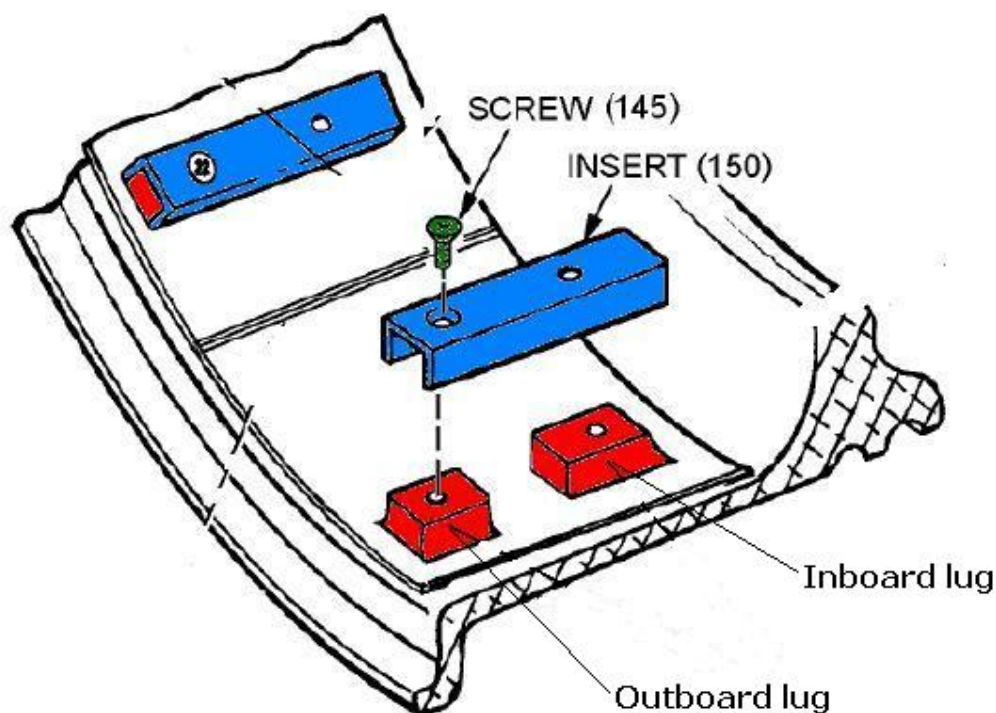
When the wheel was disassembled from the left wheel strut, a partly damaged insert was found to be loose in the wheel (see Appendix B). The insert ensures that the discs rotate in conjunction with the wheel. The insert is kept in place by two lugs, an inboard lug and an outboard lug (see figure 5).

During the inspection the tip of the screw, positioned between the outboard lug and the insert, was found in the outboard lug. Furthermore, impact marks were found on three of the five hydraulic brake cylinders of the left main landing gear. The marks that were found demonstrate that the insert had come into contact with the brake cylinders, which were subsequently damaged.

Figure 5: Detailed view of the insert (blue), the inboard and outboard lugs (red) and the screw (green).

In April 2010 the aircraft manufacturer and BF Goodrich, the wheel and brake manufacturer, published a Service Bulletin aimed at improving wheel inspections.³ The manufacturers recommend that the inboard and outboard lugs and the insert be inspected each time wheels are changed. The relevant components should be replaced when dimensions are found to be below specifications.

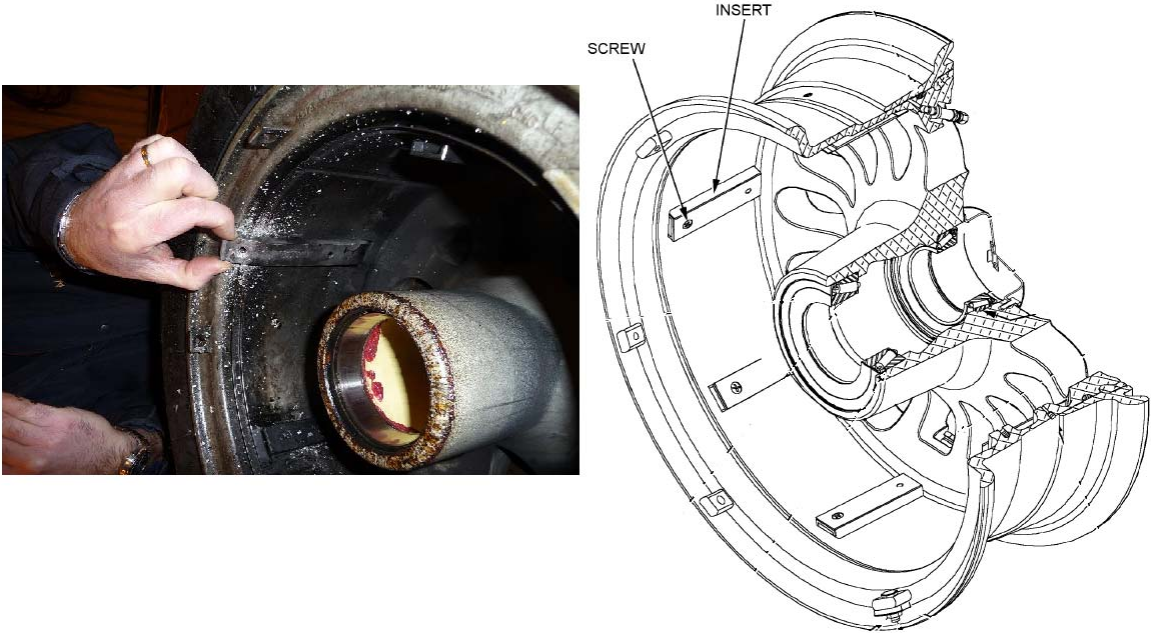
During the examination of the wheel with the loose insert, it was established that both the inboard and outboard lug on which the insert was mounted, were below the dimension (thickness) specified by the manufacturer (see Appendix C for more details). Only three of the ten lugs met the specifications. The five inboard lugs and five outboard lugs on the right wheel, however, did meet the specifications set by the manufacturer. In addition to the two wheels of the CS-DXR, an another examination was performed on a damaged wheel from the same airline where a detached insert was discovered. During the examination of this particular wheel, it emerged that 9 of the 10 lugs did not meet the manufacturer's specifications.

If either a lug or an insert does not meet the specifications this can cause the connection to be frictionless which in turn will subject the screw to cyclic loading. This was established during the investigation. When the screw ultimately fails as a result of cyclic loading the connection to keep

the insert in place is lost. The insert can be pushed outside in a lateral direction, and damages the brake cylinders when the wheel rotates. The combined direction of rotation of the left wheel and the screw thread on the brake cylinder causes the insert to loosen the brake cylinder, ultimately resulting in leakage. It should be noted that a loose insert on the right-hand main landing gear can in fact damage the brake cylinder but cannot loosen the brake cylinder.

Figure 6: The loose and damaged insert of the CS-DXR's left wheel as found during the technical investigation [left]. A wheel diagram, with a detailed view of the screw and the insert [right].

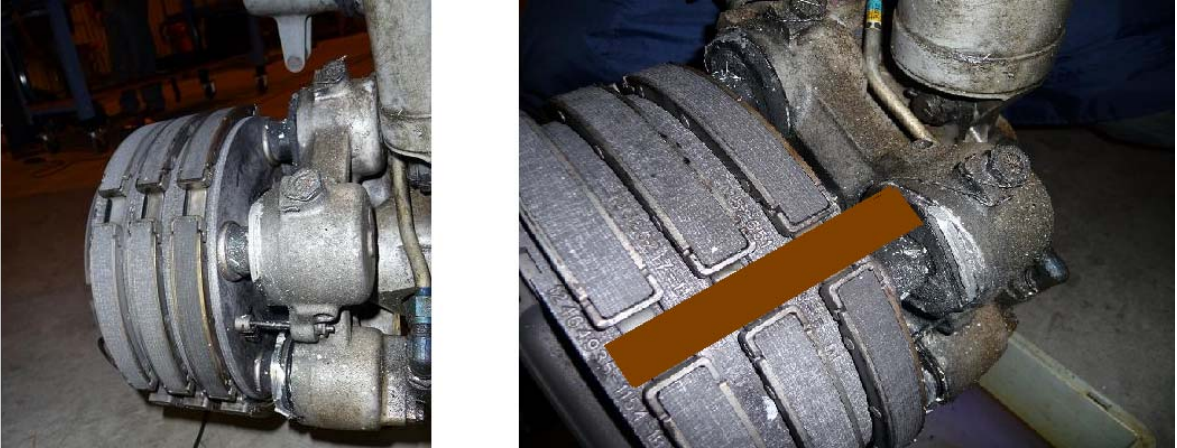
Part of the investigation was to test the brake system for leaks. To that end the hydraulic system was connected to a hand pump containing hydraulic fluid. The pressure test revealed that when pressure of hydraulic fluid was applied on the brake system the fluid leaked out two of the five brake cylinders in the left main landing gear. Closer examination of the leaking brake cylinders revealed that these were partly unscrewed, as a result the system was not completely closed. The investigation revealed that while the wheel rotated the loose insert came into contact with the brake cylinders. Repetitive impacts of the insert resulted in the turning of two brake cylinders which were subsequently partially unscrewed.

Figure 7: Brake cylinder damage on the left wheel strut with the brake discs on the left. On the right, the brown bar shows the position of the insert on the brake discs. The photograph shows that if the insert is able to move in a lateral direction, it can come into contact with the brake cylinders.

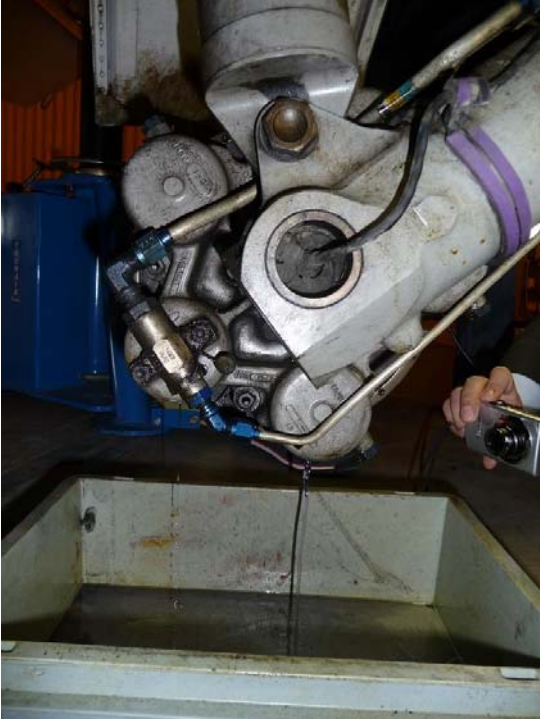
The pressure test furthermore showed that it was not possible to build up pressure in the brake cylinders on left hand side. It was concluded that when the crew activated the brakes, the available brake fluid in the primary system had leaked out as a result of the leakage in the two brake cylinders. This was most likely was the 'cloud of mist' the air traffic controller had witnessed at the rear of the aircraft.

Figure 8: Detailed photograph showing the hydraulic fluid leaking from the two brake cylinders in the left wheel strut.

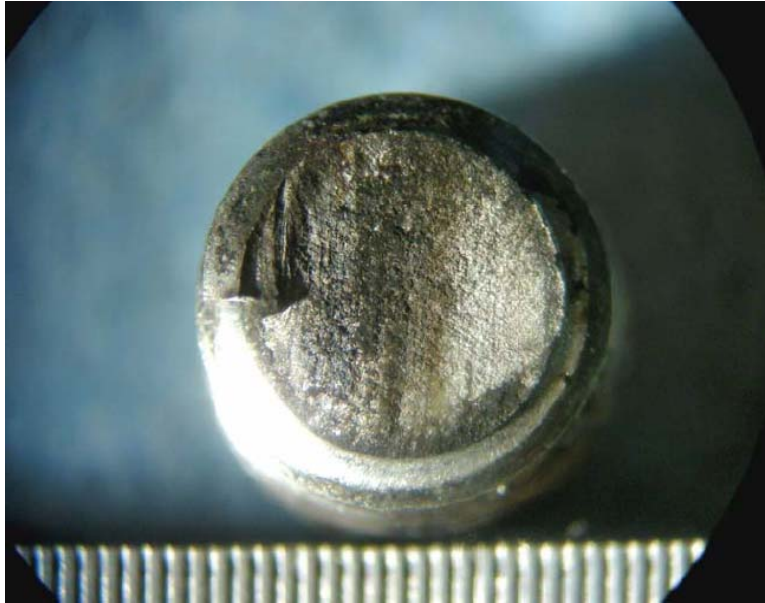
During the examination of the left wheel it was established that part of the screw connecting the insert to the inboard and outboard lugs, was still located in the outboard lug. The end of the screw was removed and the fractured surface of the screw investigated. Metallurgical investigation of the screw's fractured surface revealed that the fracture had occurred as a result of high cyclical fatigue with a low load.

Figure 9: Enlarged fractured surface of the screw found in the lug of the left wheel [Source: Cessna].

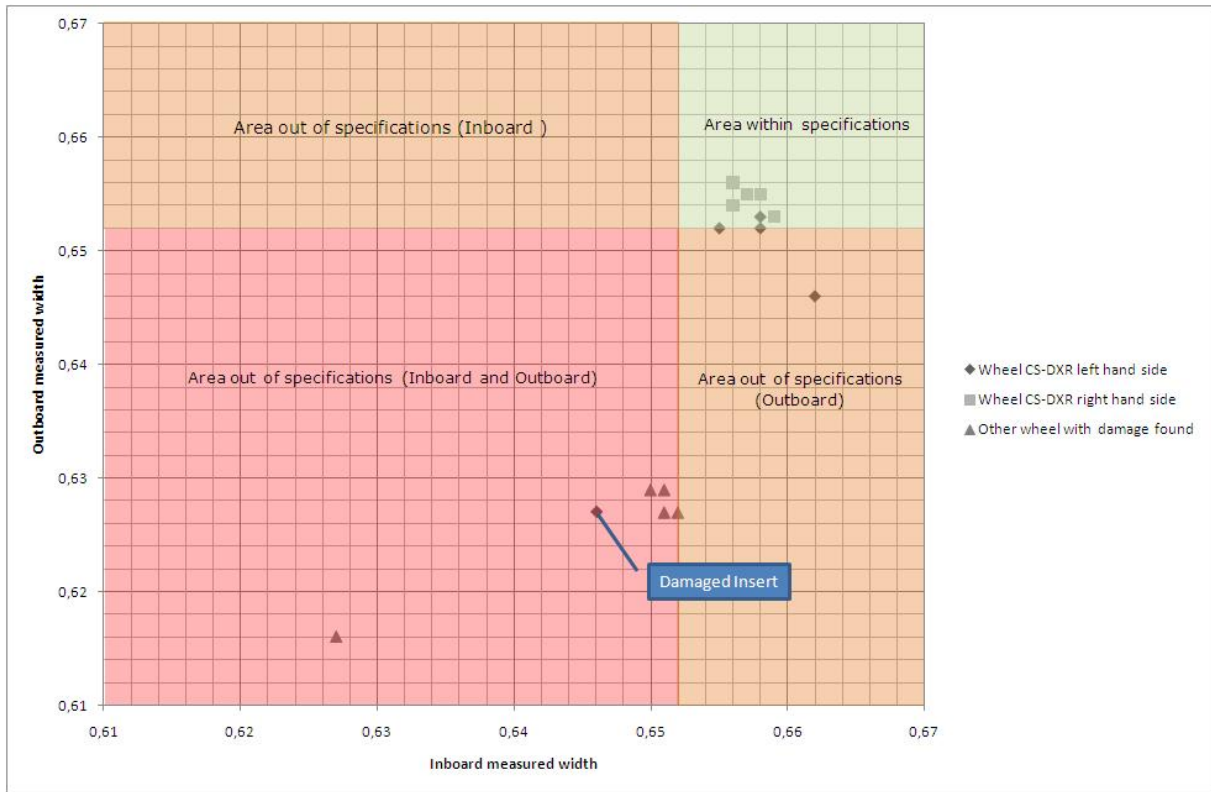
An analysis of the dimensions of the various lugs which were determined during the examination for this investigation are depicted in a graph (figure 10). The green area shows that the inboard and outboard lugs both meet the manufacturer's specifications. This means that the interference fit is adequate and fulfils the design specifications.

The orange area shows that either the inboard or outboard lug does not meet the specifications. The red area marks the area where both the inboard and outboard lugs do not meet the manufacturer's specifications. This is the area where the interference fit is not guaranteed. Analysing figure 10 it shows that the two lugs, where damage on the wheel was found, are both located in the red area. Therefore it is concluded that both the inboard and outboard lugs do not meet the specifications set by the manufacturer which entails a risk the insert can detach.

Figure 10: Graph showing the dimensions measured during the investigation of the inboard and outboard lugs of the three wheels which were inspected.
