EMERGENCY LANDING AFTER ENGINE PROBLEMS

Identification number:	2010020
Classification:	Accident
Date and time ² :	2 April 2010, 11.50 hours
Location of occurrence:	Rotterdam The Hague Airport (EHRD)
Aircraft registration:	D-HHLF
Aircraft model:	Eurocopter EC 120 B
Type of aircraft:	Helicopter
Type of flight:	Private
Phase of operation:	Takeoff
Damage to aircraft:	Serious
Flight crew:	One
Passengers:	One
Injuries:	None
Other damage:	None
Lighting conditions:	Daylight

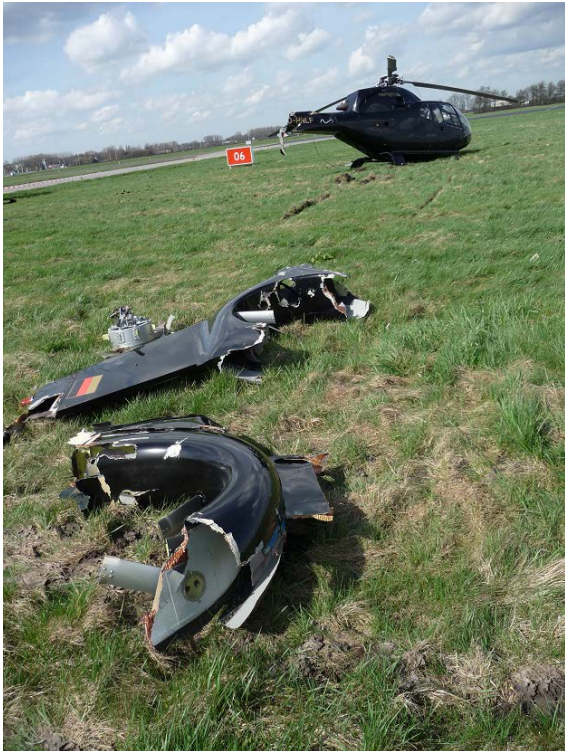
Figure 2: the aircraft shortly after the accident

At that moment he thought the rotor RPM increased again. He pulled the collective whereupon the RPM decreased. The pilot saw that the RPM was low but he did not hear the warning signal which is activated when the rotor RPM drops below 370. When he thereafter realized that the aircraft had only limited power available he concentrated on the emergency landing. At the moment of power limitation the aircraft was flying above the northwest corner of the platform. The pilot noticed several fuel trucks which were parked there. According to the pilot the only and nearest option for a safe emergency landing was the grass area between taxiway 'V' and runway 06. See figure 1. The pilot stated that he preferred a landing on the grass instead of on the concrete taxiway. Although the RPM was low during the auto rotation, the pilot stated that the aircraft felt controllable. During the flare the RPM did not increase. The forward velocity reduced, the pilot applied full collective and landed with a high vertical speed. At the moment of touchdown the rotor speed was low and the rotor blades bent downwards and struck the tail boom which was cut off. See figure 2.

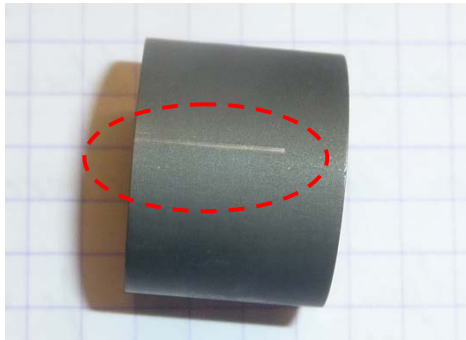
The disassembly of the FCU was performed to find any traces of damage or pollution (debris). Eventually, a scratch on one of the subcomponents was found (see figure 3). The concerned subcomponent is the working piston, a piston which is positioned in the metering stage of the FCU, directly linked to the metering needle (see figure 4). The metering stage of the FCU links the demanded power through governor input with the fuel supply to the engine. The working piston is made of steel, with a soft coating to decrease its friction. This soft coating can easily be damaged if debris is present in the working piston housing. The damage found was a straight scratch, which indicates damage that had occurred during movement of the metering needle, most likely caused by a piece of debris. The scratch could have caused a delay or temporary blockage of the metering stage resulting in a mismatch between demanded and available engine power.

It is unclear where the debris came from. During the disassembly no pollution was found in the system, which suggests it had been washed away. All filters of the FCU were found clean, which means the pollution could have been dirt from outside which was small enough to get through the filters, or internal pollution which broke off somewhere in the FCU.

Figure 3: damaged to the working piston Figure 4: position of the working piston in the FCU

The accident was most likely caused by the fact that the required engine power could not be obtained as a result of pollution in the fuel control unit. The investigation was hampered by the fact that no flight recorder data nor video camera images were available.
