GROUND HANDLING WHEELS NOT REMOVED

Identification number:	2010060
Classification:	Accident
Date, time ¹ of occurrence:	14 August 2010, approximately 12.30 hours
Location of occurrence:	Stroe
Aircraft registration:	D-HNOC
Aircraft model:	Robinson R44
Type of aircraft:	Helicopter
Type of flight:	Positioning
Phase of operation:	Landing
Damage to aircraft:	Severely damaged
Cockpit crew:	One
Number of Passengers:	None
Injuries:	None
Other damage:	None
Lighting conditions:	Daylight

SUMMARY

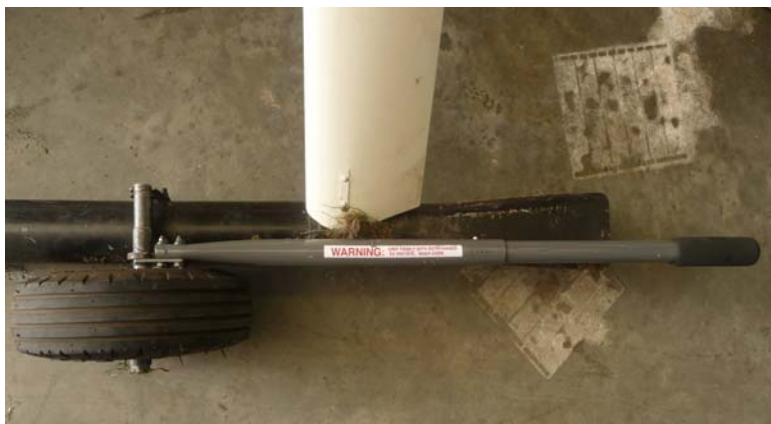
Figure 1: ground handling wheel with lifting handle mounted on left skid

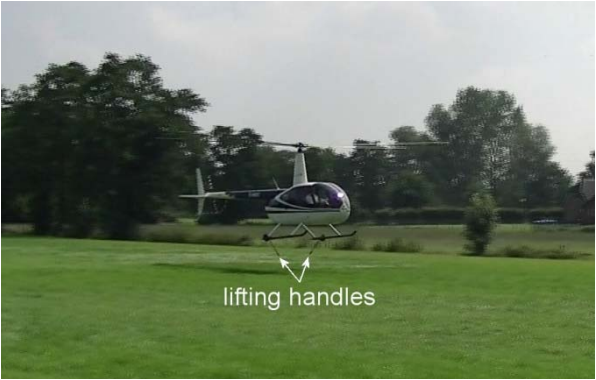
The pilot was the only occupant on the five minute flight from Kootwijkerbroek to Stroe and he was familiar with the landing location. During the flight, both ground handling wheels remained attached to the skids with their lifting handles hanging downwards (see figure 2). Before landing, the pilot hover-taxed to the landing spot. During taxiing, both lifting handles momentarily touched the ground, causing the left ground handling wheel and its handle to fall from the helicopter (see figures 3 & 4). As it descended for landing, and approximately thirty metres away from the waiting passengers, the right lifting handle hit the ground. The helicopter pivoted around the handle until the left skid touched the ground (see figure 5). Then the sequence of events occurred rapidly. The helicopter turned ninety degrees left around the top axis before the tail struck the ground (see figure 6). The tail and the tail rotor broke off, the helicopter pitched forwards and rolled to the left where it came to rest on its side (see figure 7). During the accident the left fuel tank was damaged, resulting in a fuel leak (see figure 8). The helicopter was severely damaged. The pilot suffered no injuries.

Figure 2: both lifting handles attached

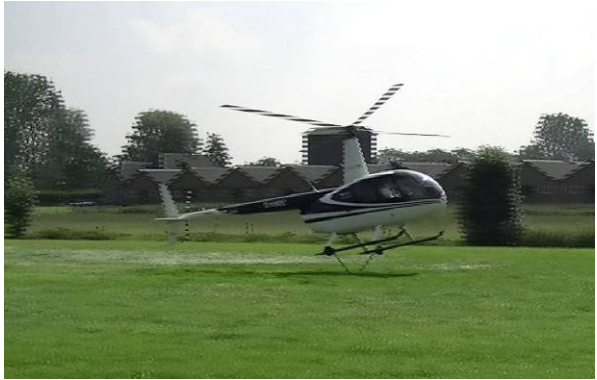
Figure 3: both lifting handles touch the ground

The flight from Kootwijkerbroek to Stroe was uneventful. While descending for landing, the right lifting handle hit the ground causing the helicopter to pivot until the left skid touched the ground. Because of this sudden and unexpected pivoting movement, the pilot was unable to retain control of the helicopter. Although fuel was spilled during the impact, there was no fire because it did not come into contact with hot engine parts or any other ignition source.

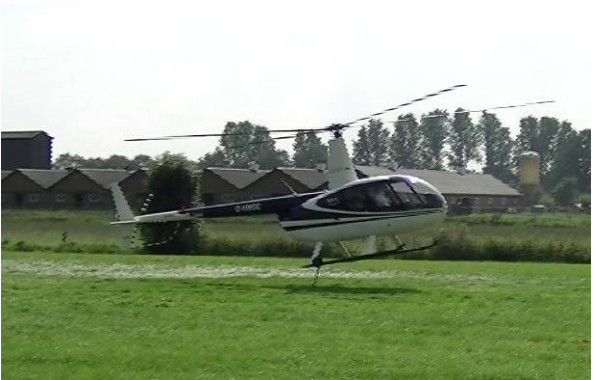
Figure 4: left lifting handle detached

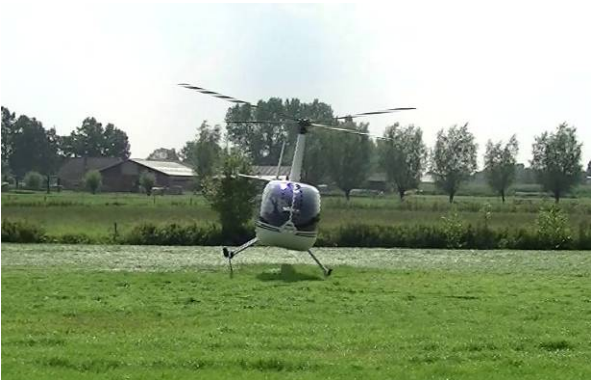
Figure 5: helicopter pivots on right lifting handle

According to the helicopter manufacturer it was not the first time ground handling wheels were not removed before flight. To prevent further accidents the helicopter manufacturer has released Service Letter SL-41 (see Appendix B) on 7 September 2011. Production of the old type R44 ground handling wheels has been discontinued and an improved version, as used on the latest model (R66), has replaced them. In this version the ground handling wheels slide into a bracket from the inside and the handle is angled across the skid so that it cannot rotate downwards if left connected. The existing wheels can be modified.

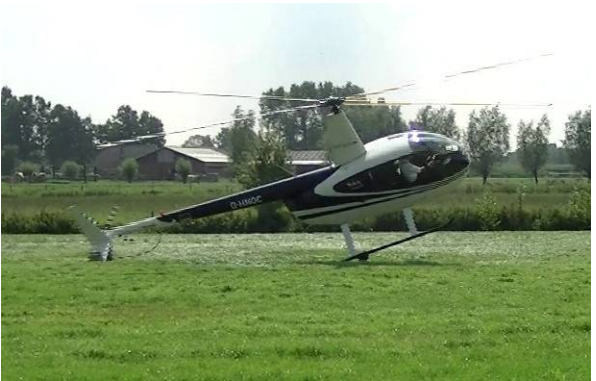
Figure 6: tail strike

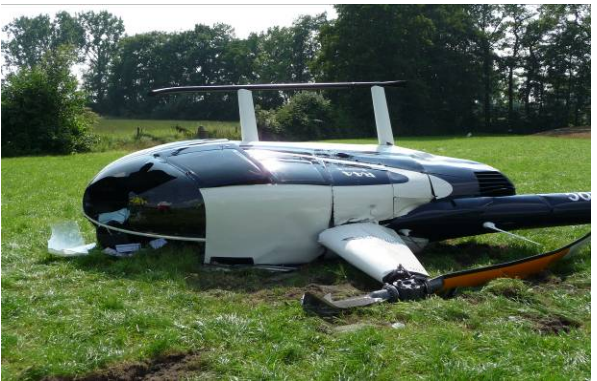
Figure 7: D-HNOC after the accident

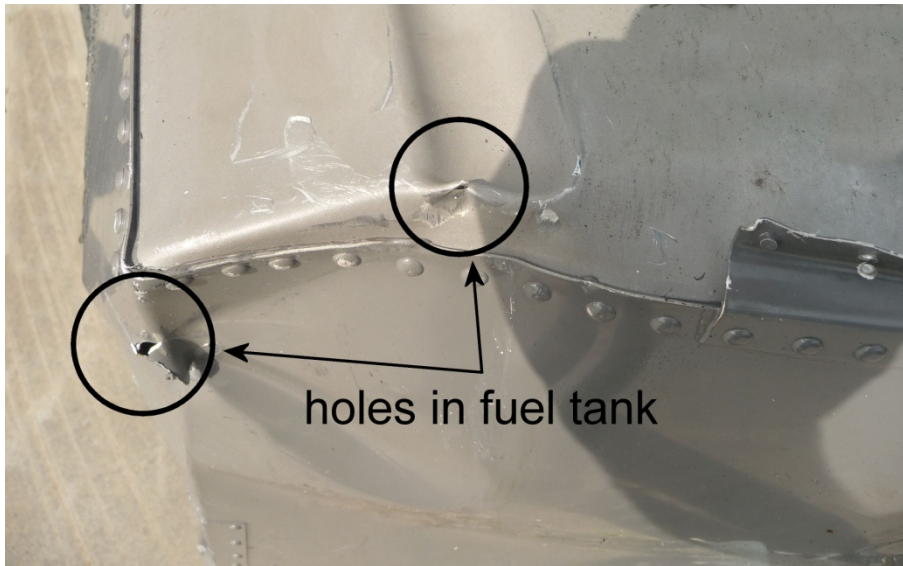
Figure 8: holes in left fuel tank

D-HNOC was equipped with a single-walled aluminum fuel tank. This tank has proved to be vulnerable to post-accident fuel leaks and fires in other R44 accidents. To improve the R44 fuel system's resistance to a post-accident fuel leak and possible fire, the helicopter manufacturer issued R44 Service Bulletin SB-78 (see Appendix C) on 20 December 2010. This bulletin requires R44 and R44 II helicopters with single-walled aluminum fuel tanks to be retrofitted with bladder-type tanks. With this modification the tank consists of a metal outer tank and a rubber inner tank which makes it double-walled and less vulnerable to fuel leaks and fire in the event of disruption of the outer tank. The SB states that compliance should be *"as soon as practical but no later than 31 December 2014."*

A single-walled fuel tank provides little protection against fuel leaks in the event of an accident. A leaking fuel tank after an accident is a fire risk.
