## SYNTHETIC FABRIC DETACHED FROM RIGHT HAND ELEVATOR

Identification number:	2011012
Classification:	Accident
Date, time <sup>1</sup> of occurrence:	1 April 2011, 08.05 hours
Location of occurrence:	Amsterdam Schiphol Airport
Aircraft registration:	PH-CGC
Aircraft model:	Dornier 228-212
Aircraft type:	Twin engine turbo propeller aircraft
Type of flight:	Coast Guard operational flight
Phase of flight:	Cruise
Aircraft damage:	Detachment of right hand elevator fabric cover
Total crew:	Four
Total passengers:	One
Injured:	None
Other damage:	None
Lighting conditions:	Daylight

During flight the crew of a Netherlands Coastguard Do-228 was faced with a sudden nose down movement of the aircraft. The crew executed the applicable emergency procedures and landed uneventfully at Amsterdam Schiphol Airport.

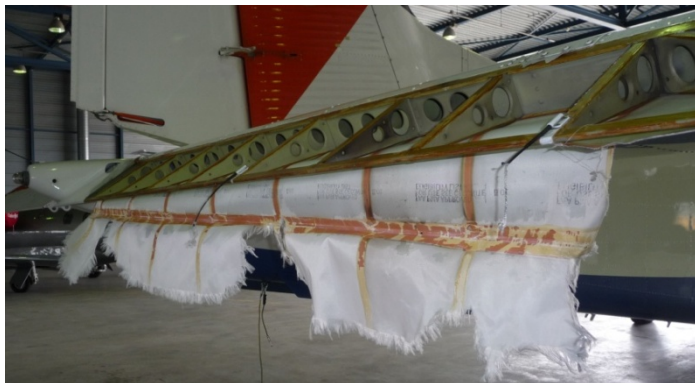
After landing the top part of the synthetic cover was found largely detached from the right hand elevator. The fabric was only attached to the trailing edge on the bottom side of the elevator. The maintenance organization started an internal investigation.

The top part of the synthetic cover largely separated from the right hand elevator. The elevator did not show evidence related to contact with a foreign object.

*Figure 2: right hand elevator after the flight*

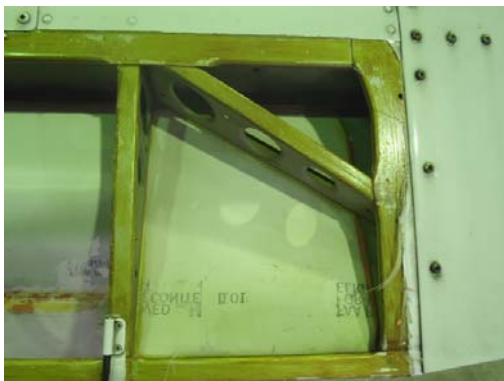
Investigation revealed that the synthetic cover of the right hand elevator was detached from the surface of the elevator construction. More than 90% of the bonding surface of the construction was smooth/shiny with tiny to no marks only from the cover fabric. According to the manufacturer this indicates insufficient bonding. Less than 10% of the bonding surface showed the typical granular/fiber surface. On the surface areas not covered with adhesive the plain metal surface was visible, there were no signs of (brown colored) primer. In some areas it was easy to peel off the cover from the surface, whereas in some small areas it was difficult.

The above mentioned results could be an indication that the gluing process was not performed adequately. Therefore the maintenance history of this particular elevator was investigated.

*Figure 3: detail of affected surface of the elevator construction*

According to RUAG toluene should have been used instead of MEK as adhesive diluents as described in the SRM. The use of MEK could have caused the bad bonding of the cover to the surface of the elevator construction. RUAG indicated also that for proper bonding a rigid wooden or metal tool (spatula) should be used in order to be able to press the cover strongly against the surface of the elevator construction. However, the SRM does not specify such a procedure. The instructions in the SRM are general and do not specify the use of a tool, nor do the instructions mention the amount of force that needs to be exerted with the tool.

It is concluded that the re-covering of the synthetic fabric was not fully executed in accordance with the procedures stated in the Dornier 228 Structural Repair Manual. Methyl-Ethyl-Ketone was used as adhesive diluents instead of toluene. Furthermore, the instruction for re-covering in the Structural Repair Manual is general and does not specify the use of a tool, such as a spatula, for proper bonding. The manufacturer offers on-the-job training for maintenance organizations that carry out repair and/or replacement of synthetic cover on elevators and rudders. The combination of incorrect adhesive diluents and the use of different tools than meant but not prescribed, could have caused insufficient bonding of the cover to the surface of the elevator frame.
