## EMERGENCY LANDING AFTER TECHNICAL MALFUNCTION

Identification number:	2011026
Classification:	Accident
Date, time <sup>2</sup> of occurrence:	11 May 2011, approximately 15.15 hours
Location of occurrence:	Veghel
Aircraft registration:	PH-HHF
Aircraft model:	Schweizer 269D
Type of aircraft:	Helicopter
Type of flight:	Commercial
Phase of operation:	Cruise
Damage to aircraft:	Burnt out
Cockpit crew:	One
Passengers:	None
Injuries:	None
Other damage:	Fire damage to grass of field
Lighting conditions:	Daylight

During cruise flight at approximately 1000 feet the pilot heard a noise, directly followed by a pitch up and left roll motion of the helicopter. The pilot recovered helicopter control, rolled off the throttle to idle and entered an autorotation which resulted in a hard landing in a field. After the pilot had shut down the engine, switched off the electrical systems and removed some items from the helicopter, a post crash fire destroyed the helicopter almost completely. The pilot suffered no injuries.

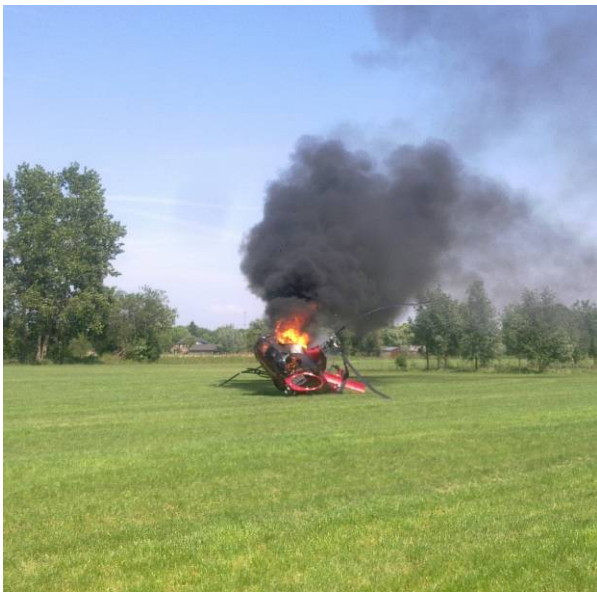
The helicopter with registration PH-HHF was on a return flight from Kempen Airport (EHBD) to its home base Lelystad Airport (EHLE) with the pilot as sole occupant. Near Veghel the pilot heard a noise directly followed by a pitch up and left roll motion of the helicopter. The pilot's first thought was he had hit a bird. After realizing that he had not seen birds in the area he treated the situation as a tail rotor drive failure and decided to make an emergency landing. The throttle was closed to idle and the pilot steered the helicopter to the right to a large field. The rotor RPM was 400 and the airspeed approximately 70 knots. The pilot stated that there was no reaction on rudder pedals input and insufficient reaction on collective input. The helicopter made a hard tail wind landing and came to rest in the grass field. The pilot reported the engine kept running. During engine shutdown the throttle detent release system<sup>3</sup> did not work. As a result the pilot had to pull the fuel cut off knob to shut down the engine. The pilot left the helicopter but returned shortly thereafter to switch off the necessary switches and to take out some items. Soon after, the helicopter caught fire and burned down to the ground (figure 1). The pilot was checked by medical personnel and suffered no injuries.

Figure 1: PH-HHF burning (source: Brabants Dagblad)

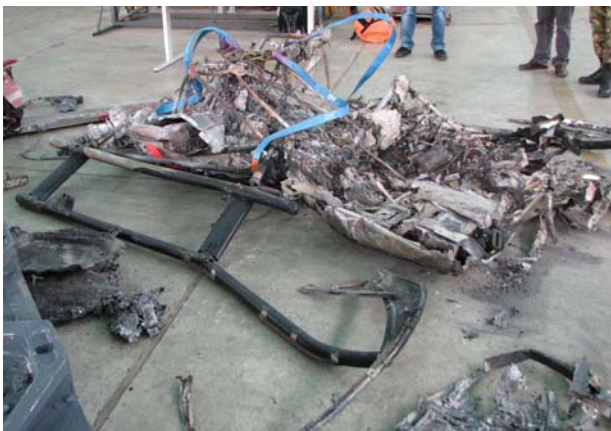
The majority of the airframe had been consumed by the post crash fire. There was significant structural damage from initial impact. The landing gear exhibited indications of high vertical velocity impact (figure 2).

Figure 2: landing gear collapsed

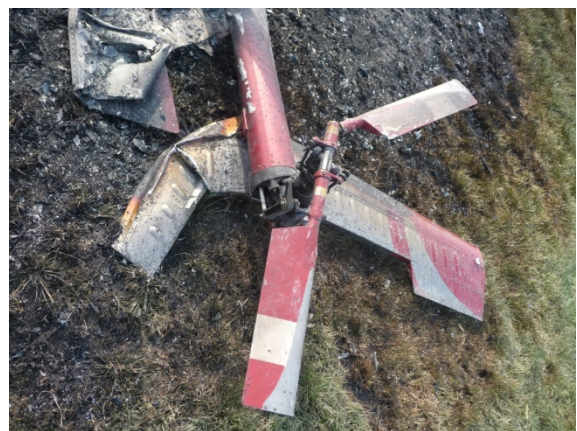
Figure 3: tail boom and tail rotor

The tail boom had been separated from the airframe by a main rotor blade strike just forward of the vertical stabilizer. The tail rotor gear box remained attached to the tail boom. Both tail rotor blades remained attached with one blade having been broken partially off in a downward direction, toward the blades trailing edge. Little rotational impact evidence was present on either blade (see figure 3).

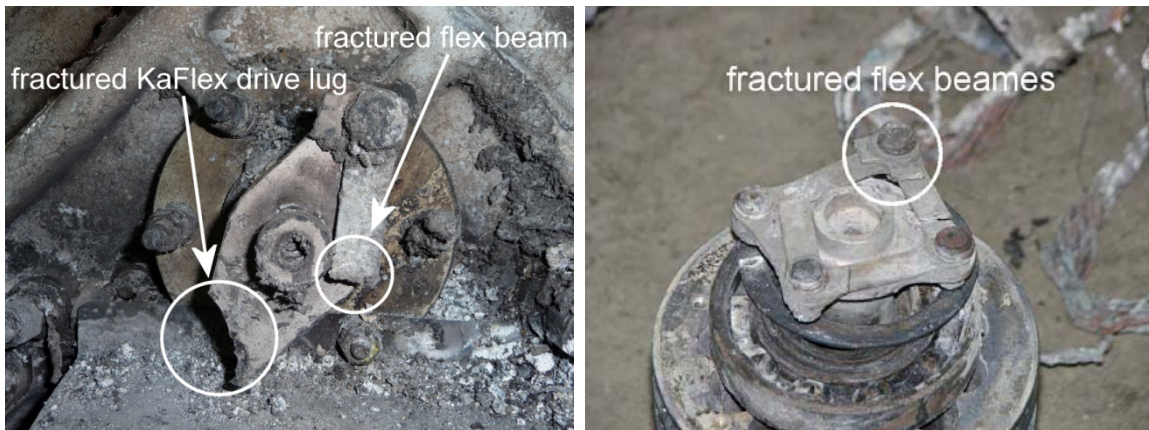
Examination of the engine drive shaft revealed a broken KaFlex coupling at the engine to lower pulley drive shaft. The forward KaFlex was attached to the drive adapter and remained installed in the engine power takeoff. It exhibited a fracture at one of the forward drive lugs and fractures of several flex beams (figures 5 and 6).

Figure 5 and 6: KaFlex fracture at engine power takeoff and main drive shaft

The lower pulley contained the aft KaFlex and the aft portion of the forward KaFlex fitting with fractured flex beams. The separated piece of the drive lug, bolt and portions of flex beams were not found.

An initial investigation of the fracture surface of the KaFlex drive lug was performed by the NLR in the Netherlands. Findings indicated metal fatigue as a possible cause of failure. To confirm the initial findings the fractured drive lug was sent to the NTSB in the USA. Investigation findings indicated that the fracture appears very similar to a fractured KaFlex coupling from another event. There are fatigue cracks on the drive side adapter lug that are originating near, but not at, the bolt hole. Correct drive shaft alignment is important to prevent fatigue. Misalignment can be caused by sagging of engine isolation mounts.

To prevent similar occurrences the helicopter manufacturer has issued ASB<sup>5</sup> DB-043, on 26 April 2012, instructing customers to perform an engine alignment check with a prescribed tool within 90 days or 100 flight hours. Thereafter the same alignment check has to be performed every 25 flight hours.
