REAR DOOR SEPARATED DURING FLIGHT

Identification number:	2011051
Classification:	Incident
Date, time ¹ of occurrence:	29 June 2011, 15.43 hours
Location of occurrence:	North-east of the village Biddinghuizen
Aircraft registration:	PH-TIN
Aircraft model:	Diamond DA 40 D
Type of aircraft:	Single engine piston
Type of flight:	Private
Phase of operation:	En route
Damage to aircraft:	Door hinge brackets broken and rear door separated
Cockpit crew:	One
Number of passengers:	None
Injuries:	None
Other damage:	None
Lighting conditions:	Daylight

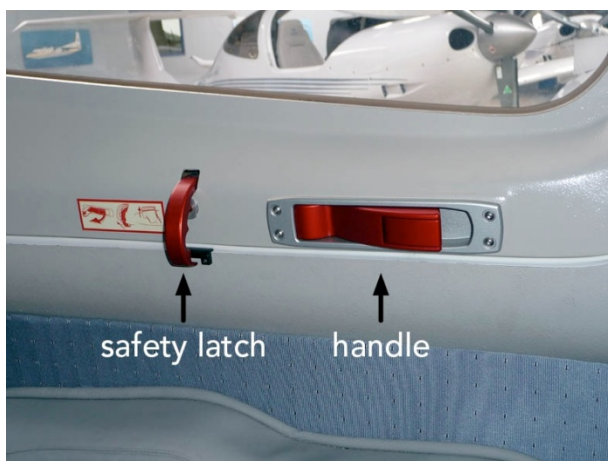
After thirteen minutes, when the aircraft was flying at 1000 feet with a speed of approximately 120 knots and a power setting of 80%, the pilot observed a 'door open' alert on the primary flight display. The pilot stated that he looked over his left shoulder and saw the door handle slowly moving out of the closed position. He noticed that the safety latch was closed (see figure 1). Within seconds the rear door separated from the aircraft and passed over the aircraft tail section. The position of the aircraft at this time was north-east of the village Biddinghuizen. The pilot reduced the speed of the aircraft to approximately 100 knots and contacted Lelystad Radio to report the occurrence. He also stated he was returning immediately to the airfield. The pilot was not able to hear the response from Lelystad Radio properly due to the wind noise. He returned to Lelystad Airport and performed a normal circuit and landed on runway 23. Thereafter the pilot taxied back to the hangar where he switched off the engine.

Figure 1: safety latch and door handle on the inside of the rear door

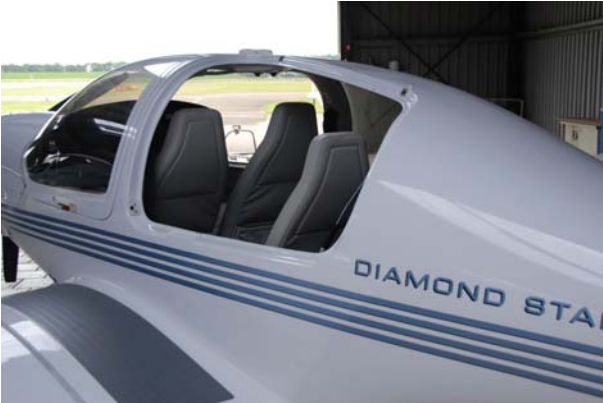
During the flight the rear passenger door separated from the aircraft and passed over the aircraft tail section. The pilot returned to the airfield of departure and made a safe landing. There was no damage to the aircraft. Only the door hinges brackets were broken. The separated door was found later.

Figure 2: rear door missing after flight (source: W.L. Nijdam)

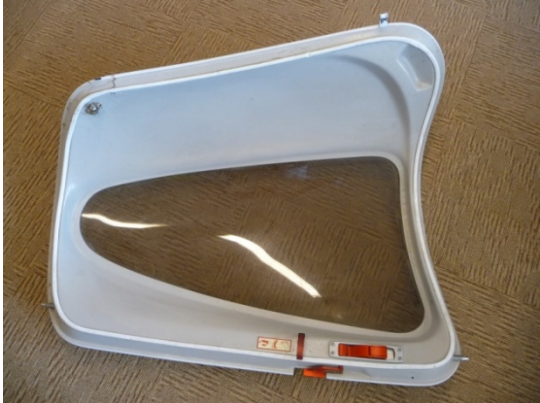
After the incident a search operation was performed on the ground and by air to find the door. However, it was not found. On 27 August, approximately two months after the incident had occurred, the door was found in a field north-east of the village Biddinghuizen. There was no

damage to properties on the ground. The door was picked up by the police and was obtained by the Dutch Safety Board; see figure 3.

Figure 3: separated rear door

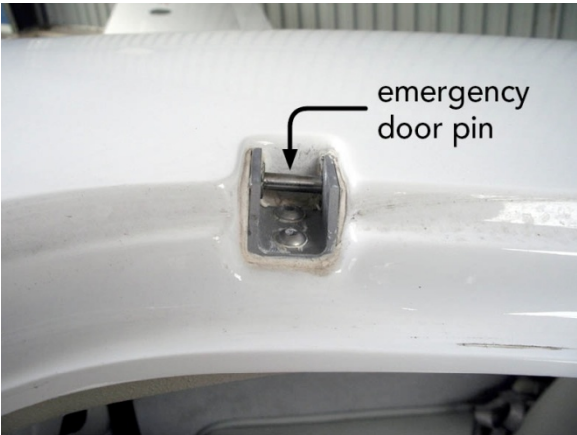
The rear hinge bracket was broken from the door. A part of the bracket was still attached to the hinge pin in the fuselage; see figure 5. The forward hinge bracket was torn. The emergency door pin was still in place; see figure 4.

Figure 4: emergency door pin and missing forward hinge bracket (source: Wings over Holland)

- *The emergency lever was not in its designated (stowed/closed) position. The emergency pin was out of the rear blind hole. This did not significantly contribute to the free play of the forward hinge. It might have contributed to damage of the hinge, but this is covered by the airplane maintenance manual procedure which prescribes the inspection of the passenger door and its locking mechanism during every scheduled 100 flight hours maintenance inspection.*

- *It is not known if the forward door hinge bracket was broken or damaged before the said flight. However, a movement mark of the emergency pin on the forward door hinge bracket was visible and indicates that the door was moving in this area for a longer period of time.*

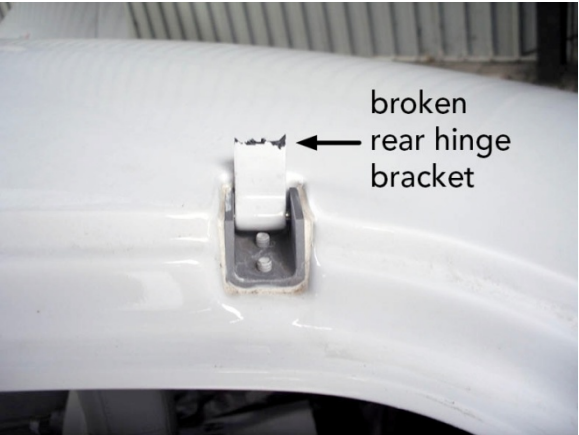
Figure 5: broken rear hinge bracket (source: Wings over Holland)

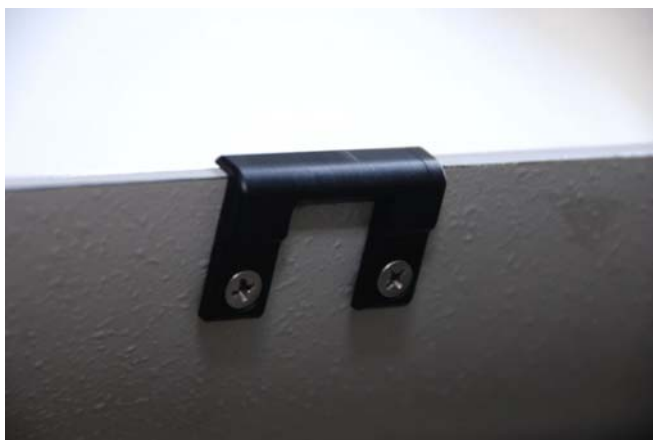
bracket (see figure 10) for the door safety latch had been designed to, together with an amended emergency procedure, prevent opening and separation of the door during flight with an unlatched door. The Service Bulletin describes the retrofit installation of the retaining bracket on aircraft already in operation.

Figure 10: improved rear door retaining bracket of PH-TIN
(source: W.L. Nijdam)

According to the company who performed maintenance on the aircraft and the owner of the aircraft, PH-TIN had not encountered problems with the rear door before. AD 2010-0235 had been complied with for PH-TIN on 20 May 2011. An improved retaining bracket was installed on PH-TIN; see figure 10.

Based on the results of the check flights that were conducted by the manufacturer, which showed that the safety latch was able to restrain the door from opening during flight, it is concluded that the most likely contribution to the door separation was excessive free play on the forward door hinge. This free play in combination with the door not being locked, caused a de-activation of the safety latch. Under those conditions the improved retaining bracket did not prevent opening and separation of the door.

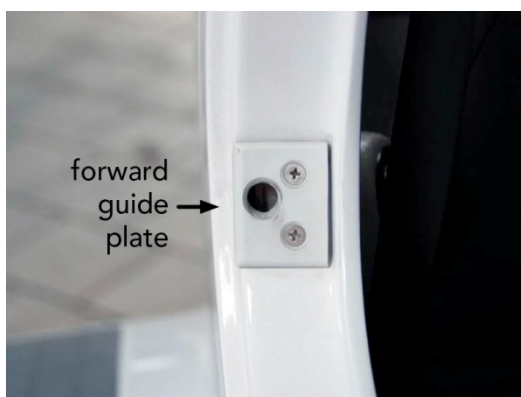
The statement of the pilot that the rear door was closed correctly prior to the flight is in contrast with the results of the examinations and tests that were carried out. The scenario that the rear door was closed properly and subsequently opened and separated could not be reproduced. If the door had been properly closed, damage marks should have been present on the guide plates in the fuselage, caused by the locking pins. See figures 11 and 12. No damage marks were present on both plates. The locking pins move into the fuselage when the door is locked by using the handle.

Figure 11: forward guide plate in fuselage
(source: W.L. Nijdam)

Therefore it is concluded that the two locking pins of the rear door closing mechanism were not in the guide plates in the aircraft fuselage at the moment the door separated. This can be explained by the scenario that the door handle was not in the locked position. As a result of this the door

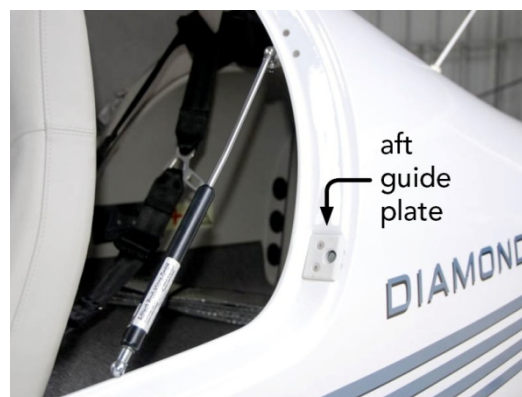
Figure 12: aft guide plate in fuselage
(source: W.L. Nijdam)
