PRECAUTIONARY LANDING AFTER CONTROL PROBLEMS

Incident number:	2011057
Classification:	Serious incident
Date, time ² incident:	15 July 2011, 17.11 hours
Place of the incident:	Near Lelystad Airport
Registration:	PH-FLD
Aircraft type:	Diamond DA 40 D
Aircraft category:	Single engine propeller airplane
Flight type:	Private flight
Flight phase:	Take-off
Aircraft damage:	None
Number of crew:	One
Number of passengers:	One
Personal injury:	None
Other damage:	None
Light conditions:	Daylight

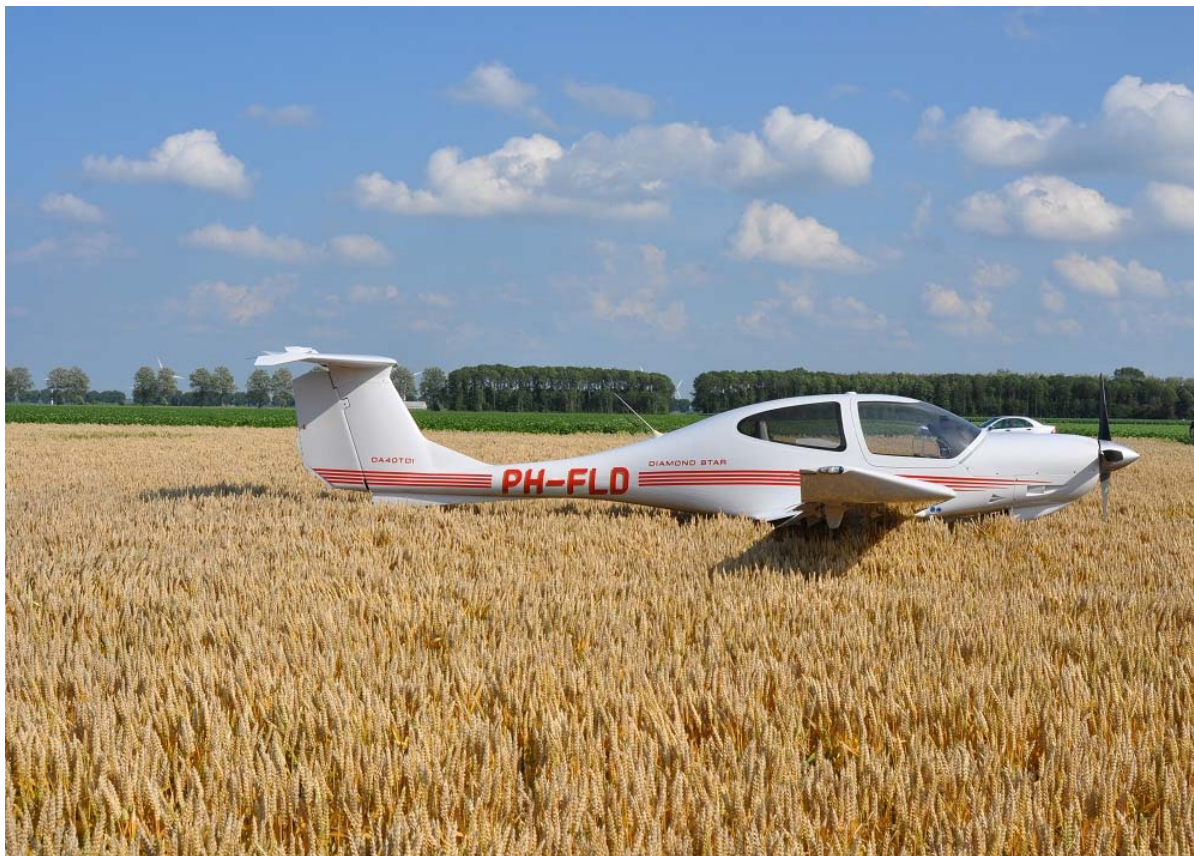
The second pilot took control and also experienced control difficulties, it was decided to make a precautionary landing. After making a right-hand turn at approximately 250 feet, a precautionary landing was made in a field of standing crops. There was no damage to the aircraft and the occupants were able to exit the aircraft unharmed (Figure 1).

Figure 1: the PH-FLD after the precautionary landing in a standing crop field (source: KLPD – Aviation Police)

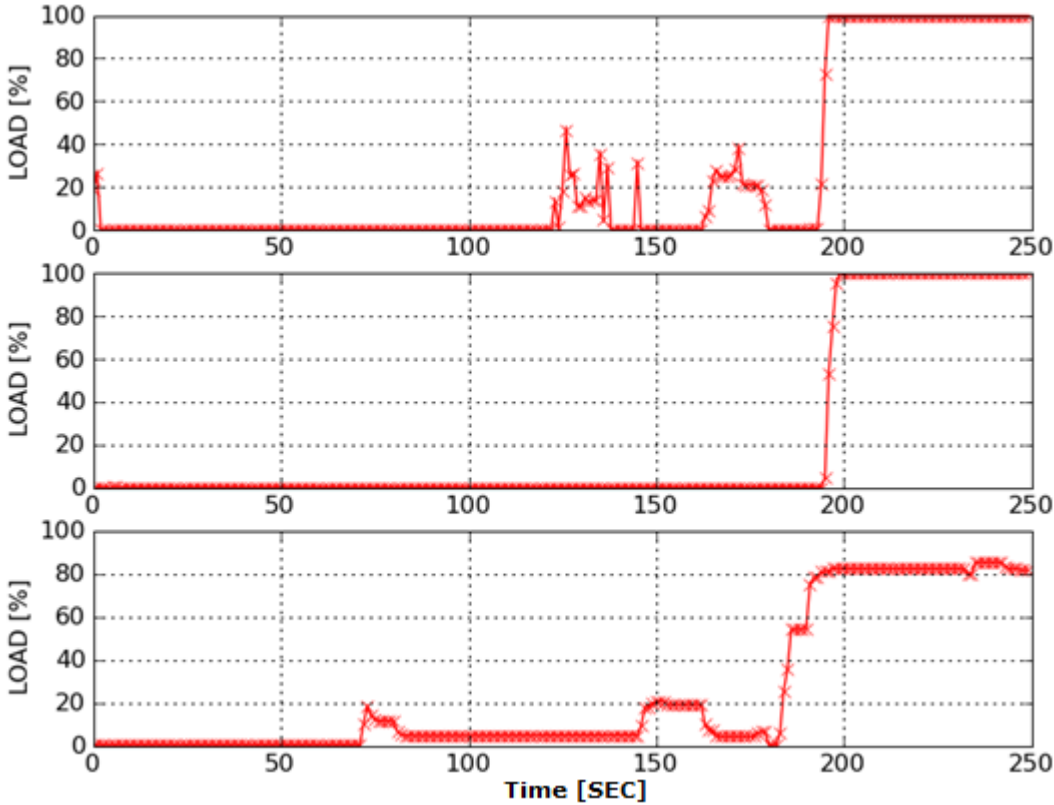
The aircraft is equipped with an engine and propeller which are electronically controlled and regulated by a digital Full Authority Digital Engine Control⁵ (FADEC) unit. The FADEC includes a failure and data recording system which may be utilised for engine troubleshooting. The data also may be downloaded after a flight, for analysis purposes. At the request of the Dutch Safety Board the FADEC data was downloaded after the event but it could not be used to explain the high control forces. Analysis of the data did show, however, that the aircraft took off with 83% selected power (LOAD⁶) (Appendix B). In the Take-off checklist it is stated that maximum power should be selected, and during takeoff roll the indicated LOAD indication should be between 90 - 100%.

Figure 3: overview of the LOAD selection of three PH-FLD takeoffs. The first two takeoffs a load of 100% is selected, the third takeoff (event flight) a LOAD of 83% is selected.
