## HARD LANDING DURING AUTOROTATION TRAINING

Identification number:	2011061
Classification:	Accident
Date, time <sup>1</sup> of occurrence:	31 July 2011, 11.27 hours
Location of occurrence:	Lelystad Airport (EHLE)
Aircraft registration:	PH-WTW
Aircraft model:	Guimbal Cabri G2
Type of aircraft:	Helicopter
Type of flight:	Training flight
Phase of operation:	Landing
Damage to aircraft:	Severe
Cockpit crew:	Two
Passengers:	None
Injuries:	None
Other damage:	None
Lighting conditions:	Daylight

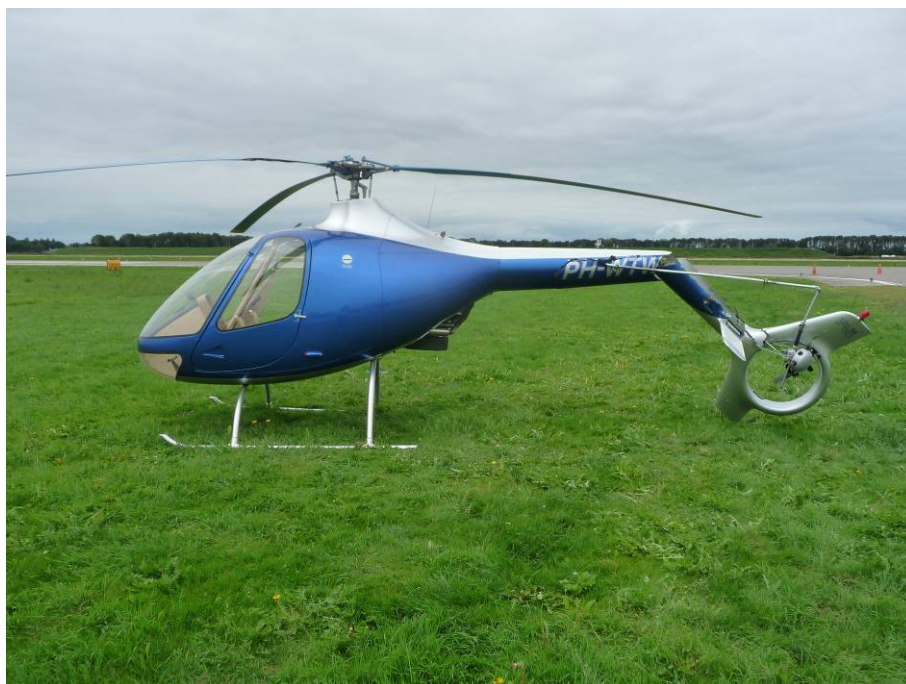
The instructor set the throttle to idle, the pilot lowered the collective<sup>3</sup> and decreased the airspeed to the speed used for autorotation. During descent, shortly before landing, the instructor realised that the intended landing spot would be over flown and announced that it was better to perform a power recovery.<sup>4</sup> At a height of about 10 feet over taxiway D, throttle was increased while the pilot started the flare by pulling the collective. Next the helicopter hit the ground and the crewmembers heard a loud bang from behind and observed pieces of debris flying around. The helicopter bounced back into the air and came to a standstill a few meters away from the initial impact point. The main rotor was still turning and the pilot used the rotor brake switch to slow down the rotor, but there was no response. The engine was still running and the main rotor stopped turning some time after switching off the engine. Both occupants left the helicopter without injuries. The helicopter's tail boom was found broken and the tail rotor had disintegrated.

Figure 2: PH-WTW after the accident

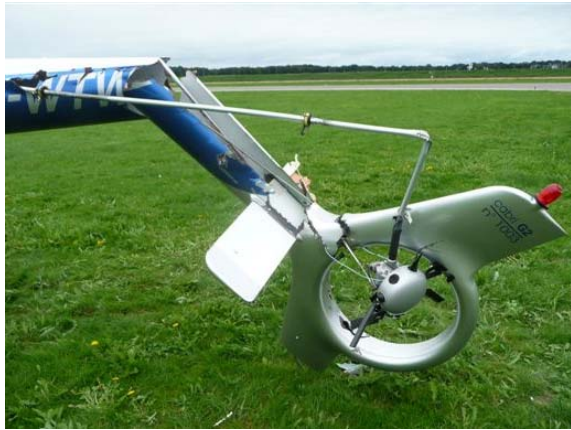
The main and tail rotor controls were checked. No indications for a pre accident malfunction were found. The tail boom was cut off by two of the three rotor blades. The first blade that hit the boom penetrated 20 mm into the boom skin, clearing the tail rotor driveshaft. The absence of any mark on the blade's paint aft of the steel leading edge proved that the tip pitch was close to zero at impact. The next blade penetrated 40 mm into the boom and hit the tail rotor driveshaft (see figure 2). The blade tip shows dents in the stainless steel cap which match with the tail rotor driveshaft damage. Since the structure and paint of the blade tip was intact, it confirmed the strong down-bending during the impact of the blade.

The rear end of the tail rotor drive shaft is connected rigidly to the tail rotor gearbox with no sliding coupling. The tail rotor had disintegrated as a result of a pulling force of the drive shaft on the tail

rotor gearbox in combination with high inertial forces on the tail blades created by the sudden jamming of the drive shaft. There are no indications that the tail struck the ground in flight. The observed damage on the tail skid had occurred when the tail fell on the ground after the tail boom was cut.

Figure 3: damaged tail and -tail rotor driveshaft Figure 4: flexible coupling

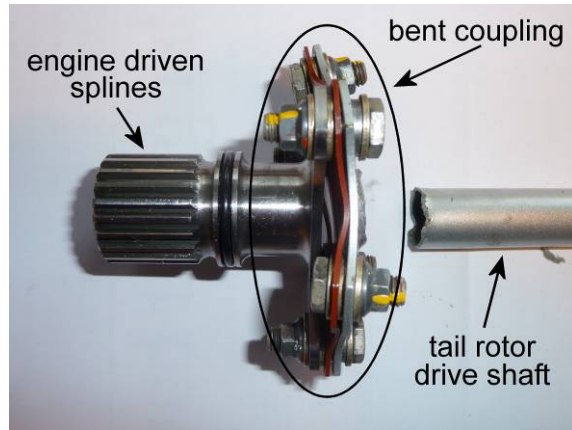
A flexible coupling connects an engine driven pulley to the tail rotor driveshaft. One side of the flexible coupling is connected to the pulley by external splines while the other side of the flexible coupling is welded to the tail rotor driveshaft. After the tail rotor driveshaft was hit and bent by the main rotor blades, the front part of the shaft moved backwards (see figure 3). Because the splines allow axial movement (see figure 4) and the rear part of the shaft is attached to the tail rotor gear box, the flexible coupling was pulled out of the pulley. When the tail rotor shaft with the coupling moved further backwards, the coupling became stuck at a cross bar of the airframe. Due to high forces the flexible coupling got bent and finally broke off near the weld (see figure 4). The coupling was catapulted into the airframe cowling (see figure 5).

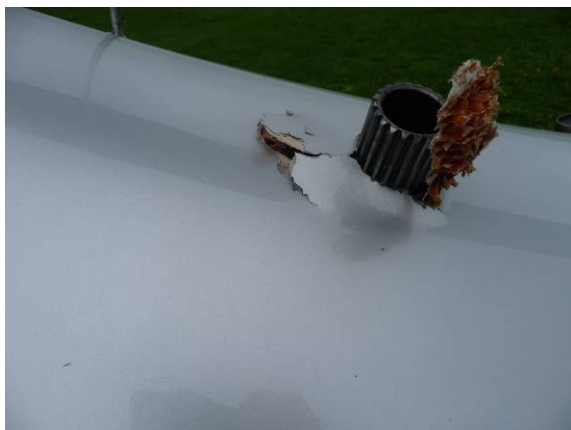
Figure 5: coupling stuck in airframe cowling Figure 6: engine driven pulley with bent coupling
