DUTCH  
SAFETY BOARD

# Quarterly Aviation Report

January - March 2018

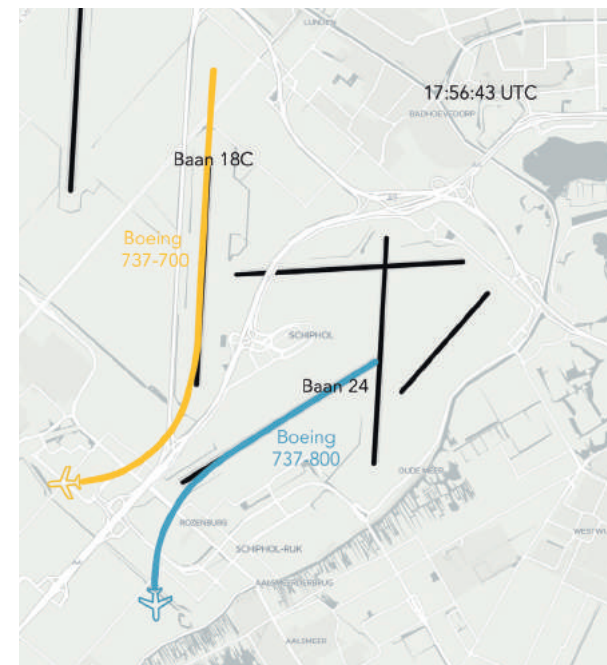
A Boeing 737-700, which was engaged in executing a landing at runway 18C at Schiphol Airport, performed a last minute go-around. The crew immediately reported this to Air Traffic Control. Shortly before this, a Boeing 737-800 had received permission for take-off from runway 24. Due to the fact that the extensions of both runway intersect one another, this resulted in a potentially hazardous situation. The air traffic controller recognised this and instructed the Boeing 737-700 performing the go-around to turn right as quickly as possible. After take-off, the crew of the Boeing 737-800 was instructed to perform a left turn at a heading of 180. The pilots of both aircraft made visual contact with one another. Later on, the crew of the Boeing 737-700 was instructed to maintain a heading of 270. The Boeing 737-800 continued its flight and the Boeing 737-700 landed on runway 18C shortly thereafter without incident.

Schematic representation of flight paths.

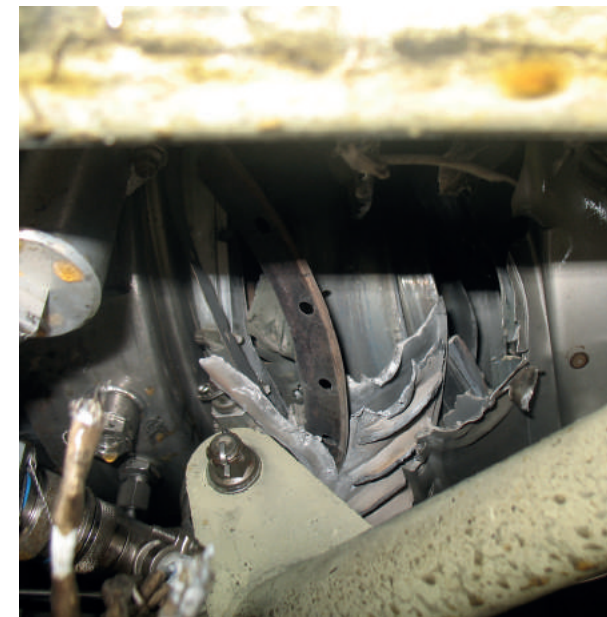
Prior to the flight from Albrecht Dürer Airport Nürnberg in Germany to Zürich Kloten Airport in Switzerland, the Fokker 100 was de-iced. The employee conducting the de-icing procedure heard the rpm of the *auxiliary power unit* (APU) increase, whereupon he stopped de-icing. At that moment, there was an explosion and the employee took shelter in his safety cage. Immediately after that, there was an even bigger explosion, at which point the APU shut itself down. During these events, a service hatch on the underside of the aircraft had opened up, out of which a flame jet of approx. 2 metres escaped. The hatch was damaged.

The aircraft crew stated that the aircraft shook. A broken piece of the APU pierced the pressure bulkhead at the rear of the cabin and for a short while smoke entered the cabin. The passengers were subsequently instructed to make their way to the smoke-free front section of the cabin, after which they disembarked and were taken to the terminal on buses.

An investigation revealed that the de-icing fluid had seeped into the APU, resulting in a significant increase in the turbine speed.

*The damaged APU. (Photo: BFU)*

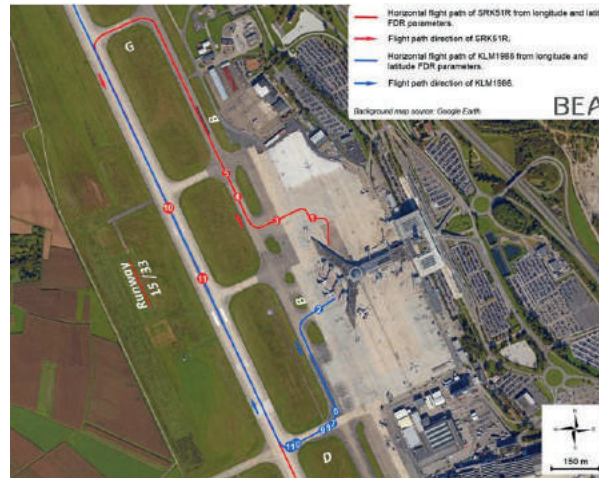
According to the report drawn up by the French investigatory authority BEA, the incident was caused by the cockpit crew of the Embraer misunderstanding the instructions of Air Traffic Control and Air Traffic Control's failure to notice that the Embraer's cockpit crew read back the instruction incorrectly.

Horizontal flight paths Embraer 190 (blue) and Dornier 328 (red).  
(Photo: BEA)

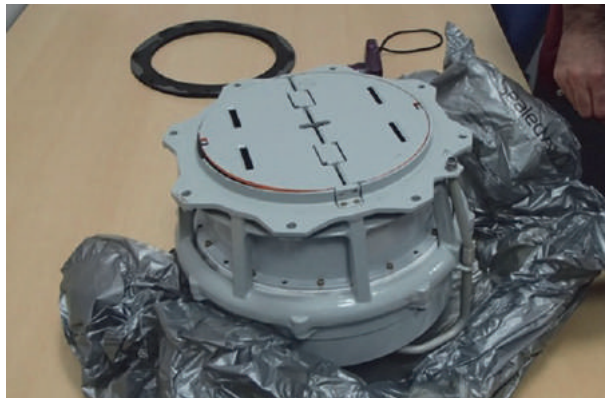
Following an investigation, it was established that the cabin had not been able to pressurise correctly due to a faulty positive pressure relief valve (PPRV). Both PPRVs had been replaced by refurbished valves when the plane had previously undergone maintenance shortly before. Testing and disassembly of the faulty valve did not yield any definitive answer regarding the reason for the failure of the valve. The possibility of dirt residues having been inside the valve during the flight could not be excluded.

Faulty positive pressure relief valve (PPRV). (Photo: AAIB)

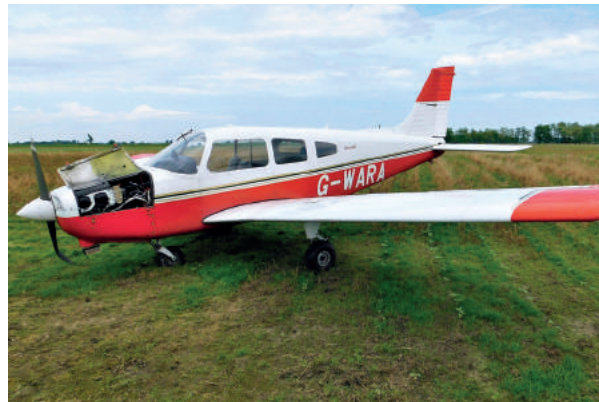
The Piper Cherokee, owned by a Dutch national, was carrying out a flight from Oradea International Airport in Romania to Brno–Turany Airport in the Czech Republic with the pilot and one passenger on board. During the flight, the plane's electrical power system stopped working. The pilot was forced to make an emergency landing in a field. Neither of the occupants on board were injured in the process. The plane incurred damage to the propeller, nose landing gear and engine suspension.

G-WARA after the emergency landing. (Photo: TSB)

The first investigation carried out by the Hungarian investigatory authority (TSB) indicated that the pilot had been aware of the fact that the battery of the plane was defective. Prior to departure, he had started the aircraft engine using an external power source. The TSB subsequently decided that this incident warranted no further investigation or action from the TSB, and on 28 February 2018, it informed the Dutch Safety Board that it had suspended its investigation.

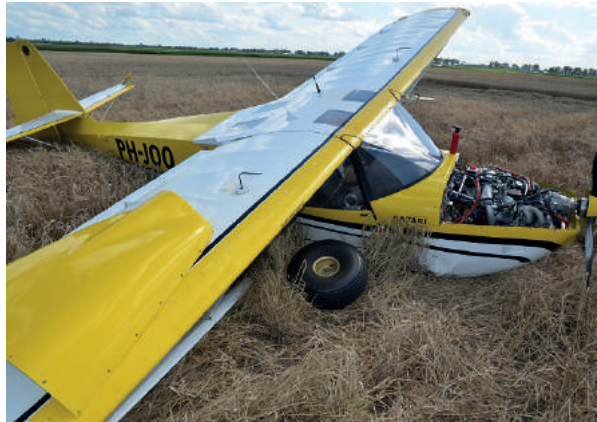
The landing was heavy and, shortly after contact with the ground, the aircraft slid sideways. Within a few seconds, the heavily damaged aircraft came to a halt, ending up on its right side, thus blocking the door on the passenger's side. The pilot ensured that the passenger left the aircraft via the left-hand side, after which he informed the airport authority, deactivated the electrical system and cut off the fuel supply. He subsequently deactivated the Emergency Locator Transmitter (ELT) and left the aircraft. As soon as the airport manager of Stadskanaal Airfield had seen the aircraft disappear behind the trees, he initiated the airfield's emergency procedures.

Shortly after the accident, the aircraft manufacturer transferred the data stored on the on-board computer (iEFIS). This data could then be used to analyse the situation before, during and after the engine failure. The data showed that, following an initial descent, the aircraft was no longer in descent and was flying roughly 1 metre above the ground in the final 20 seconds of the flight. Thereafter, the aircraft stalled and hit the ground with a gravitational acceleration of 3.9 g.

Furthermore, the flight data shows that approximately 4.8 litres of fuel had been used during the flight, which roughly matches the content of the header tank. Upon closer examination, the fuel valves in the wings appeared to be closed. It is not known when these valves were closed. There is no warning system that alerts the pilot to a fault regarding the fuel supply from the wing tanks to the header tank. The on-board computer only indicates fuel consumption per hour and calculates the total remaining amount of fuel available.

The accident was caused by a fuel shortage. The engine was only being supplied with fuel by the header tank, but the header tank was not being fed by the wing tanks during the flight, due to the fact that the fuel valves of these tanks were closed.

*PH-JOO after the accident. (Photo: Aviation Police)*

As a result of this accident, the manufacturer will be issuing a Service Bulletin that will contain the following elements:

- a sensor that records the fuel level in the header tank, with a warning lamp and an audible alarm on the instrument panel in the event of a fuel shortage;
- securing the fuel valves on the wings in an open position;
- including a check of the wing fuel valves during the pre-flight checklist.
