DUTCH
SAFETY BOARD

Quarterly Report Aviation

October-December 2016

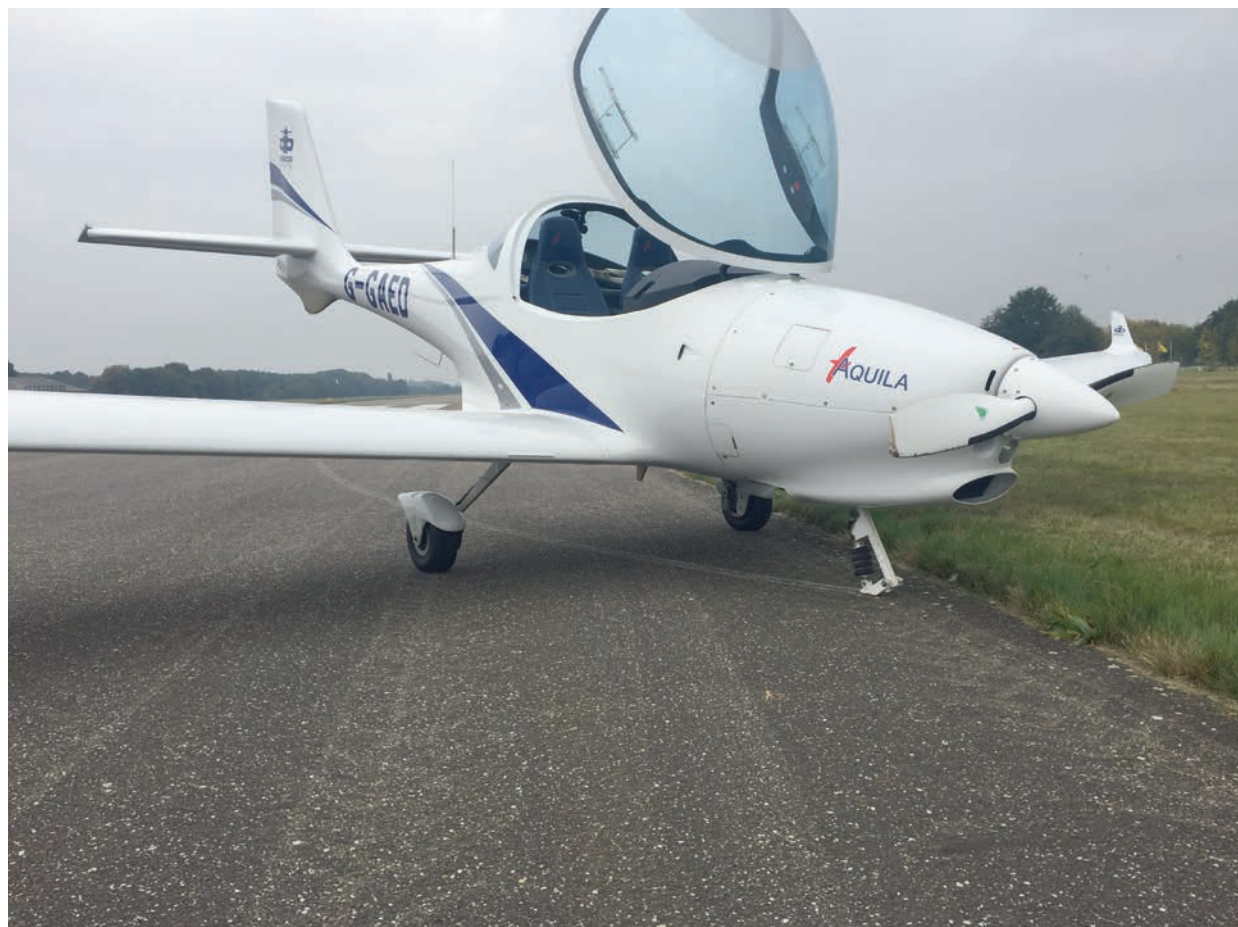
switching magneto; however, this did not have the intended effect. The aircraft made an emergency landing with tailwind on runway 25 and bounced. This caused the aircraft's nose wheel support to break, and the propeller came into contact with the runway.

G-GAED following the occurrence. (Photo: National Police)

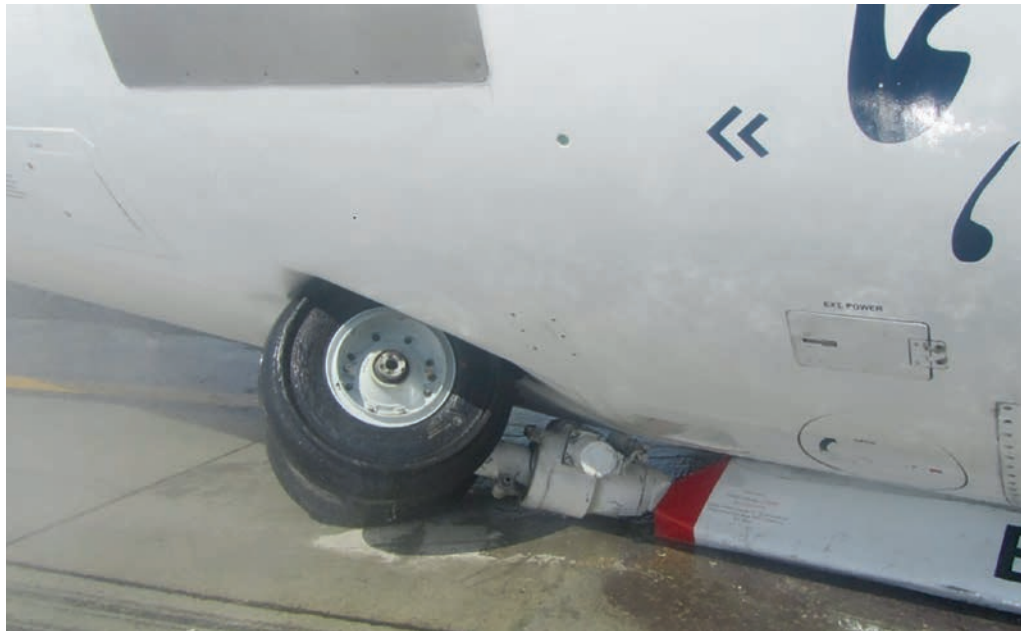
While taxiing from the aircraft stand to the runway, a component of the nose landing gear on the Fokker 100 broke off. As a result, the nose of the aircraft came into contact with the taxiway, and suffered damage. There were no injuries.

The position of the nose landing gear. (Photo: AAIB Iran)

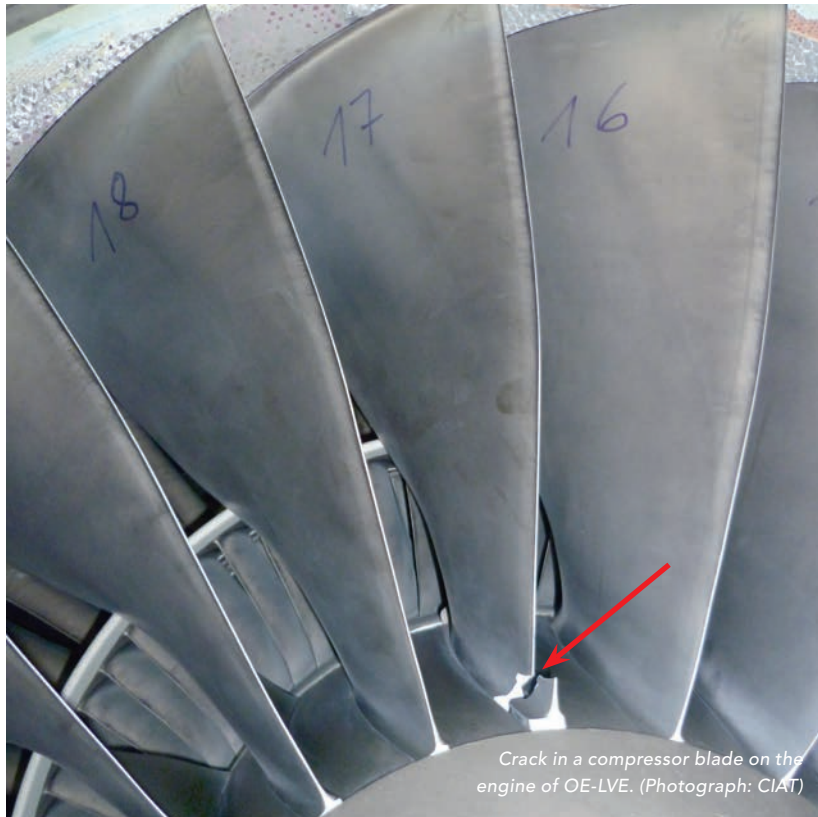
Crack in a compressor blade on the engine of OE-LVE. (Photograph: CIAT)

During cruise flight from Vienna (Austria) to Pristina (Kosovo), the aircraft started to vibrate. The automatic pilot switched itself off and there were indications in the cockpit suggesting problems with the left engine. Passengers in the cabin observed sparks and flames originating from the left engine. Shortly thereafter the left engine stopped, at which point the crew initiated the engine failure procedure. The crew diverted to Belgrade airport (Serbia) where a safe landing was made. Upon inspection of the engine, a crack was observed in a compressor blade.

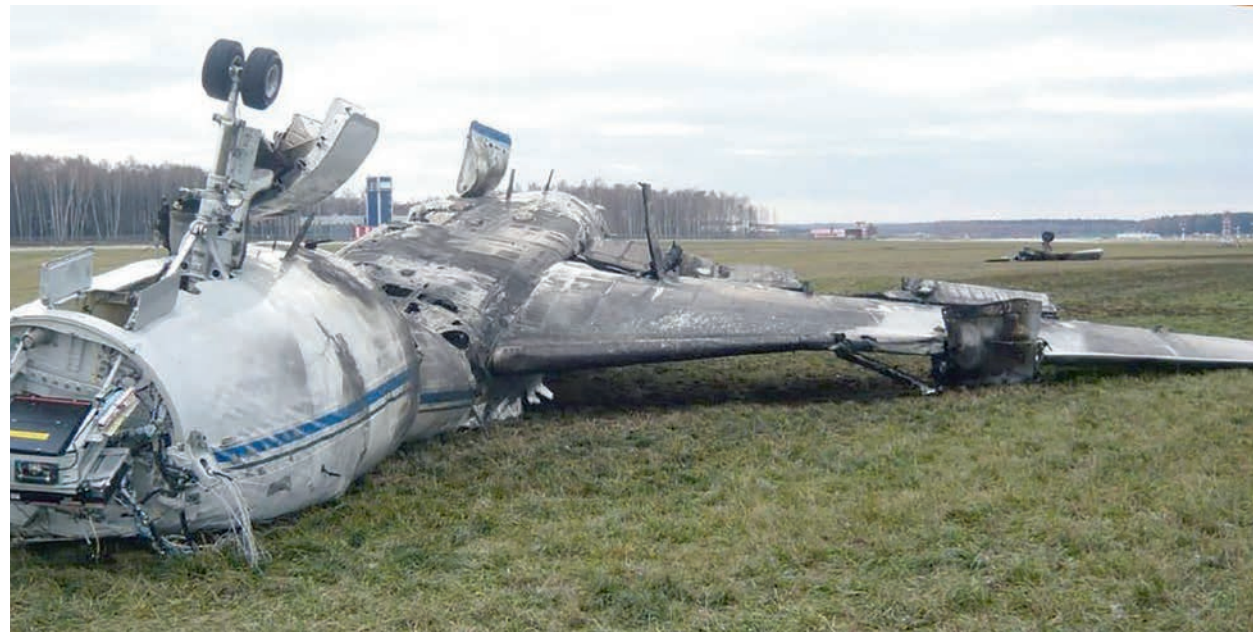
Shortly following rotation during take-off, the Falcon 50EX came into collision with a snowplough on runway 06 at Vnukovo Airport (Russia). Due to damage to the right wing as a result of the collision, the aircraft started to roll uncontrollably to the right. The crew were unable to halt this rolling motion, by turning the control column full left. The aircraft crashed 250 metres further on, where it collided with the ground, inverted. The four persons on board the aircraft were killed. The driver of the snowplough was unhurt.

F-GLSA following the accident. (Photo: IAC)

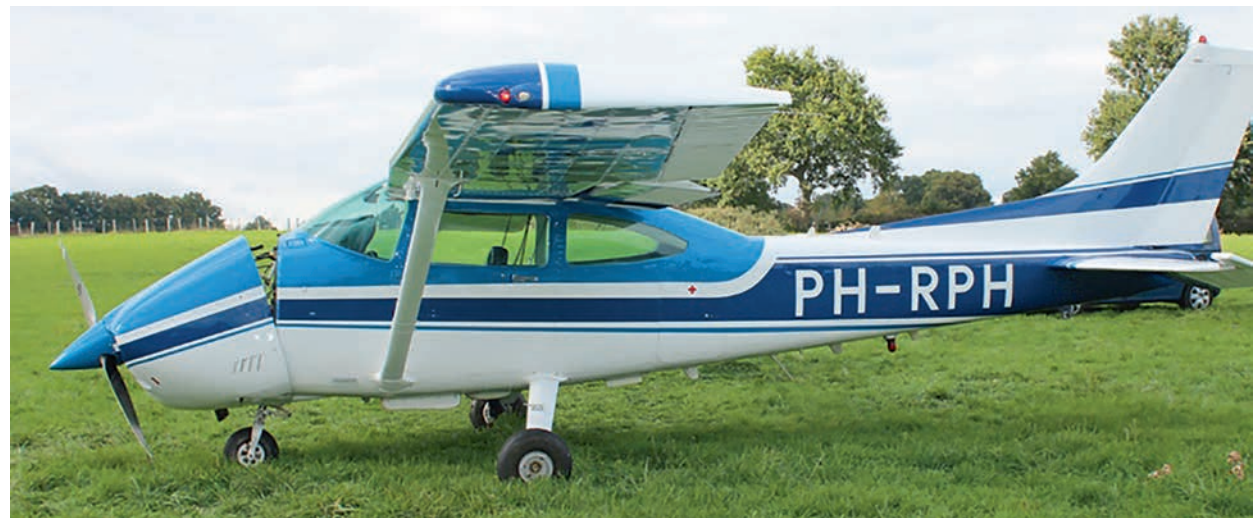
After the landing, the fuel gauge showed empty. The right-hand tank was found to be completely empty and the left-hand tank contained just 3 litres of fuel. The pilot stated that prior to departure for the 15 minutes positioning flight, there had been 90 litres of fuel remaining in the tanks. Following arrival at the airfield of Roanne Renaison, a further 20 litres of fuel were added. The pilot assumed fuel consumption of 60 litres per hour, and estimated that each parachute flight would last around 30 minutes. He assumed that there was sufficient fuel in the tanks for three flights. The aircraft was not equipped with a low-fuel warning system.

The accident was caused by a miscalculation of fuel consumption during the flight preparation. This caused the engine to stop during flight. No account was taken of fuel reserve or the volume of unusable fuel in the fuel tanks. Because the aircraft was forced to manoeuvre to

avoid a row of trees shortly before the landing, the aircraft stalled and made a hard landing resulting in damage to the aircraft. The pilot suffered injuries.

PH-RPH following the emergency landing. (Photo: BEA)

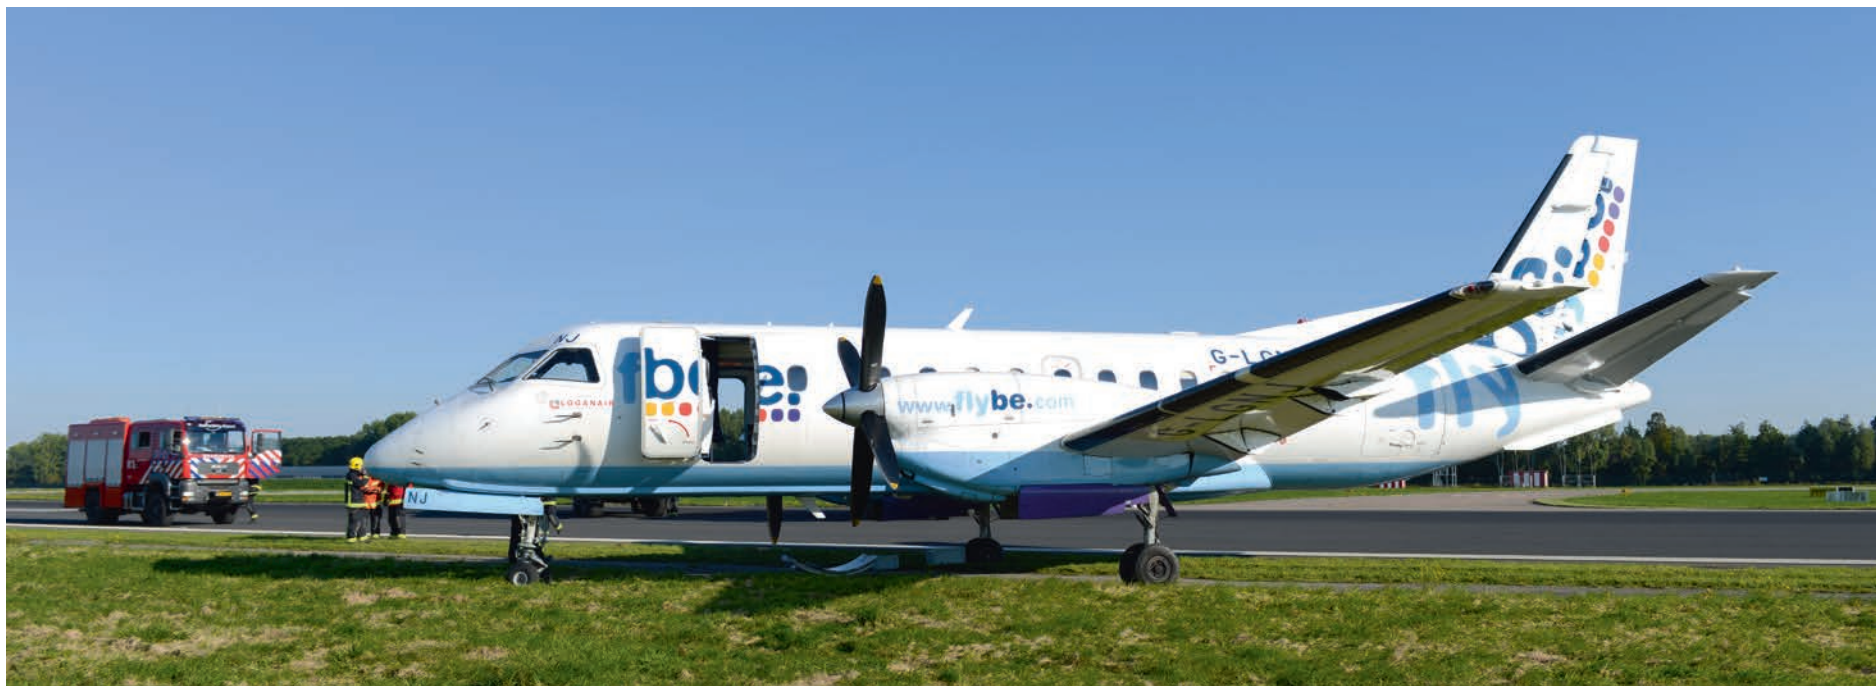
The investigation showed that the central hydraulic system failure had occurred due to hydraulic fuel leakage from a broken downlock swivel on the main right-hand landing

gear. The swivel was broken due to metal fatigue. The manufacturer had issued a Service Bulletin in 2013 for the replacement of these swivels. This Service Bulletin had not yet been implemented for the operator's entire fleet. The aircraft involved in the incident was not yet flying with the modified swivel.

G-LGNJ alongside the runway. (Photo: Rotterdam The Hague Airport)

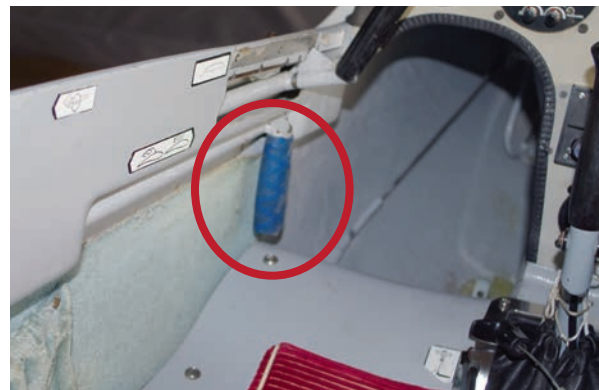
Airbrakes in locked position.

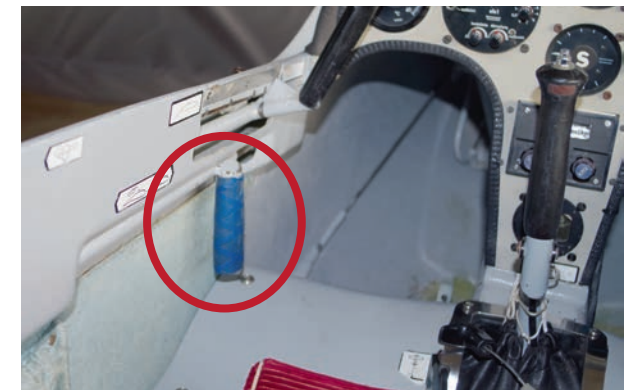
The glider rose free from the ground. The person operating the winch, the winch operator, noticed that the airbrakes had opened, and that the pilot was making large aileron adjustments, in order to keep the wings horizontal. The increased resistance caused by the open airbrakes meant a reduced rate of climb for the glider. Because the winch operator had already selected maximum power, he considered it unwise to continue winching the glider to a higher altitude in the current condition because of the risk of stalling. At a height of just a few metres, the winch operator therefore fully throttled back the winch control. A contributing factor in the winch operator's decision was the possibility that the pilot of the glider may have little experience with the winch launch method. It subsequently emerged that this was not the case. At the moment that the winch operator reduced power, the glider was at an altitude of between three and five metres, in a gentle climb attitude. The pilot released the winch cable and initiated the descent of the glider. Because the airbrakes were open, the glider subsequently lost height rapidly. Because the winch operator was under the impression that the winch cable was still connected to the glider, the operator attempted to increase the flying speed of the glider, by briefly delivering more power. Because the winch cable had already been released, this had no effect on the glider, which made a hard landing, causing damage to the nose wheel housing, and the attached brace. Neither passenger suffered any injury.

Airbrakes in unlocked position. (Photographs: captain PH-1252)

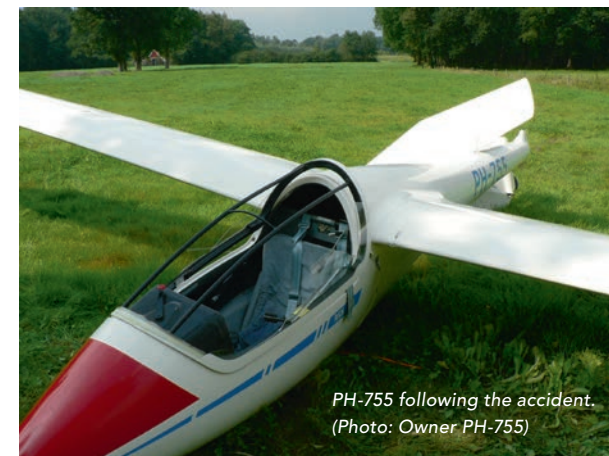
approximately halfway along the length of the field. Following initial contact, the glider bounced, and returned to the ground approximately 15 metres before the end of the field. The glider eventually came to a standstill in a barbed wire fence, with the left wing against a fence post, approximately 10 metres from a barn. The pilot suffered serious back injuries. He himself called the emergency services by dialling 112 (the emergency number). The glider suffered serious damage.

PH-755 following the accident.
(Photo: Owner PH-755)

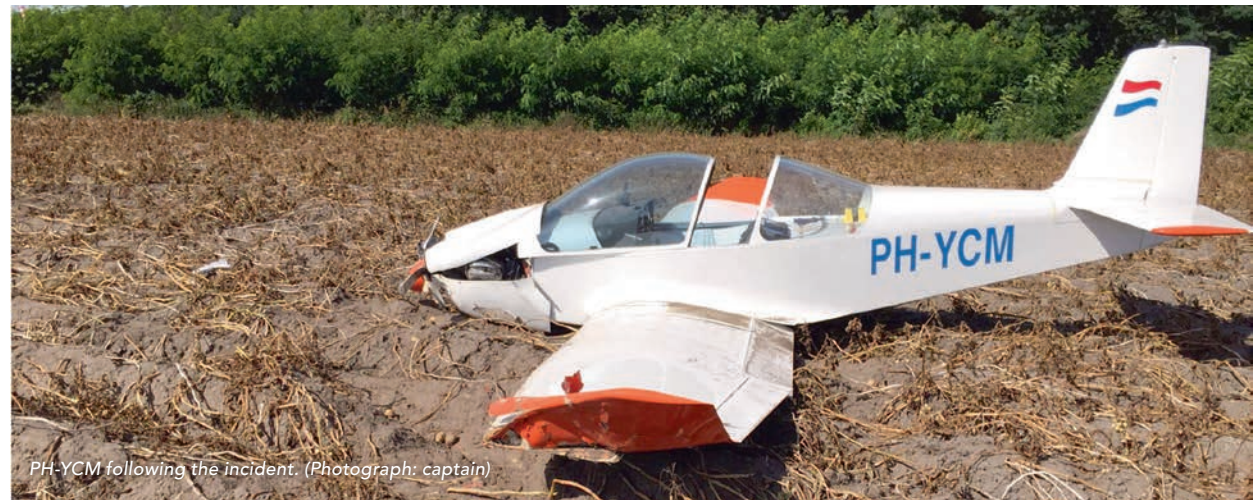
The captain stated that he had in fact aimed at a point further up the runway, so as to be able to fly over the interchange before the beginning of runway 07, with sufficient margin. There was not sufficient space left to bring the aircraft to a standstill, on the runway. PH-YCM passed the end of the runway, and crashed through the airfield outer fence. With a sharp turn on the ground, the aircraft came to a standstill in a potato field, beyond the end of the runway. The passengers were uninjured. The aircraft suffered severe damage.

PH-YCM following the incident. (Photograph: captain)

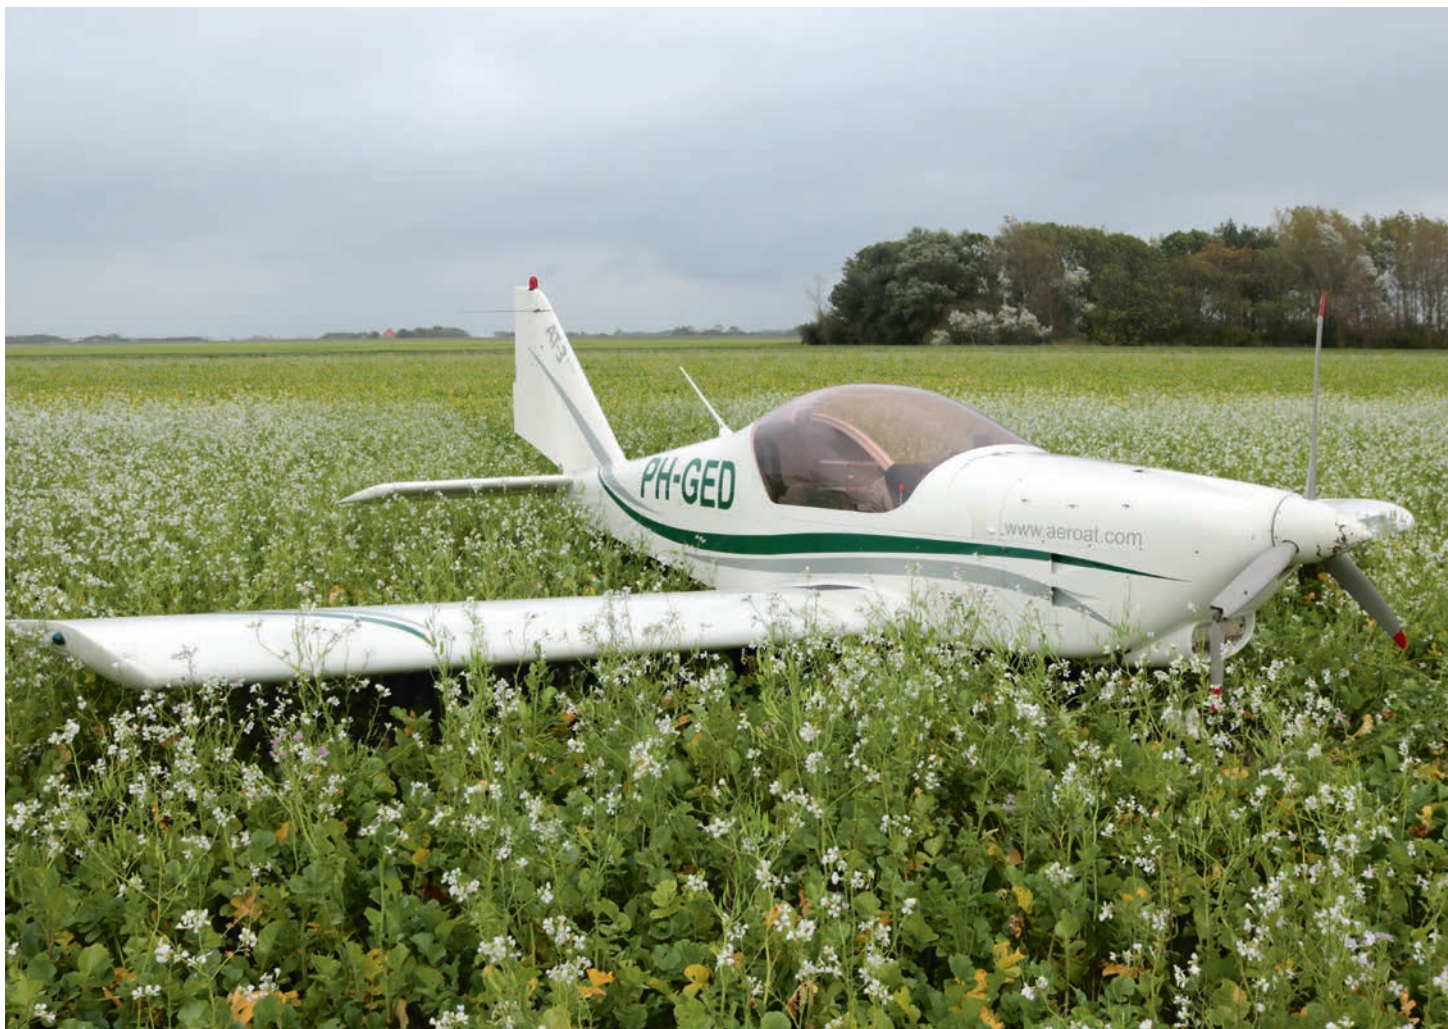
PH-GED after the accident. (Photo: Texel International Airport)
