DUTCH
SAFETY BOARD

Carbon monoxide in bow thruster room

The Hague, November 2015

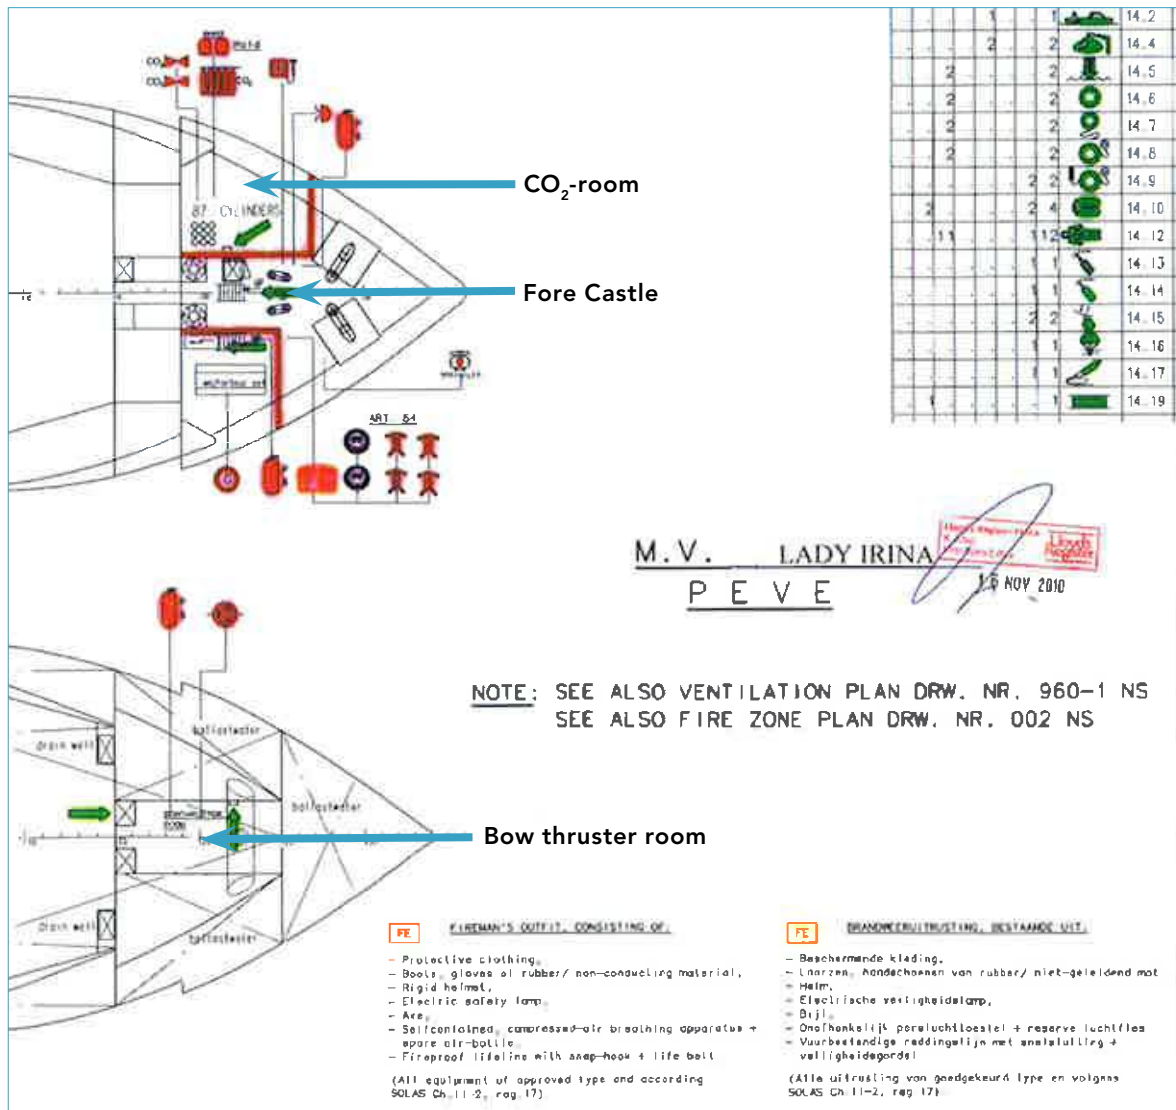
The bow thruster room on board Lady Irina is located beneath the vessel's forecastle deck between the ballast water tank and directly under the forecastle. The bow thruster room can only be approached via the forecastle and has no door to the outer deck (see figure 2).

Neither the forecastle or bow thruster room have mechanical ventilation.

Figure 2: Lady Irina forecastle. (Source: Wijnne Barends shipping company)

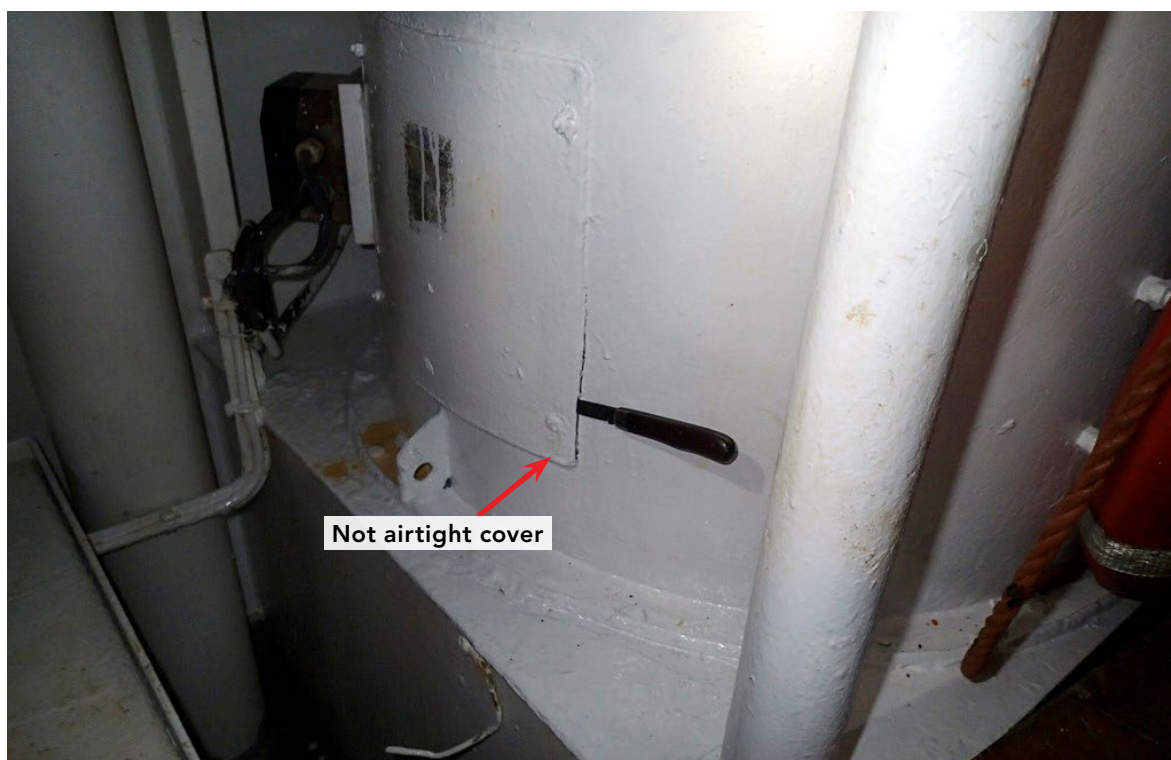
During the investigation⁸ a gap was determined in the inspection hatch on a ventilation duct that runs from the cargo hold through the forecastle (see figure 3). The largest proportion of carbon monoxide probably entered the forecastle via this gap. The cargo of wood pellets that produced the carbon monoxide was stored in the cargo hold. The hold was not ventilated, which meant that carbon monoxide levels were able to rise and ultimately enter the forecastle via the gap in the ventilation duct. Carbon monoxide was able to spread further to the bow thruster room via air circulation through the hatch from the forecastle. The investigation did not demonstrate that carbon monoxide also entered the forecastle via the other routes, but this possibility exists as no single route can be guaranteed as entirely air tight.

Figure 3: Gap in inspection hatch cargo hold ventilation duct forecastle. (Source: Lloyd's Register EMEA Denmark)

The cargo on board Lady Irina produced carbon monoxide that could have leaked into the forecastle via various routes from the cargo hold. Probably the largest proportion of the carbon monoxide entered the forecastle via a gap in the cargo hold ventilator duct's inspection hatch and then into the bow thruster room. As the bow thruster room and forecastle had not been ventilated for more than 24 hours, carbon monoxide levels had increased. The chief engineer was exposed to high concentrations of carbon monoxide in the holds, which led to carbon monoxide poisoning.

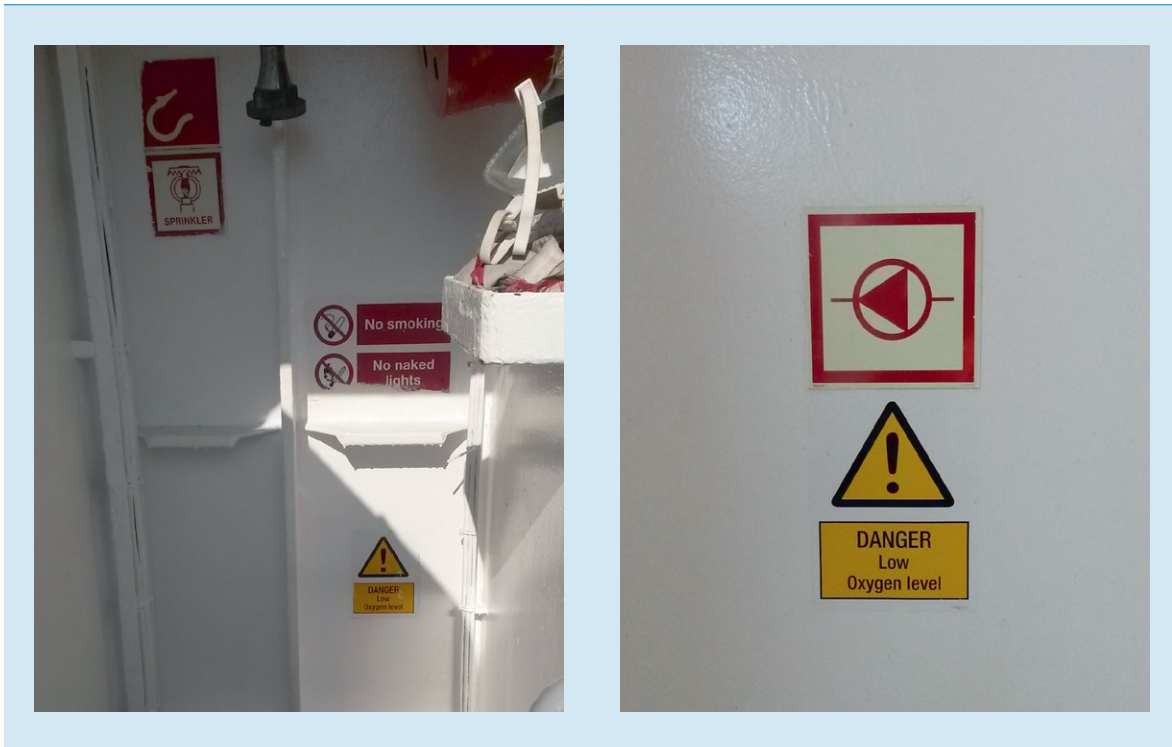
The access from the forecastle and the access from the bow thruster room were therefore also provided with warning stickers that warn for the possibility of low levels of oxygen in the atmosphere.

Figure 4: Warning stickers entrance to tank and bow thruster room. (Source: Wijnne Barends)

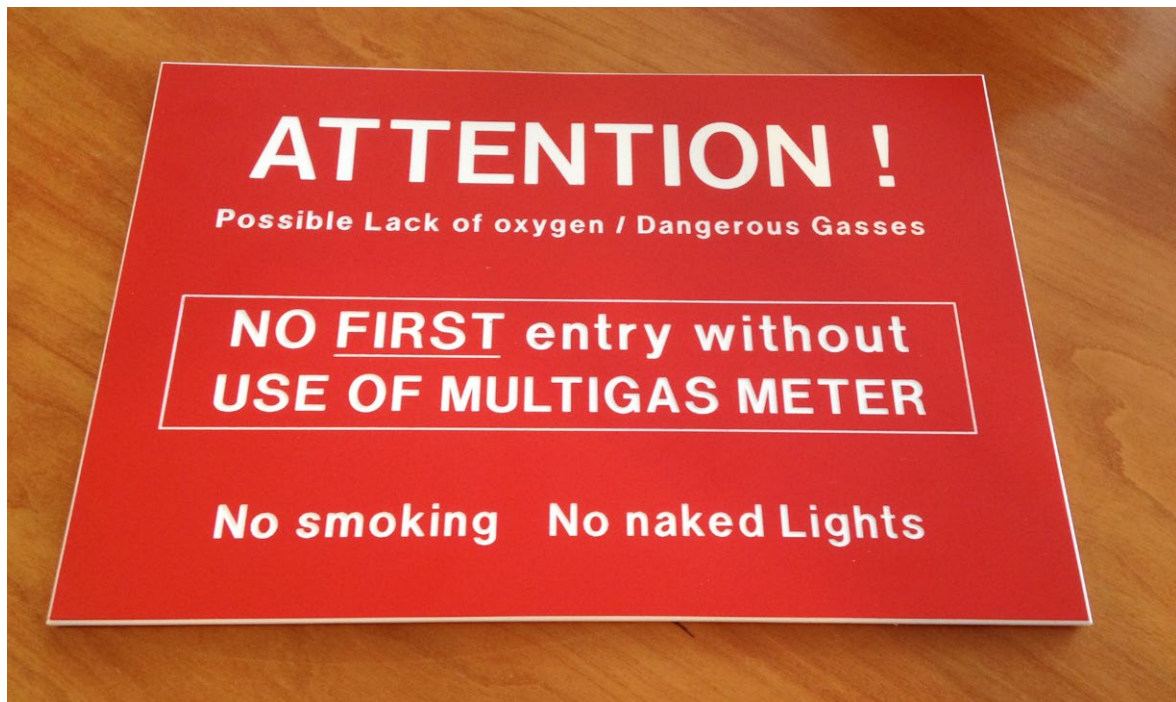
Figure 5: Sign regarding new working method. (Source: Wijnne Barends)

The working method concerns a 'First Entry'. 'First Entry' means the 'first' entry of a space on board a ship after it has been closed. The working method states that the person making the 'First Entry' must carry an operational multi-gas meter. This multi-gas meter gives an alarm signal when a concentration of hazardous gas is measured or if there is a lack of oxygen in the air. To be able to implement this, the shipping company has ensured that each vessel has at least three multi-gas meters available. This working method applies to the cargo hold and the adjacent spaces. On the Lady Irina, the forecandle and bow thruster room fall under this.

The shipping company uses a new sign for this working method (see figure 5). This sign has been placed on all accesses from the external deck to the hold and to the adjacent spaces on board all the shipping company's vessels. This contains a warning that an area is being entered in which there is a possible hazard for lack of oxygen or hazardous gases. The sign states that it is forbidden to enter the area for the first time without a multi-gas meter.
