DUTCH
SAFETY BOARD

Fatal accident during transfer at sea

Annelies Ilena, Cool Expreso,
Southern Pacific Ocean, 7 August 2014

The Hague, December 2015

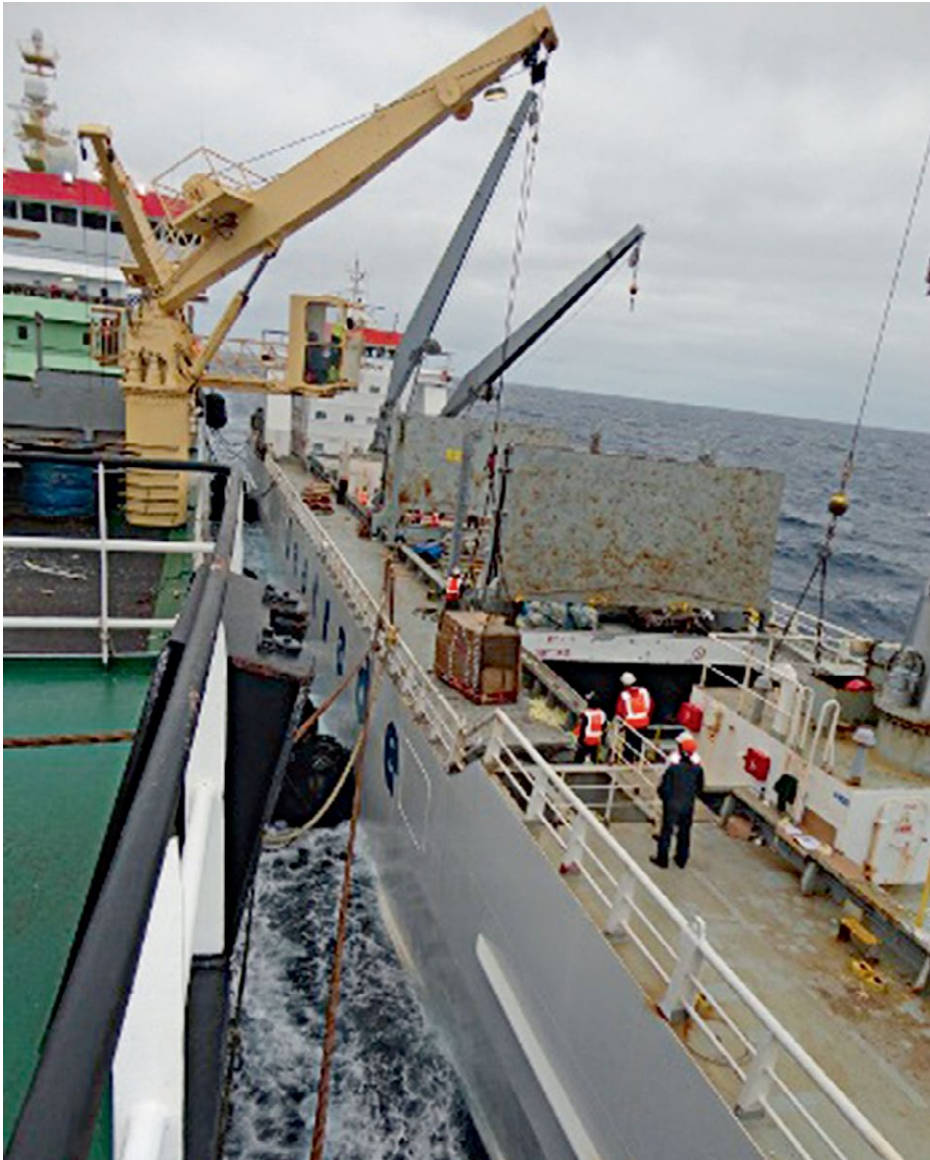
Figure 2: Annelies Ilena (left) and Cool Expresso (right) during transfer. (Source: Parlevliet en Van der Plas B.V.)

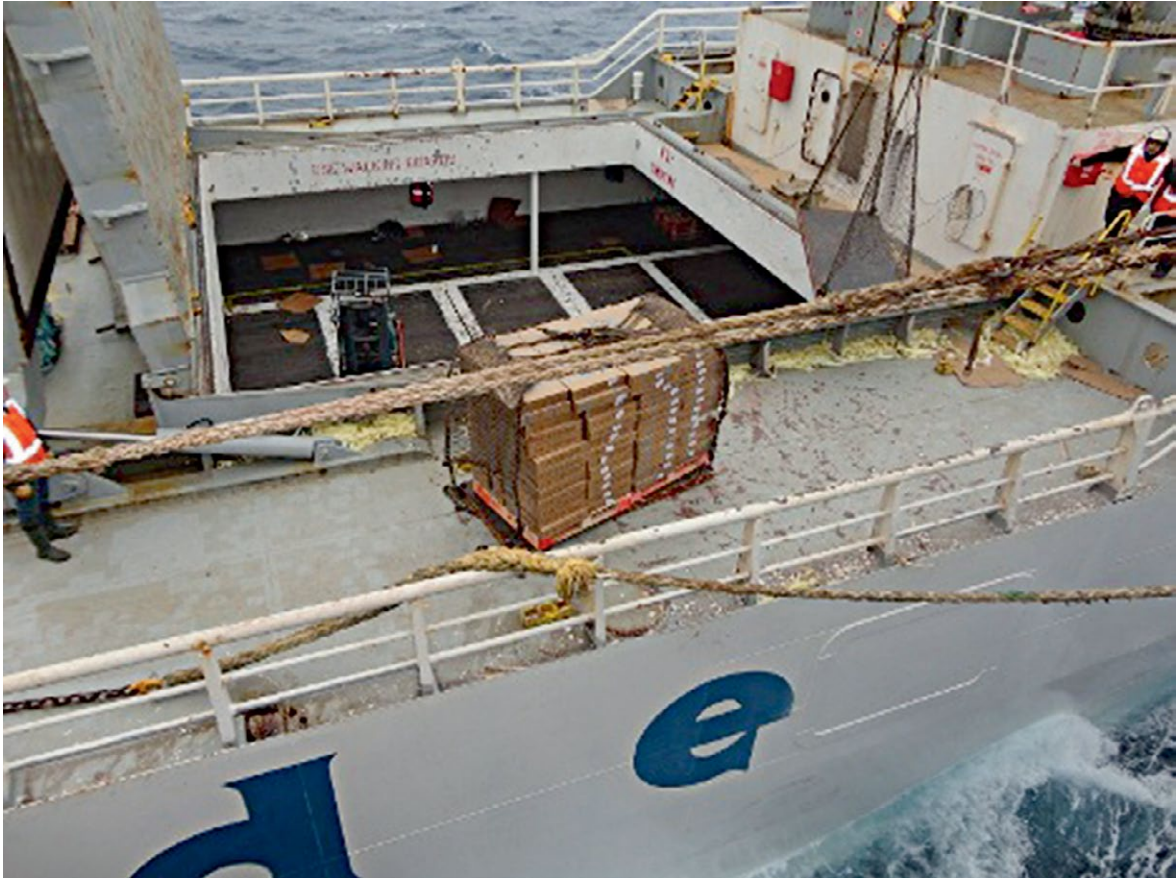
The incident occurred during transfer of the final platform of pallets, just before the end of the shift. The pallets were placed on the Cool Expresso gangway and one crew member was still busy labelling the packages. The platform with pallets was attached to the crane and the other Annelies Ilena crew members were preparing themselves for transport back to their own ship. Around 13:55 hrs they heard a scream. They then saw that the pallets, through hoisting, had shifted on the gangway. Because of this, the crew member who was still labelling the packages was trapped between the pallets and the railing. The crew member was trapped with his back towards the pallets. Directly after hearing the scream the pallets were swung out of the way by the crane driver, which released the crew member. The crew member tried to walk away, but collapsed a few seconds later.

Figure 3: Platform with pallets containing packages of frozen fish. (Source: Parlevliet en Van der Plas B.V.)

None of the crew members who were present during the incident saw that the platform containing the pallets with packages of frozen fish had shifted. It is plausible that the motion of the ship contributed to this shifting, but this was not the only force. The platform on which the pallets are placed is provided with an anti-slip coating. The combination of the anti-slip coating and the weight of the pallets ensures that the pallets do not shift easily. Another force is needed to cause the platform containing the pallets to shift. The Cool Expreso crew member eye witness statement seems to indicate that the platform containing the pallets was being hoisted, which resulted in the platform shifting and causing the crew member to become trapped between the pallets and the railing. As the crane driver was able to swing the pallet away from the victim immediately after hearing the scream, the Dutch Safety Board considers it likely that the pallets were attached to the Cool Expreso crane.

The pallets that shifted were the final load that the shift was to transfer before being relieved. The platform containing the pallets had already been attached to the Cool Expreso crane prior to labelling being completed, probably so that the crew members could get ready to be hoisted over to their own ship. The Safety Board considers it likely that the crane driver interpreted the crew members walking away (apart from the victim) as the agreed sign to hoist the pallets and place these into the hold. The hoisting of the pallets then caused the victim to become trapped between the pallets and the railing, because the platform containing the pallets did not only move vertically, but also horizontally. From the position of the crane driver it was not possible to see the victim between the pallets and the railing.

Following the investigation the Board considers it likely that the deceased crew member became trapped between the platform containing pallets and railing when the pallet was hoisted while the crew member was still attaching labels.

- Organising a safety meeting before the transfer is implemented.
- Appointing a coordinator during the transfer on both vessels.
- Designating someone to give hand signals to the crane driver during transfer.
