DUTCH
SAFETY BOARD

Quarterly Report Aviation

January-March 2016

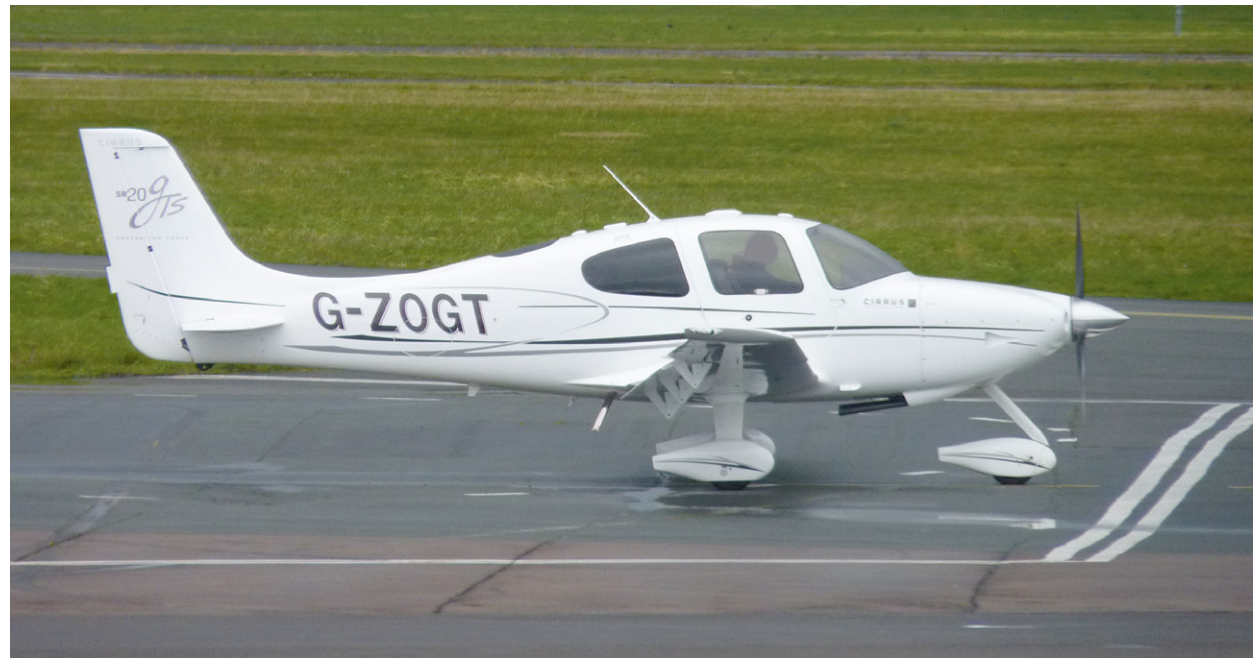
Crash during flight, Cirrus SR20, G-ZOGT, North Sea (near Camperduin), 4 January 2016

A Cirrus SR20, the pilot being its only occupant, took off from Gloucestershire (UK) for a flight to Osnabrück-Atterheide (Germany). During its flight, at a point off the Dutch coast the aircraft disappeared from air traffic control's radar. During the search that was conducted subsequently, the pilot was found. He did not survive the accident. Various pieces of flotsam and wreckage washed up on shore have been recovered. In addition, in cooperation with the Directorate-General for Public Works and Water Management a number of pieces of wreckage were recovered from the seabed, including the aeroplane's engine and emergency parachute.

Archive picture of G-ZOGT. (Photo: AAIB)

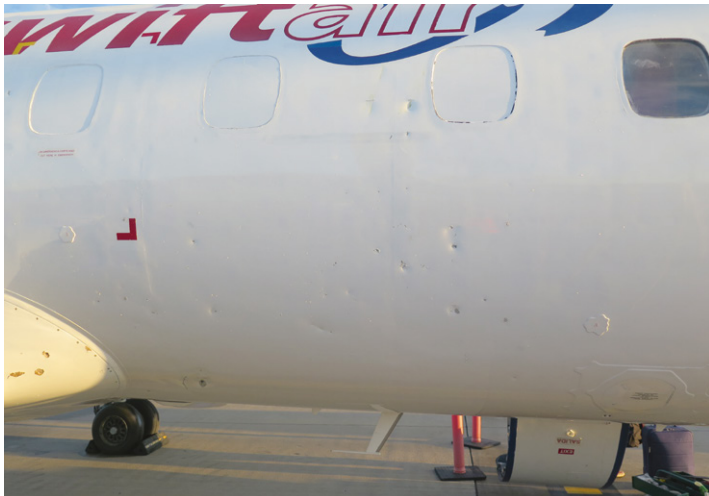
Runway lights hit during take-off, Embraer 120, EC-JBD, Amsterdam Airport Schiphol, 18 January 2016

The twin-engine Embraer 120 cargo aircraft departed from Amsterdam Airport Schiphol's runway 24 for a flight to London Stansted Airport in the United Kingdom. After landing in the United Kingdom, damage to the aeroplane's fuselage and one of its propellers was detected. An inspection of the runway on site did not yield anything noteworthy. At the airport of departure (Amsterdam Airport Schiphol), several lamps of the lighting on the right-hand side of runway 24 turned out to be broken. It is clear that the aircraft hit these lamps during take-off.

Damage to EC-JBD after landing. (Photo: AAIB)

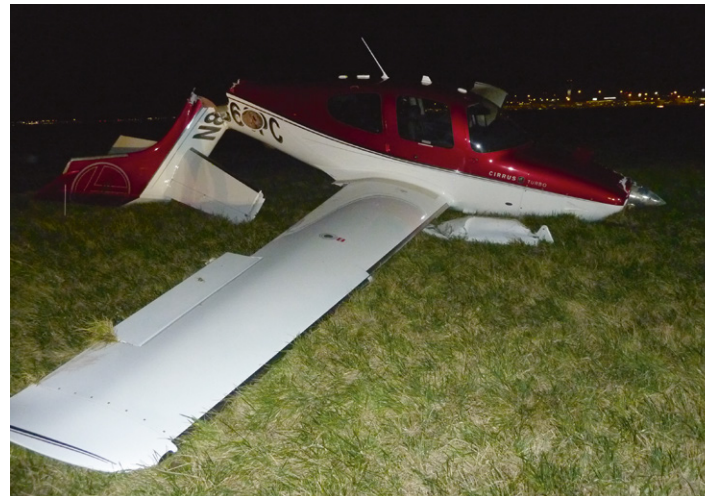
Loss of control during go-around, Cirrus SR22T, N860PC, Amsterdam Airport Schiphol, 2 February 2016

The Cirrus SR22T landed on runway 27 at Amsterdam Airport Schiphol. After landing, the aircraft bounced several times, after which the pilot initiated a go-around. During the go-around, the pilot lost control of the aircraft at low altitude, after which the aircraft came to a stop in the grass to the south of the runway. The pilot, who was the only occupant, did not sustain any injuries. The aeroplane was heavily damaged.

The crashed N860PC. (Photo: Royal Netherlands Marechaussee)

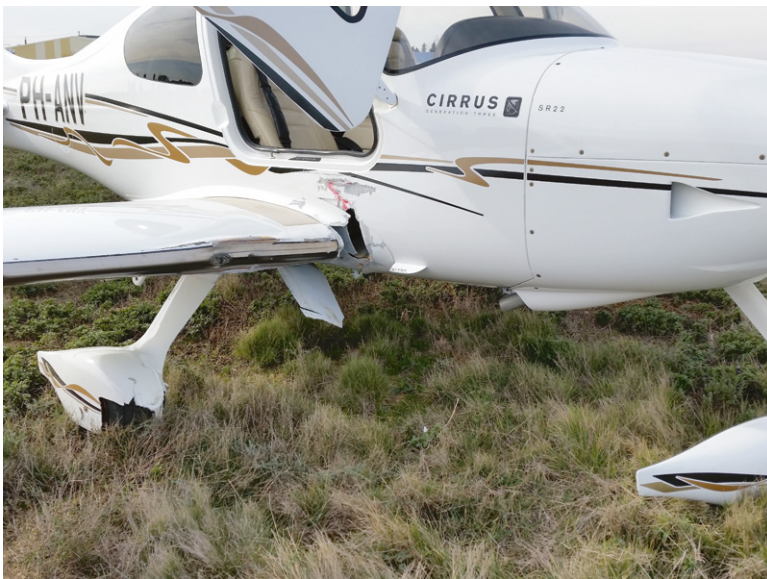
Runway excursion, Cirrus SR22, PH-ANV, Béziers Vias Airport (France), 2 February 2016

After a flight from Ibiza (Spain) to Béziers (France) the pilot of the Cirrus, registered in the Netherlands, commenced to brake after landing, after which the aircraft moved to the left. The pilot failed to correct this deviation to the left, resulting in the aeroplane leaving the runway, hitting a sign in the process. Neither of the two occupants sustained any injuries. The aeroplane sustained damage to its fuselage and one of its wings.

The damaged PH-ANV. (Photo: captain)

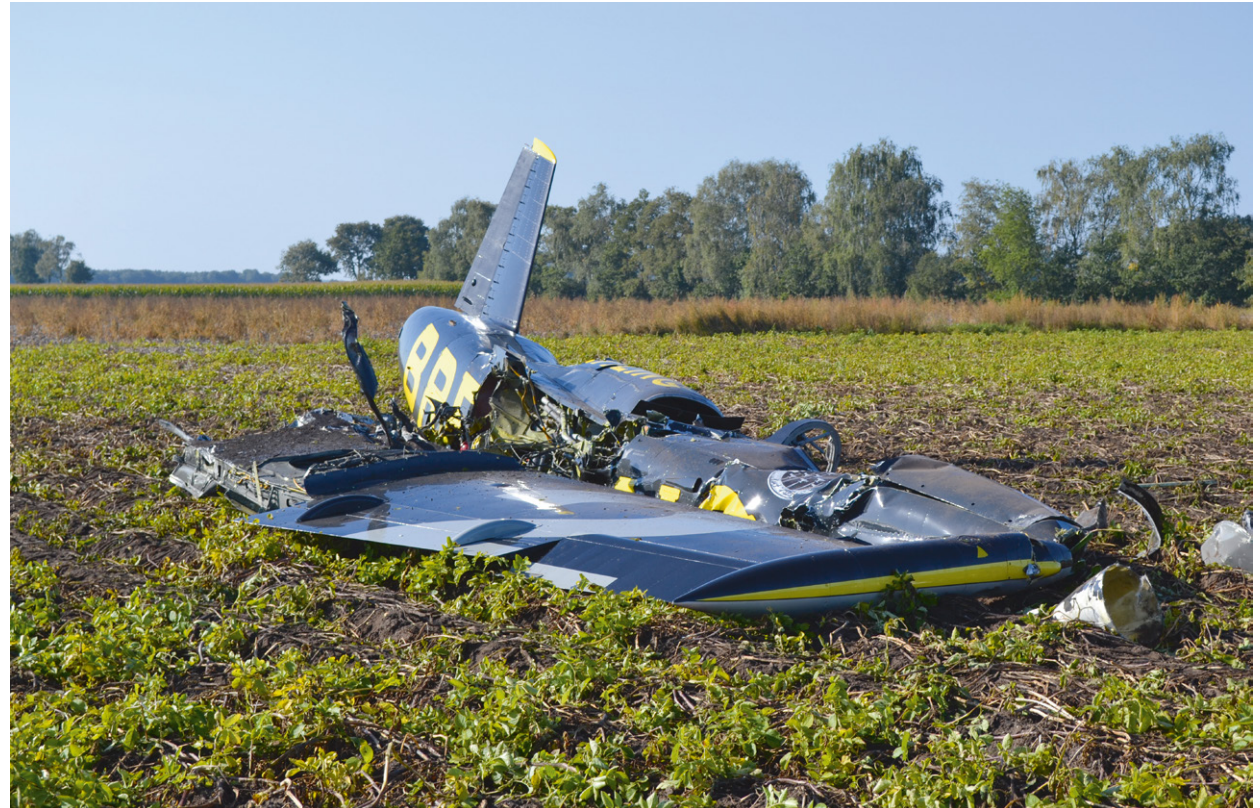
Crash following engine failure, AeroVodochody L-39C, near Valkenswaard, 15 September 2012

Being one of seven aircraft of the Breitling Jet Team, the L-39C Albatros jet experienced engine problems during the flight. These problems became so serious that the flight could not be continued. The pilot then shut down the engine and steered the aircraft towards an open area. Here, he and the second occupant left the aircraft with the ejection seats. The aircraft ended up in a field. Both occupants were unharmed.

After extensive investigation it was found that the engine problems were primarily caused by a defective low pres-

sure turbine front bearing. Further it turned out that the assessment of the engine oil quality by a laboratory was done without any written references. Finally it was concluded that the L-39C does not have to comply with European safety level requirements.

ES-YLS after the accident. (Photo: National police)

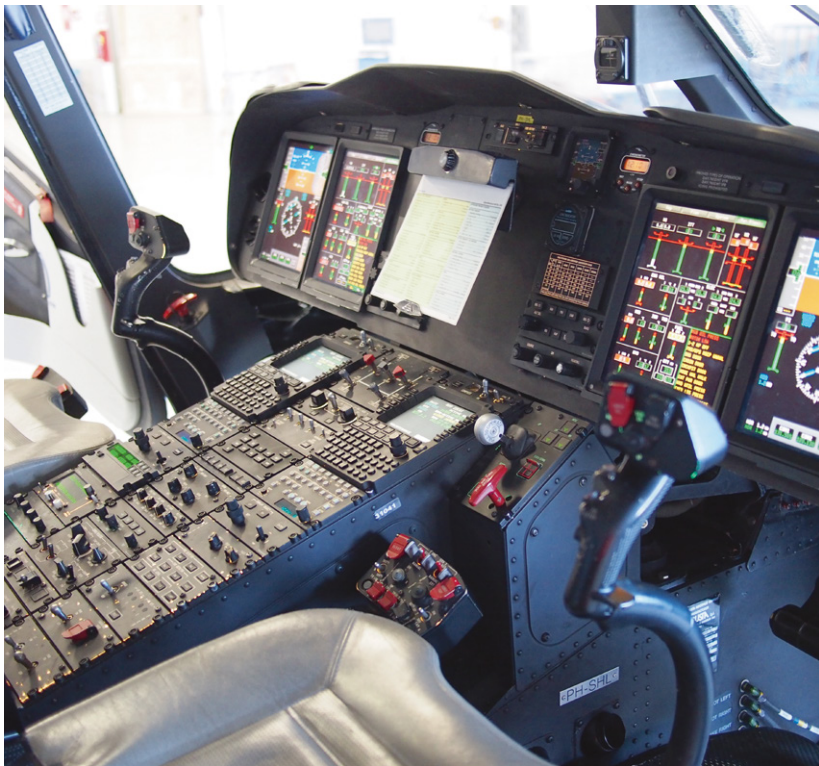
Cockpit AW139.

The ergonomics of the control panel of this type of helicopter meant that it took the co-pilot a long time to find the desired button. According to the crew, this is particularly a problem when flying this type of helicopter in the dark. Consequently, it took some time for the co-pilot to notice that the commander was spatially disorientated.

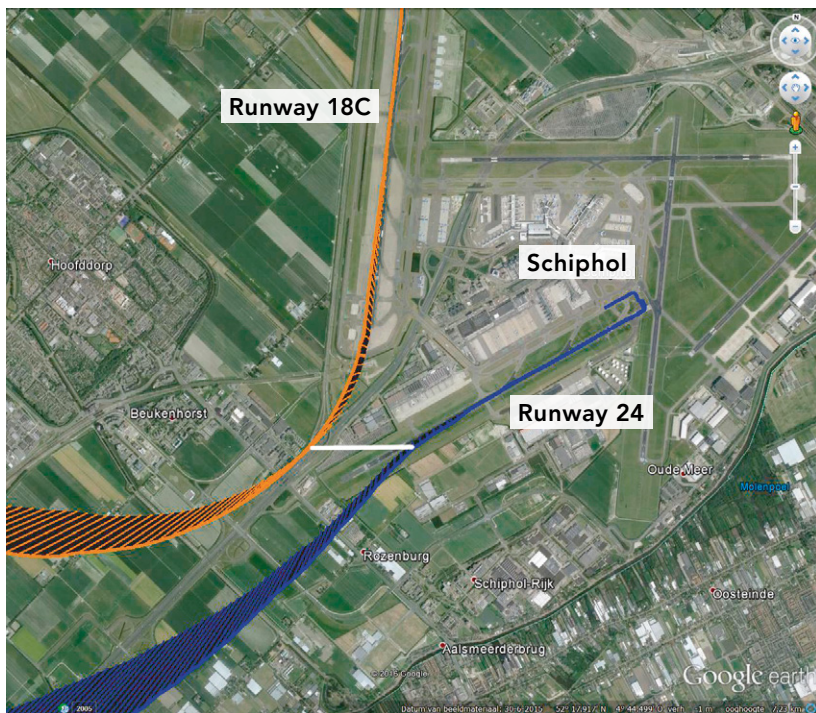
On becoming aware of the situation, the runway controller immediately instructed the crew of the A320 to make a right turn. The E190 was now travelling too fast to abort the take-off. After it had left the ground, the E190 was instructed to make an "early-left turn". Having just left the ground, the crew of the E190 were not expecting any course change instructions. At that stage of a flight, that is not usual. On receiving the instruction to make a right turn, the A320's crew realized that this was related to traffic departing from runway 24. They started to make a right turn. This, together with the plane's resulting attitude, meant that they were unable to observe the E190 taking off from runway 24. The A320's pilot requested and received a heading from the runway controller, after which the A320's crew turned their aircraft onto a heading of 270 degrees.

The course instructions were equally unclear to the crew of the E190 (the runway controller had not given any reasons for his instructions regarding course changes) so, when they saw the A320 making a right turn, they wondered where that aircraft "had suddenly come from". After confirming that the A320 (which was climbing about as fast as they were) was not closing on them, the crew of the E190 shifted their heading by approximately 20 degrees to the left.

Overhead view of the flight paths of both aircraft (A320: orange, E190: blue). The white line between the flight paths indicates the minimum separation between the aircraft.

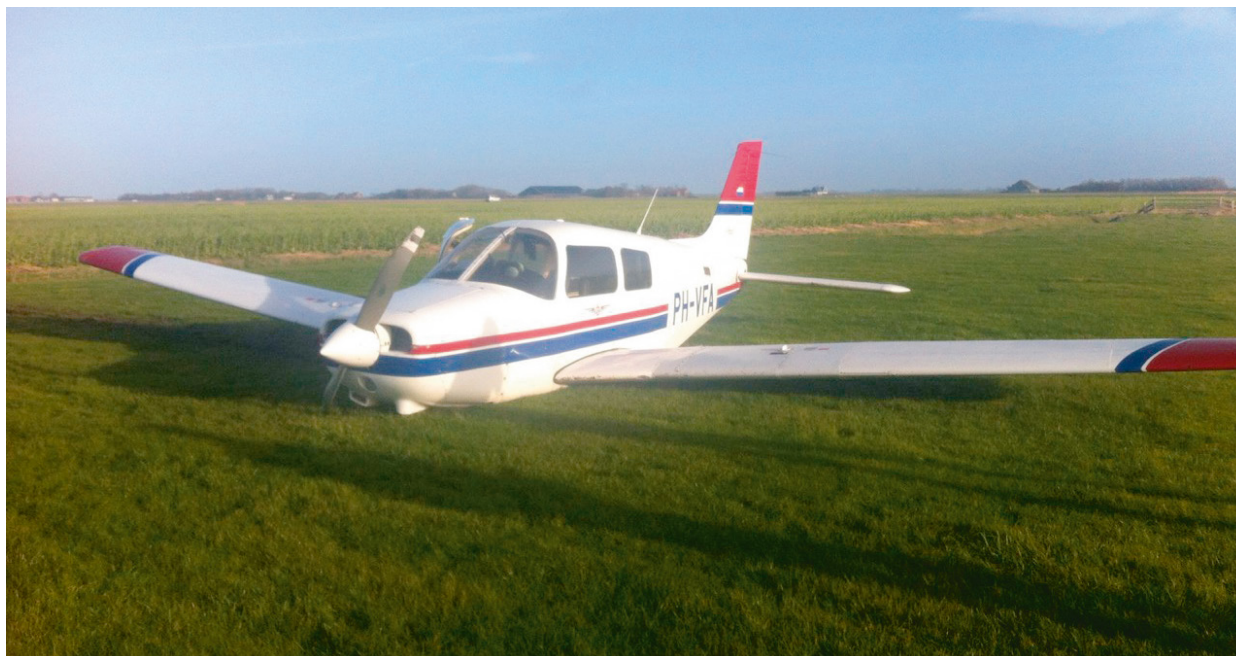
Landing before the runway, Piper PA-28-161, PH-VFA, Texel International Airport, 23 January 2016

The flight departed from Texel International Airport. On board were the captain, in the left cockpit seat, and a certified pilot, in the right cockpit seat. After take-off from Texel International Airport the captain intended to perform five landings followed by a go-around ('touch-and-gos') at Texel International Airport and then fly to Lelystad Airport. The captain first performed three touch-and-gos with full flaps. He stated that visibility during final approach was poor because of the low angle of the sun. Because of the low angle of the sun, the airport operations manager positioned two white flashing lights to the left and to the right of the runway (at the second runway markings) to make the runway easier to distinguish during final approach. The captain stated that he maintained a slightly higher speed than normal during final approach. As a result, the pitch attitude was lowered such that he was just able to keep the flashing lights in view underneath the sun during final approach. The captain performed the fourth approach to runway 22 without using the flaps. He explained that the sun was shining right into his eyes, as a result of the aeroplane's increased pitch attitude and the position of the sun, which had lowered. Full concentration was required not to lose sight of the flashing lights next to the runway. As the captain was familiar with the airport, he assumed that he would see the beginning of the runway in time.

also insufficiently aware of the aeroplane's critical situation. The captain stated that the limited visibility, which was partially caused by the low angle of the sun, demanded so much of his attention during final approach, that at a certain moment he was unaware that the aircraft was about to hit the ground in a field outside the airport grounds. The captain further stated that the decision to continue the approach was taken despite the lack of any perspective (depth perception) and was largely based on a pattern of expectations resulting from experience. The limited visibility was accepted as a matter of course.

The PH-VFA after the accident. (Photo: Aeroclub)
