DUTCH
SAFETY BOARD

Fatal entrapment between quay and vessel during mooring

UK268 Jacoba Alyda, Lauwersoog

4 December 2013

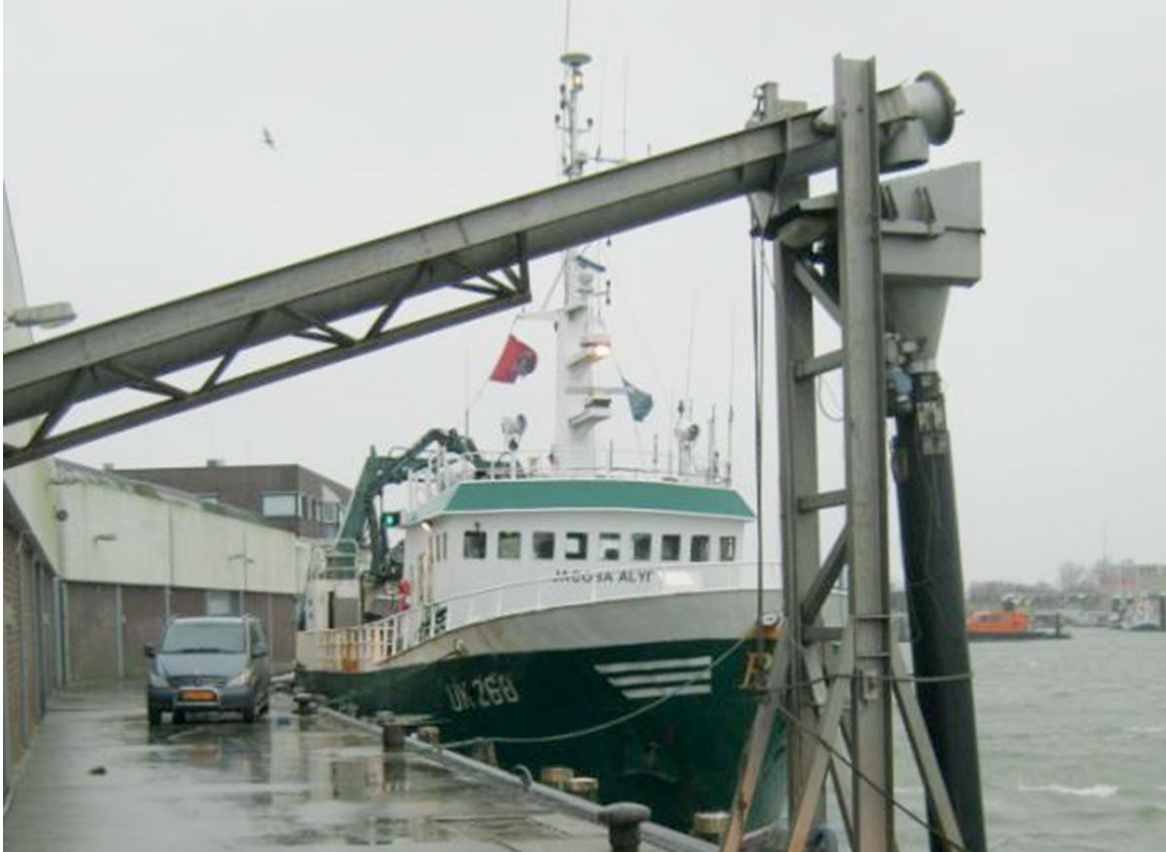
Figure 1: The UK 268 Jacoba Alyda moored at the fishing port at Lauwersoog. (Source: Inspection SZW-direction Arbo)

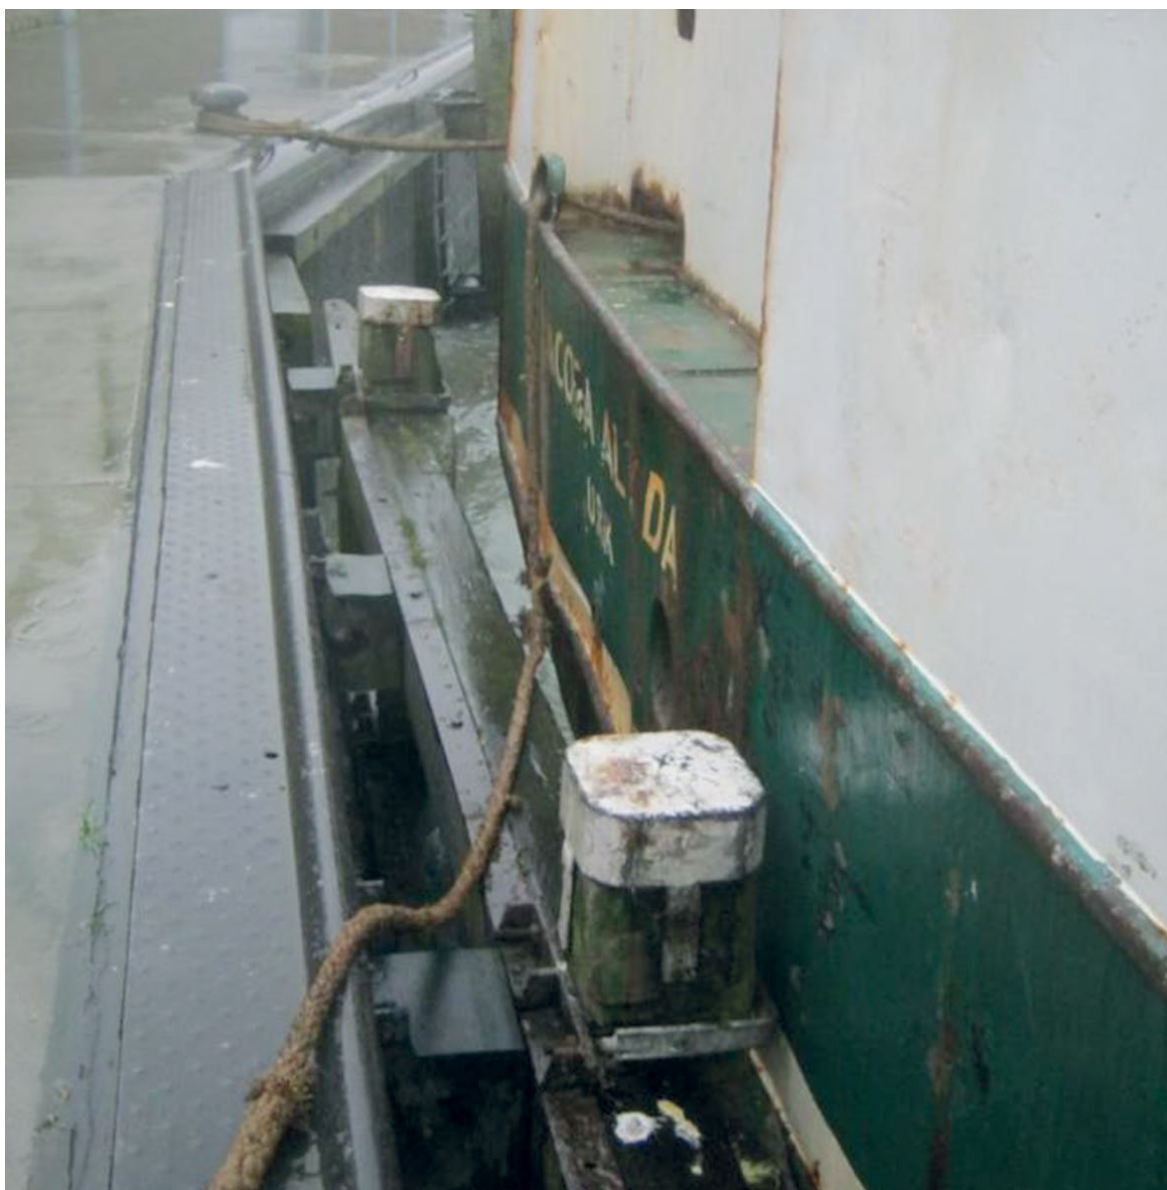
As the vessel was moving astern, the north-westerly wind was pushing it against the quay. Because this made the astern movement more difficult, the captain compensated for the wind by manoeuvring away from the quay at regular intervals. When the captain slowed the vessel's speed the crew member probably attempted to step back onto the quay from the stern in order to be ready to take hold of the hawsers. At this point he fell between the quay and the vessel. The crew member managed to hold onto the slippery wooden fender wall so that he hung by his arms and only his legs were submerged in the water while his upper body remained dry. A fellow crew member who was engaged with the hawsers on the afterdeck heard a yell. He looked up and saw his colleague hanging from the wooden fender wall. Because the vessel was now in the right position, the captain was no longer manoeuvring to compensate and the north-westerly wind was once more pushing the vessel up against the quay. Being unable to pull himself up in time, the crew member became severely crushed between the quay fender wall and the vessel's hull.

Figure 2: Wooden fender wall and stern of the UK268 Jacoba Alyda. (Source: Inspection SZW-direction Arbo)

The wooden revetment was slippery from the wet conditions and accretion of moss, which may have been one of the factors that caused the crew member to slip upon disembarking from the vessel. (It should be noted that the revetment is intended as a fender and not as an aid to embarkation or disembarkation.)

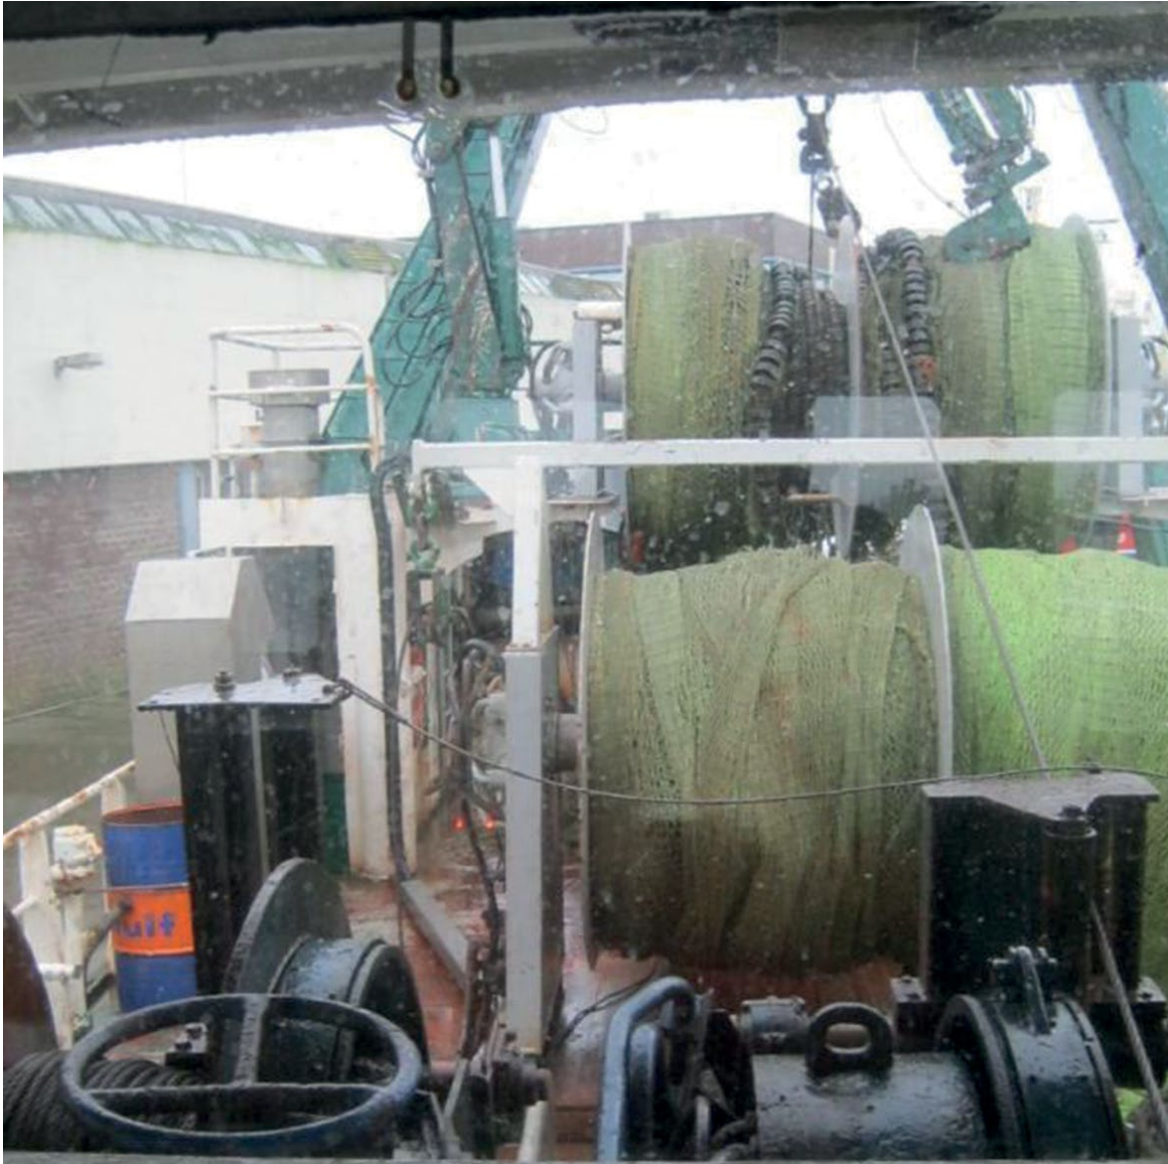
The colleague who had seen what happened stepped onto the wharf to aid the crew member. A second colleague who had been engaged with the hawsers on the foredeck also rushed over to the spot. This movement alerted the captain of the situation as he was until that time not aware that something was wrong. He could not see the location of the accident from the wheelhouse and there was no direct communication with the deck crew.

Figure 3: Rear view from the wheelhouse of the UK268 Jacoba Alyda. (Source: Inspection SZW-direction Arbo)

Owing to the lack of communication among the deck crew and the fact that the captain did not have a view of the disembarkation point, the captain was unaware of the crew member's situation. As a consequence, he was not able to keep the vessel clear of the wharf in order to prevent the crew member from being crushed.

Communication between disembarking crew and the captain is crucial, all the more in situations where the captain does not have an unobstructed view of the disembarking crew members. Clear agreements regarding when a crew member is permitted to disembark and the use of walkie-talkies could be useful in this respect, as would discussing the manoeuvre to be undertaken in advance.
