DUTCH  
SAFETY BOARD

# Runway incursion Amsterdam Airport Schiphol

18 April 2012

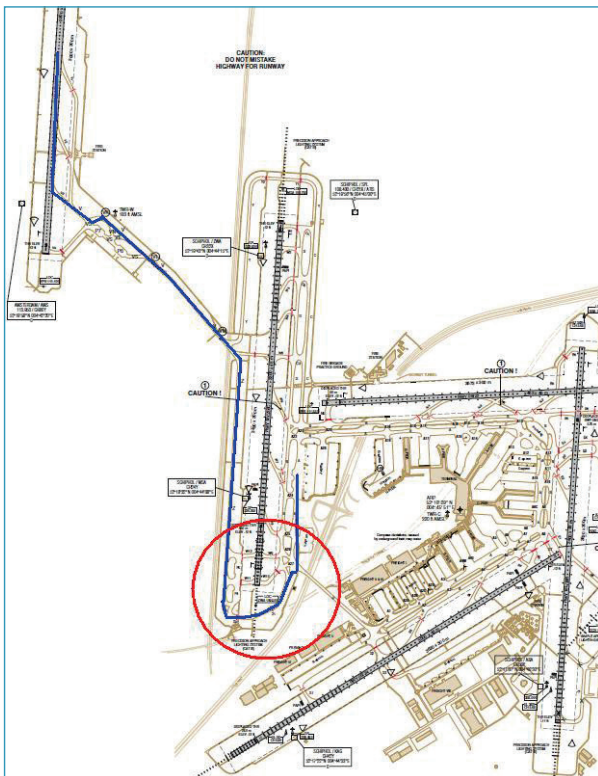
After landing on runway 18R at Amsterdam Airport Schiphol (Schiphol) the crew of the Airbus A330 taxied to their assigned gate E17 at Schiphol-Centre (see figure 1, blue line). The aircraft was taxiing in a southerly direction on taxi track Zulu, parallel to the west side of runway 18C/36C, when the ground controller instructed the crew to cross at Zulu 2 (hereafter abbreviated as Z2) that is situated south of the beginning of runway 36C.

Figure 1: Overview of runways and taxiways at Amsterdam Airport Schiphol, including taxi route from runway 18R, via Zulu to Alpha (blue). (Source: Aeronautical Information Publication Netherlands)

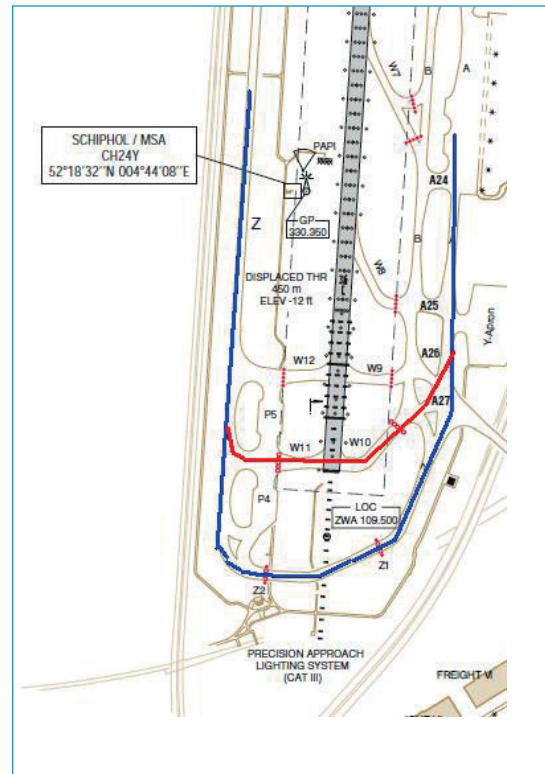
Figure 2: Detailed view of intersections around Zulu (red circle in figure 1) –planned route in blue, actual route in red.

The crew, just prior to reaching intersection W11, understood they were cleared to cross runway 18C, in use for landing. The crew crossed the active landing runway at the southernmost point at W11 (see figure 2, red line), thereby causing a runway incursion.<sup>2</sup> At the moment of the crossing an aircraft approaching the airport for landing was at a distance of approximately 3 nm from the runway threshold in the north.

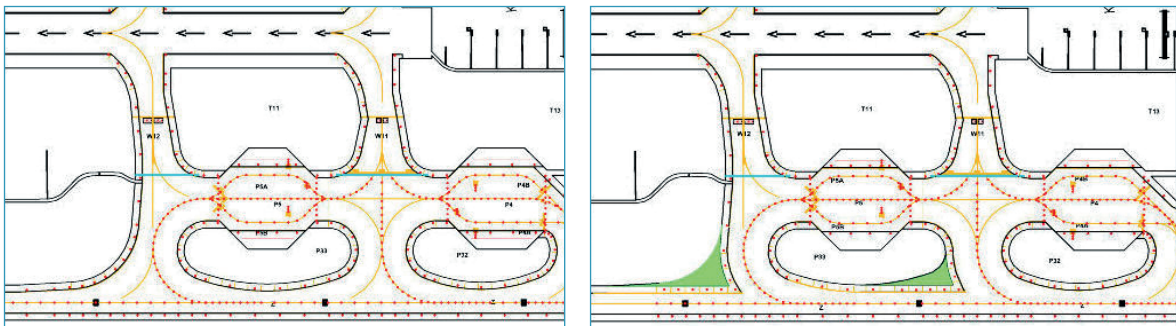
On 14 June 2012<sup>8</sup> the airport authorities reconstructed the markings of the two turns on taxi-track Zulu towards intersections W11 and W12 (see figure 3) and the barriers were removed. Unfortunately these alterations did not prevent aircraft crews from turning to the left at W11, instead of continuing via Z1 and Z2.

Figure 3: The markings at occurrence date (left) and markings after the April incident from 14 June 2012 (right) near intersections W11 and W12, viewing from west to east. (Source: Amsterdam Airport Schiphol)

Because of the recurring nature of the incidents, the airport authorities reinstalled the barriers near the entrances of intersections W11 and W12 to prevent future turns to the left. As a structural measure, the layout of the entries was reconstructed in such a way that both entries from taxi-track Zulu to intersections W 11 and W12 are closed on a permanent basis. The AIP Netherlands was amended.

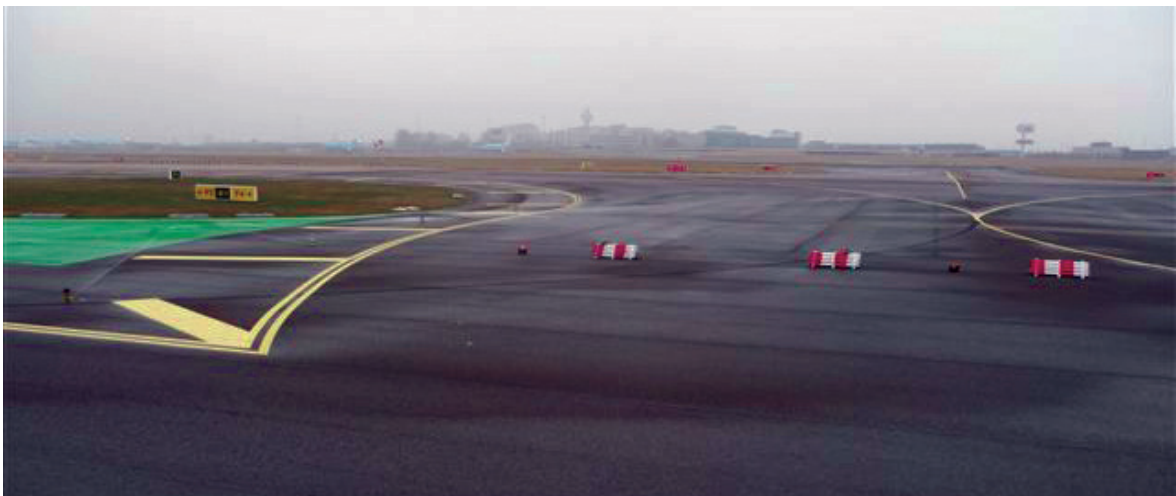
Figure 4: Intersection W11 (February 2013) looking from west to east (note the adapted lining and green painted surface as shown in figure 3, bottom drawing, infrastructural changes made by the airport authorities in June 2012).
