DUTCH
SAFETY BOARD

Shipping Occurrences Report

November 2016 - April 2017

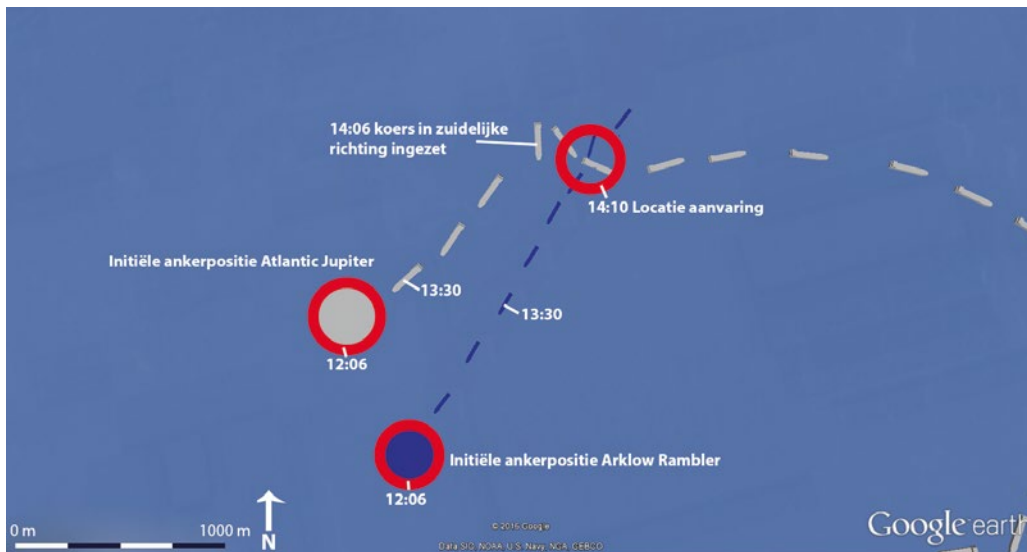
On Monday 8 February 2016, the Hong Kong tanker Atlantic Jupiter collided with the Dutch freighter Arklow Rambler. The Arklow Rambler suffered damage to the bow while the Atlantic Jupiter suffered a 15-metre gash just above the water line. Both ships were anchored in anchorage 4E, close to the port of Rotterdam. Due to poor weather conditions, the anchors of the two ships had been dragging and they drifted from their positions. The Atlantic Jupiter then decided to hoist the anchor and to wait for improved weather under power. However, the manoeuvre that the Atlantic Jupiter completed after hoisting its anchor caused it to drift towards the Arklow Rambler, resulting in a collision. The Arklow Rambler then sailed into the port of Rotterdam. The Atlantic Jupiter followed nine hours later.

The ships crawled backwards from the anchorage, then the Atlantic Jupiter hoisted its anchor and wanted to sail south. During this manoeuvre, the Atlantic Jupiter hit the Arklow Rambler (Source: Google Earth)

- Take no unnecessary risks by continuing to sail with major damage to the ship: find a safe port as soon as possible. Extra costs associated with this should not outweigh the safety of the crew.
- If having a VDR on board is required, make sure that it works as well. The VDR contributes to determining the cause of an accident, and thereby to the lessons that can be learned and to maritime safety.

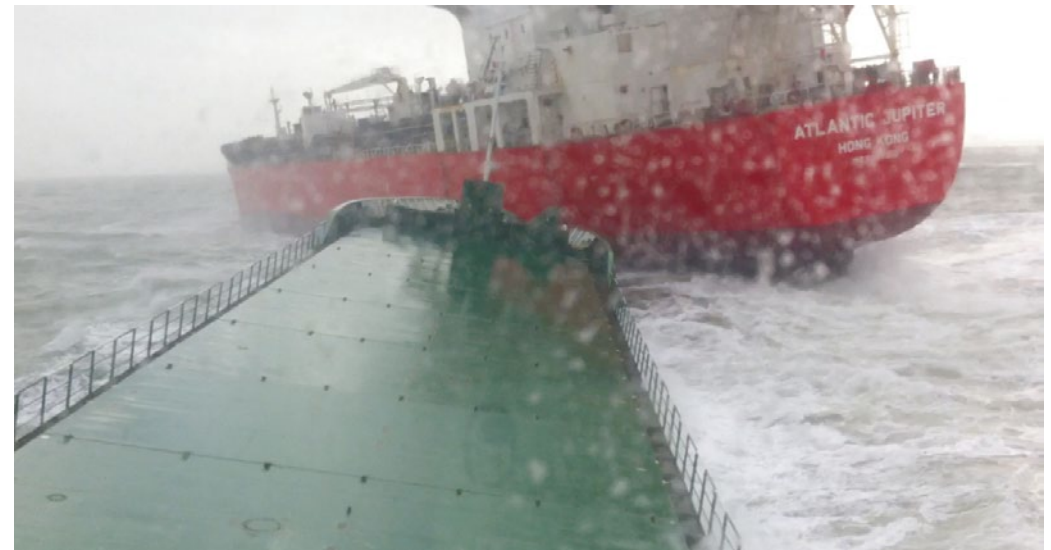
Moment shortly before the collision seen from the bridge of the Arklow Rambler (Source: Arklow Shipping)

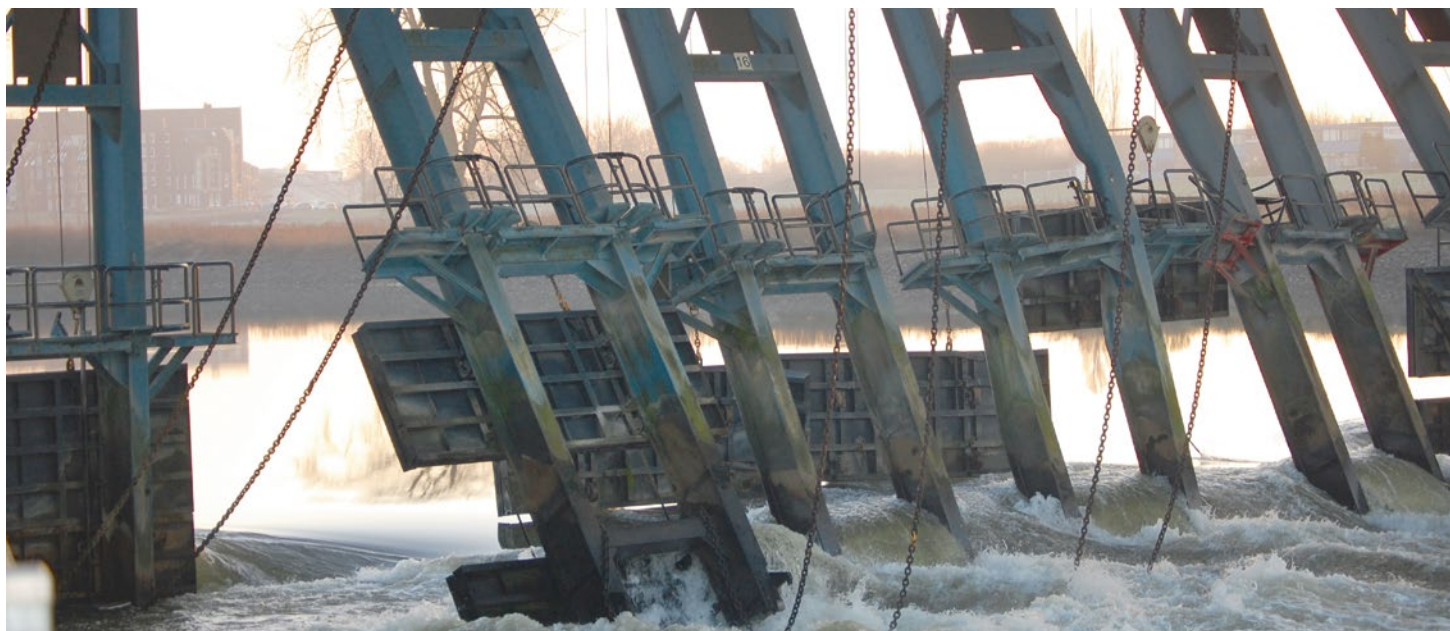
On Thursday, 29 December 2016 at around 19:30 hours, an inland tanker vessel carrying benzene sailed in thick fog into a weir in the river Maas at Grave. No persons were injured as a result of the accident. However, the material damage (to the weir and the ship) and the consequences for society (residents and businesses in the surrounding area and inland shipping) were considerable in both the short and longer term. The Dutch Safety Board launched an investigation which focused not just on the collision itself, but also on the way the consequences were dealt with.

Damage to the weir at Grave after a collision by an inland vessel.

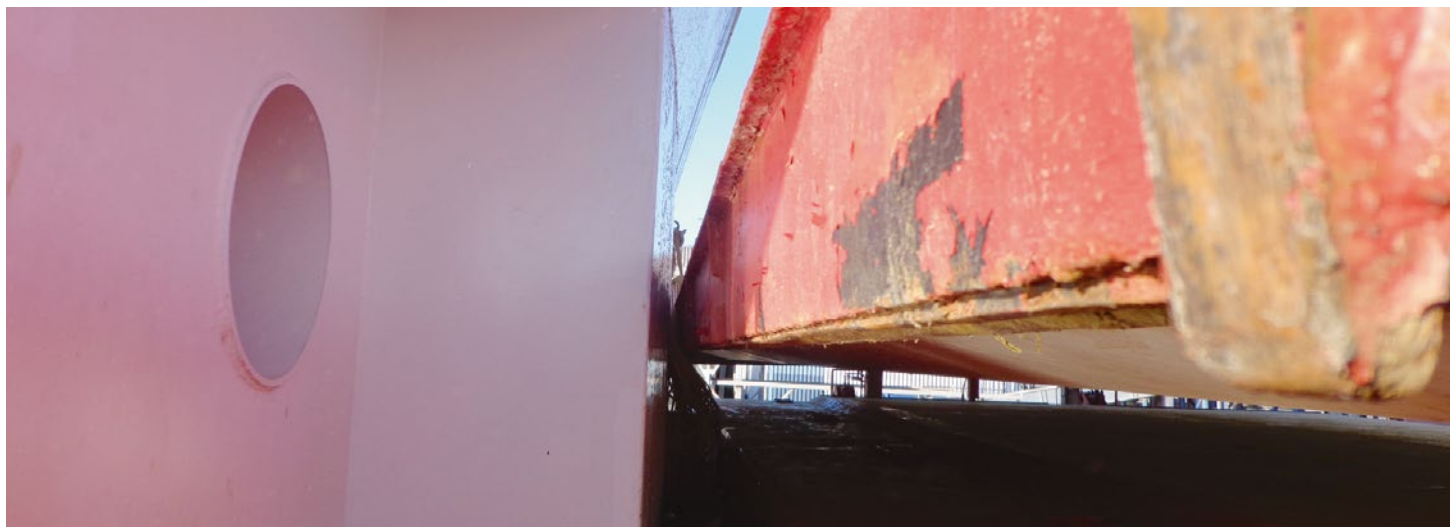
On 2 December 2016, a member of the crew died on a freighter sailing under a Dutch flag. The ship was loading in the port of Szczecin in Poland during rainy conditions. During loading at around 01:30 hours, one of the hatch covers to the rear had to be replaced. This was done using the hatch-cover crane, but the wheels of the crane skidded on the rails. To give the wheels more grip, sand was applied to the rails. The hatch-cover crane carrying the hatch cover eventually started to move, but once it arrived where the hatch cover was needed, the wheels skidded again and the hatch-cover crane skidded further along the rails. The victim became trapped between the hatch cover and the accommodation and died on site.

Hatch-cover crane after skidding. (Photo: PKBWM)

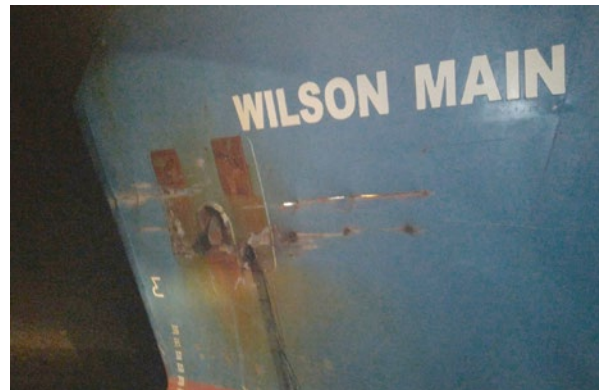
On 17 January 2017 the sea-river vessel Wilson Main was involved in a collision with the inland tanker Aegir. The Wilson Main, sailing under the flag of Barbados, was on the river Waal close to Tiel, with fair visibility. The width of the waterway was limited due to an unusually low water level. The captain and a river pilot were on the bridge. The ship was sailing on ECDIS maps and being steered by a river automatic pilot. The river pilot was communicating with other shipping in Dutch; the Russian captain could not understand this language. At around 20:20 hours visibility dropped dramatically to some

Damage to Wilson Main (Photo: ILT)

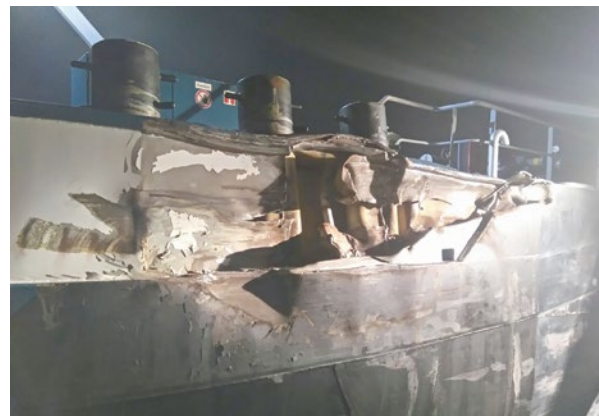
Damage to Aegir (Photo: ILT)

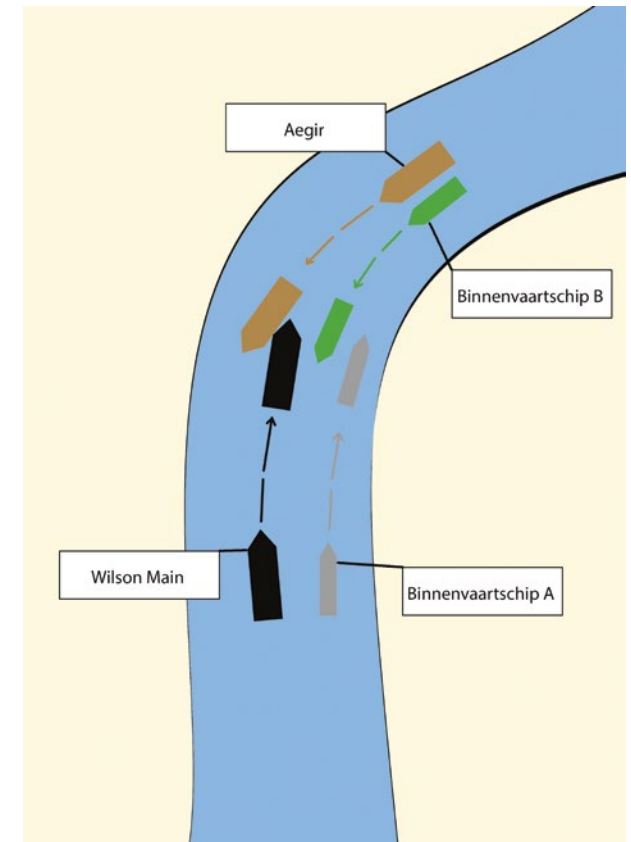
Situational sketch of the Wilson Main - Aegir collision.

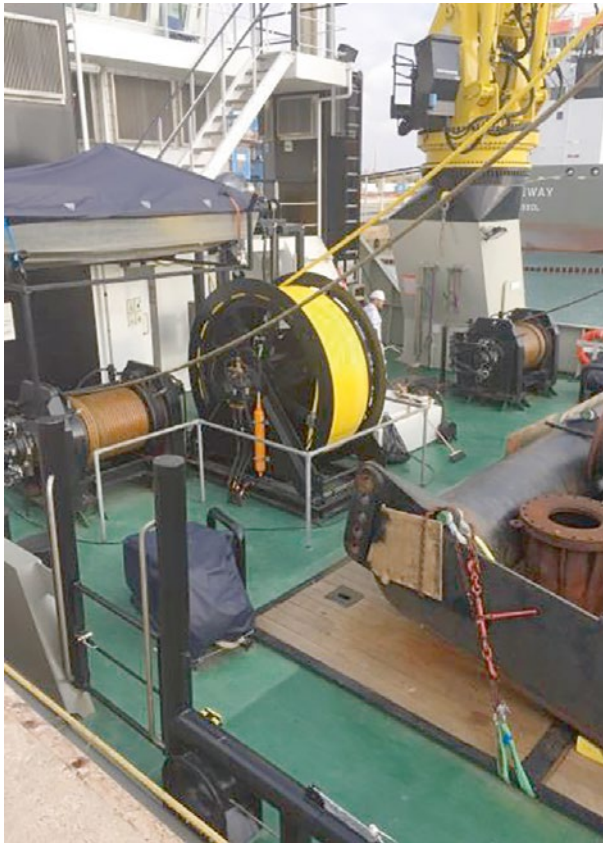
Work on the cable began on 20 January 2017 at 9:15 hours. The electrician used a grinder to grind through the defective cable. The chief engineer was present to provide assistance. At the moment that the cable had almost been ground through, the chief engineer attempted to hold the already free-hanging cable away from the grinding disc, using his hand. The electrician had not requested this move. Just a moment

The drum with the umbilical cable (yellow) on board the Terra Plana.
(Photo: BosKalis)

later the grinding disc cut through the entire cable, causing it to snap, and it struck and injured the chief engineer's right forearm. The seriously injured chief engineer was taken to hospital by ambulance where he underwent surgery.

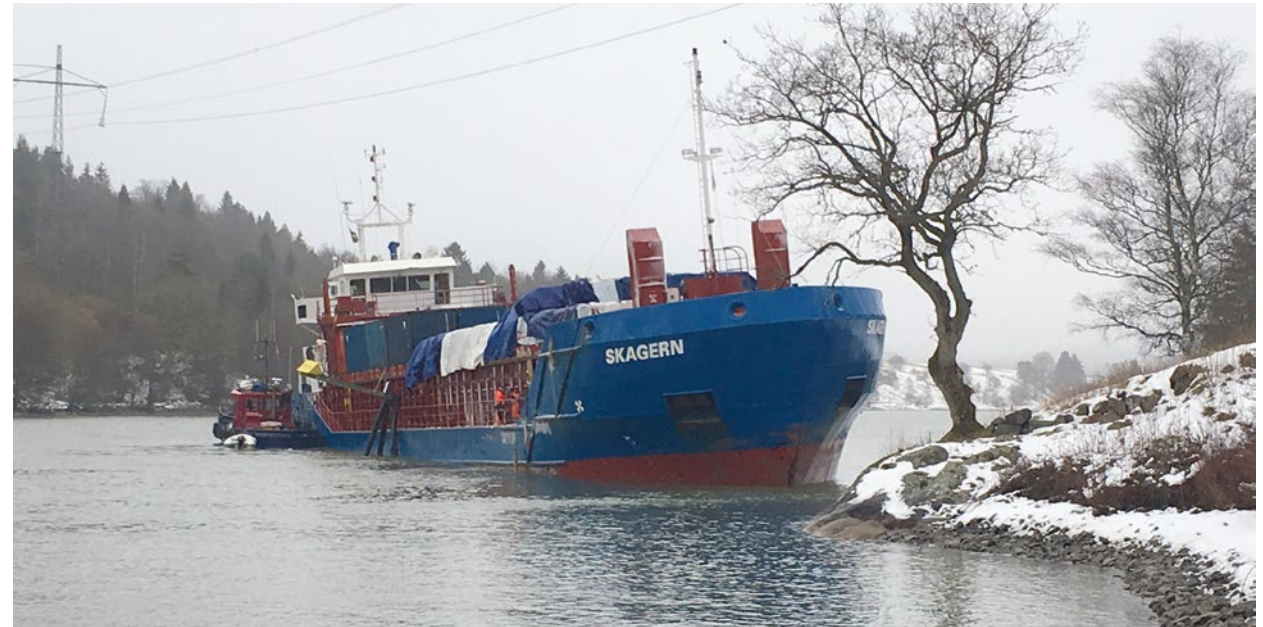
The Dutch freighter Skagern ran aground on the river Göta in Sweden on 9 March 2017. The ship suffered technical problems (black-out), after which it ran aground to the south-west of the Trollhättan Locks. In the process the ship suffered a tear in its hull, leading to water entering the ballast tank. The water was pumped out using the pumps present on board. Before the ship could be recovered, part of its cargo of wood has to be removed. The cargo was loaded onto a pontoon by a

Skagern aground. (Photo: Swedish Maritime Administration)
