DUTCH  
SAFETY BOARD

# Emergency landing after engine failure Diamond DA-40

# Emergency landing after engine failure Diamond DA-40D

*The Hague, July 2014*

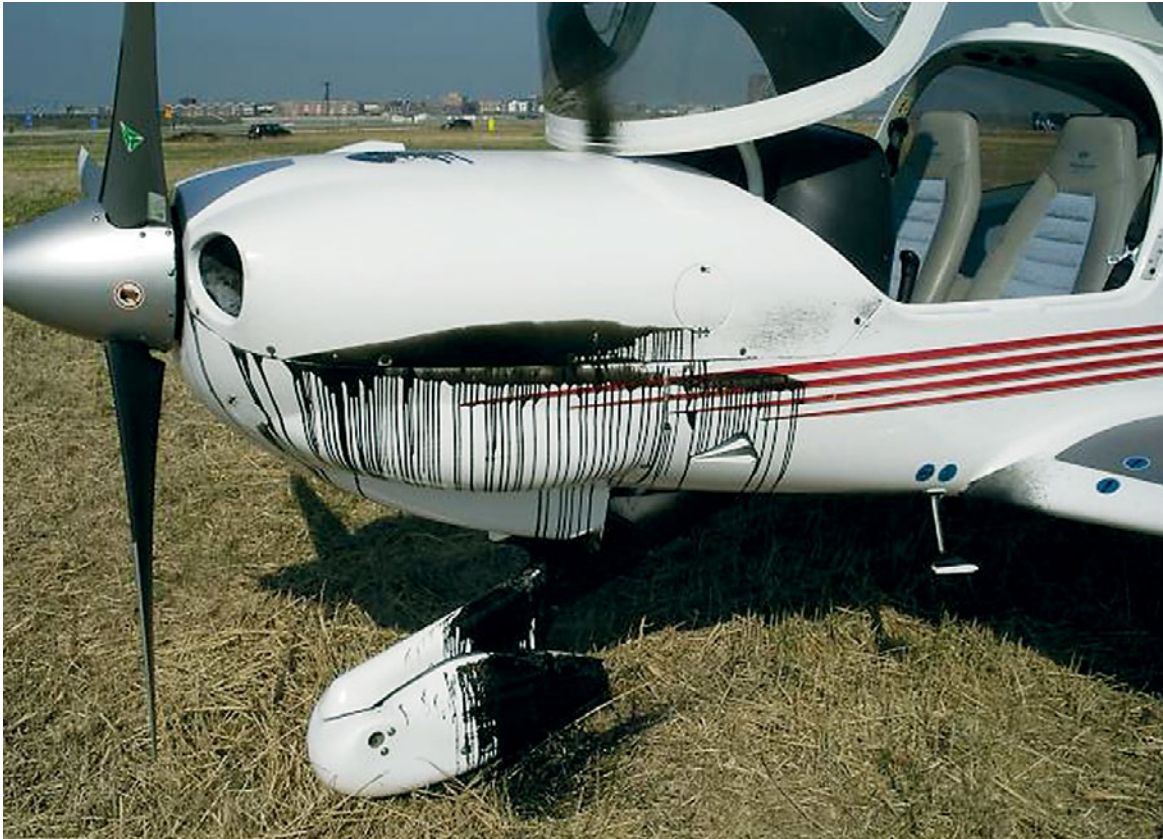
When turning to final the pilot switched on the "Electric Master" switch again (briefly) in order to be able to lower the flaps to 10 degrees. According to the pilot he landed the aircraft in a grass field with an airspeed of 70 knots and applied full brakes after touchdown. After about 150 meters the aircraft came to a standstill. Both occupants left the aircraft without injuries. The engine cowling was found to be covered with engine oil; see figure 2.

Figure 2: Engine cowling covered with engine oil. (Source: Wings over Holland)

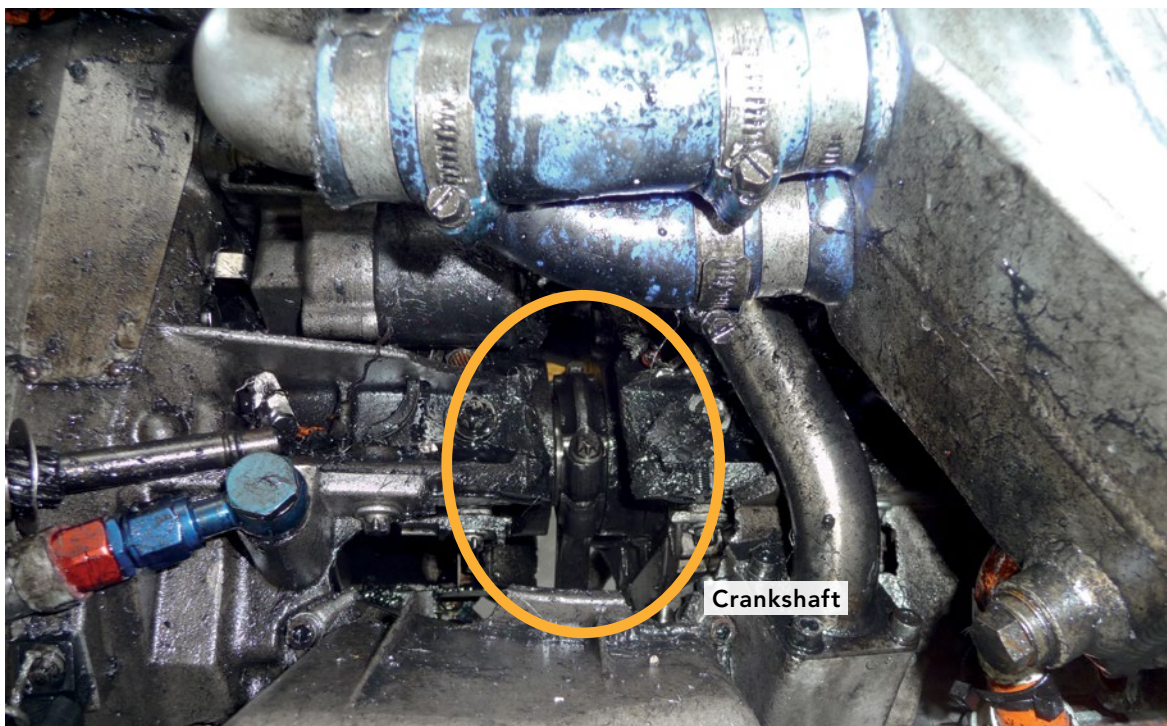
After the event the aircraft was transported to a maintenance facility for an initial investigation. The investigation revealed that there was a hole in the upper left-hand side of the engine casing. Through the hole the crankshaft was visible; see figure 3. A second hole was visible in the lower left-hand side, with part of a connecting rod sticking out; see figure 4. Furthermore, the engine compartment was covered with engine oil. No signs of fire were found.

Figure 3: Upper left hand side engine. (Source: Wings over Holland)

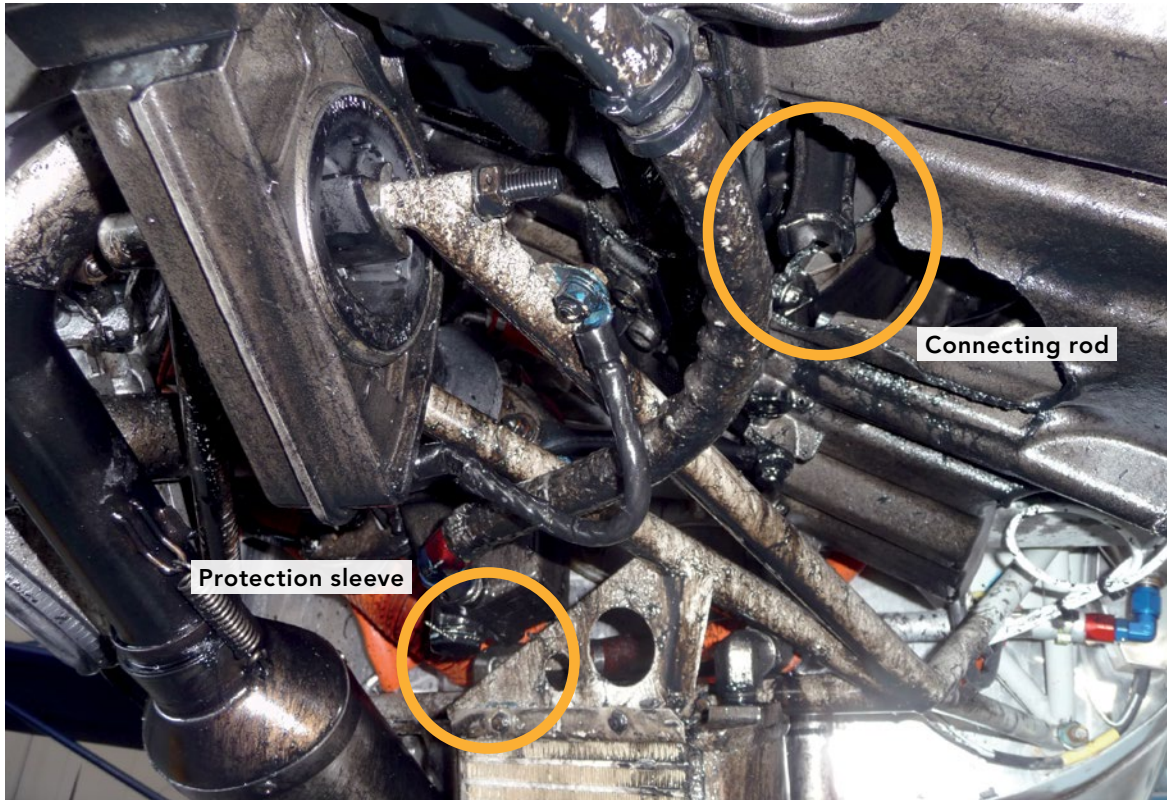
Figure 4: Lower left hand side engine. (Source: Wings over Holland)

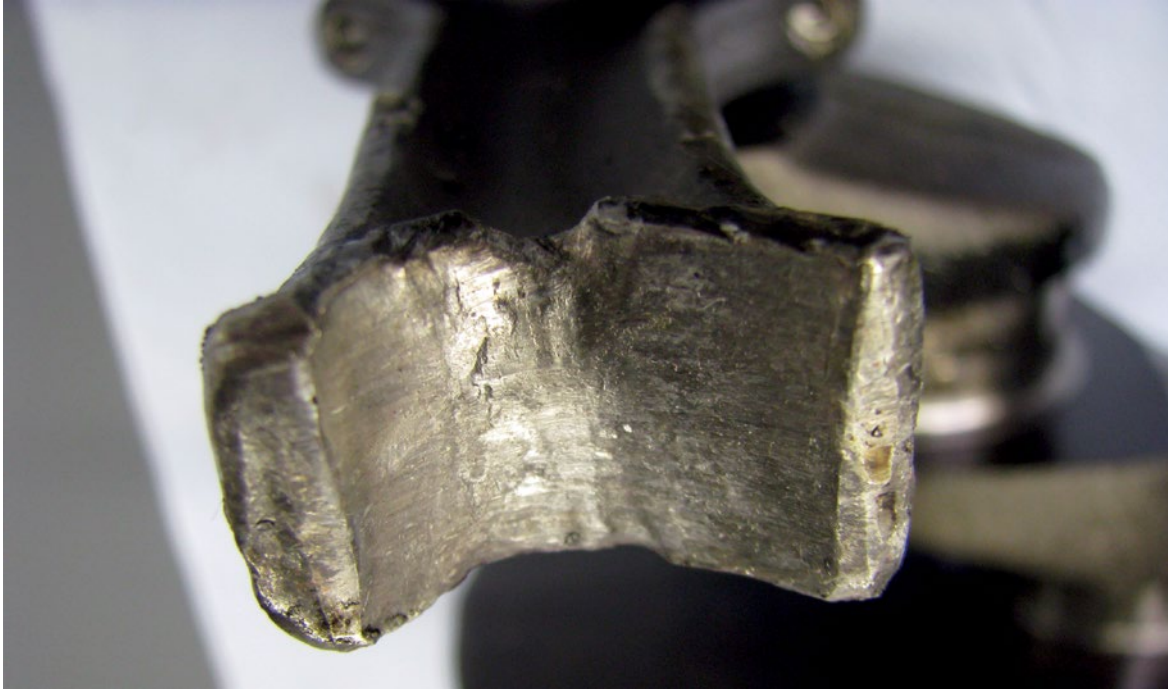
The inspection revealed no evidence of a general, overall lack of lubrication. All four piston cooling oil nozzles were in place. The upper half of the small end bearing of connecting rod number 3 was missing. The number 3 connecting rod was slightly bent and the fracture surfaces and the surface of the small end bearing were completely deformed; see figure 5.

Figure 5: Small end bearing. (Source: BFU)

As the small end bearing is one of the most heavily strained bearings in a piston engine, it is believed that the initial failure was that the small end bearing of the number 3 connecting rod failed. Consequently, the detached connecting rod could move freely, bent slightly and punctured the crankcase in two places.

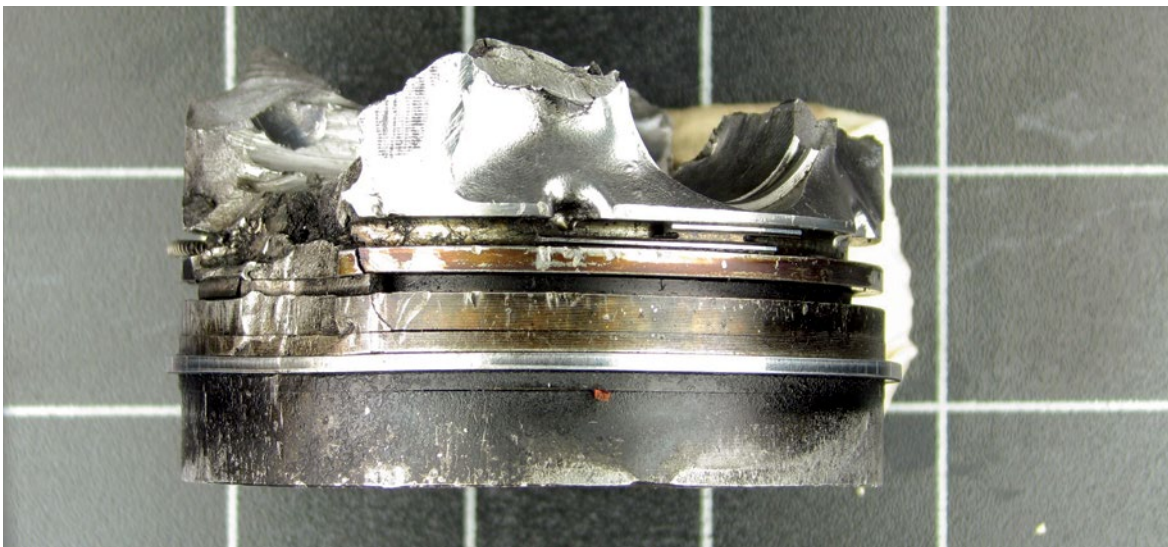
For investigation purposes the crankcase was cut near cylinder number 3 to gain access to relevant engine parts and to avoid additional scratches on the piston and on the cylinder barrel. Due to mechanical damage of the connecting rod, it was not possible to identify the mechanical failure mechanism from the fracture surface. There was major damage to the underside and skirt of piston number 3; see figure 5. The piston pin was missing.

Figure 6: Piston number 3 with fire protection sleeve particle. (Source: BFU)

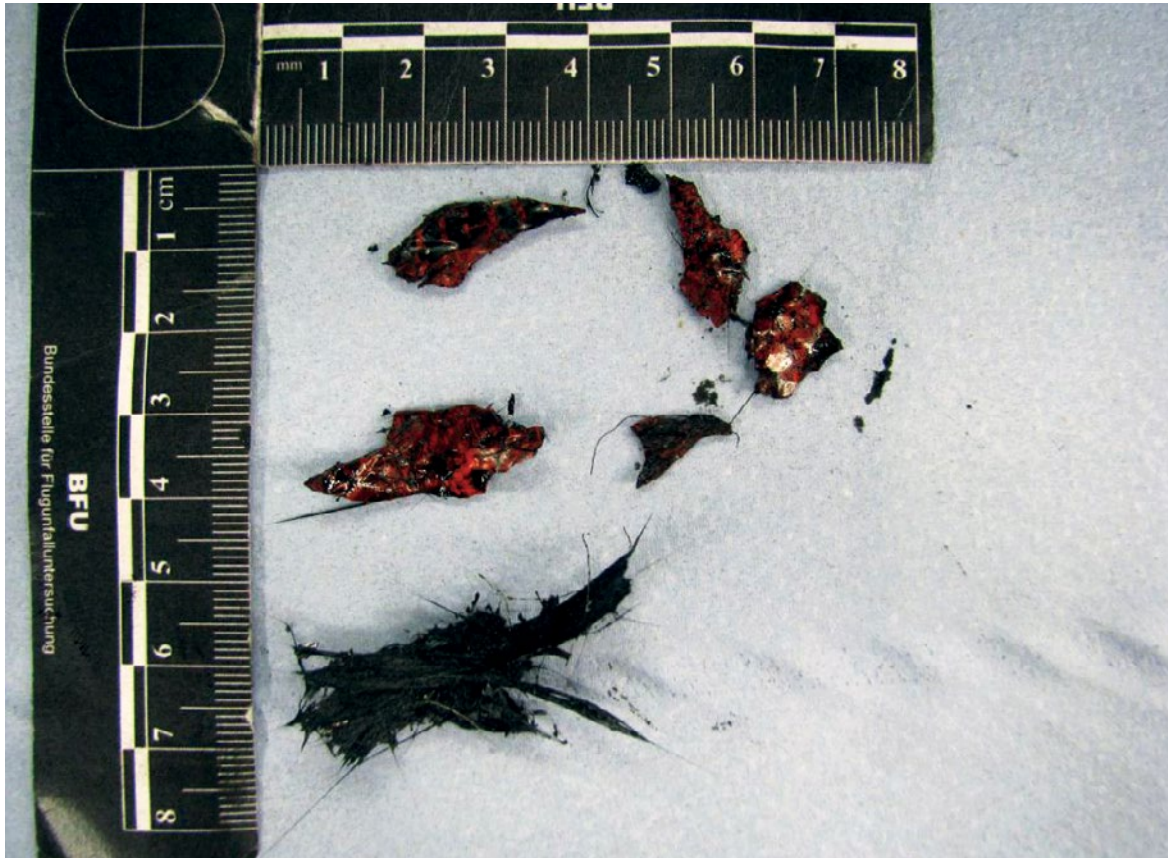
Red rubber particles and non-metallic fibres were found on piston number 3 and in the combustion chamber; see figure 7. According to the engine manufacturer, the rubber material and fibres were part of the fire protective sleeve from one of the oil hoses that ran across the outside of the engine block. The fire protection sleeve is used for both fuel and oil hoses and as prevention for scuffing of lines. A damaged hose was found on top of the engine during the investigation. With the exception of overload damage in cylinder number 3, all other cylinders were in good condition without significant wear and tear.

Figure 7: Red rubber particles and fibres found on piston number 3 and in the combustion chamber.  
(Source: BFU)

According to the manufacturer engine failure sequence was due to the piece of fibre protection sleeve dropping into the air hose between the compressor and the intake manifold accidentally during, for example, maintenance. This piece subsequently passed through the valves and was hammered/cut into small pieces. The fibres and very small rubber parts then prevented the free movement of the piston ring and consequently restricted the heat transition between the piston and cylinder wall. The piston slightly expanded and finally jammed due to fibres and rubber parts between piston ring and cylinder wall. As a consequence of this seizure, the small end of the connecting rod failed. This was evident by the fact that the pistons, which were jammed in the cylinder bore, could not be moved during disassembly. The piece of fire sleeve was found on both sides of the cylinder barrel. After cutting the cylinder bore, the piston could easily be removed. There were no signs of friction welding either on the piston ring or on the cylinder wall. There were no severe scratches on the cylinder wall and no signs of severe over-heating, which means that sufficient engine oil had been present.
