# Fatal accident during an attempt to prevent the sinking of a sailing ship in the Baltic

Crew of Msv Wylde Swan on board Msv Wyvern, 11 July 2013

*The Hague, September 2014*

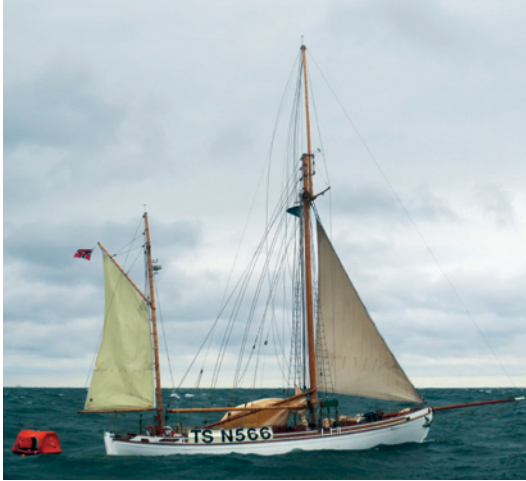
Figure 2: Wyvern.  
(Source: Crew Wylde Swan)

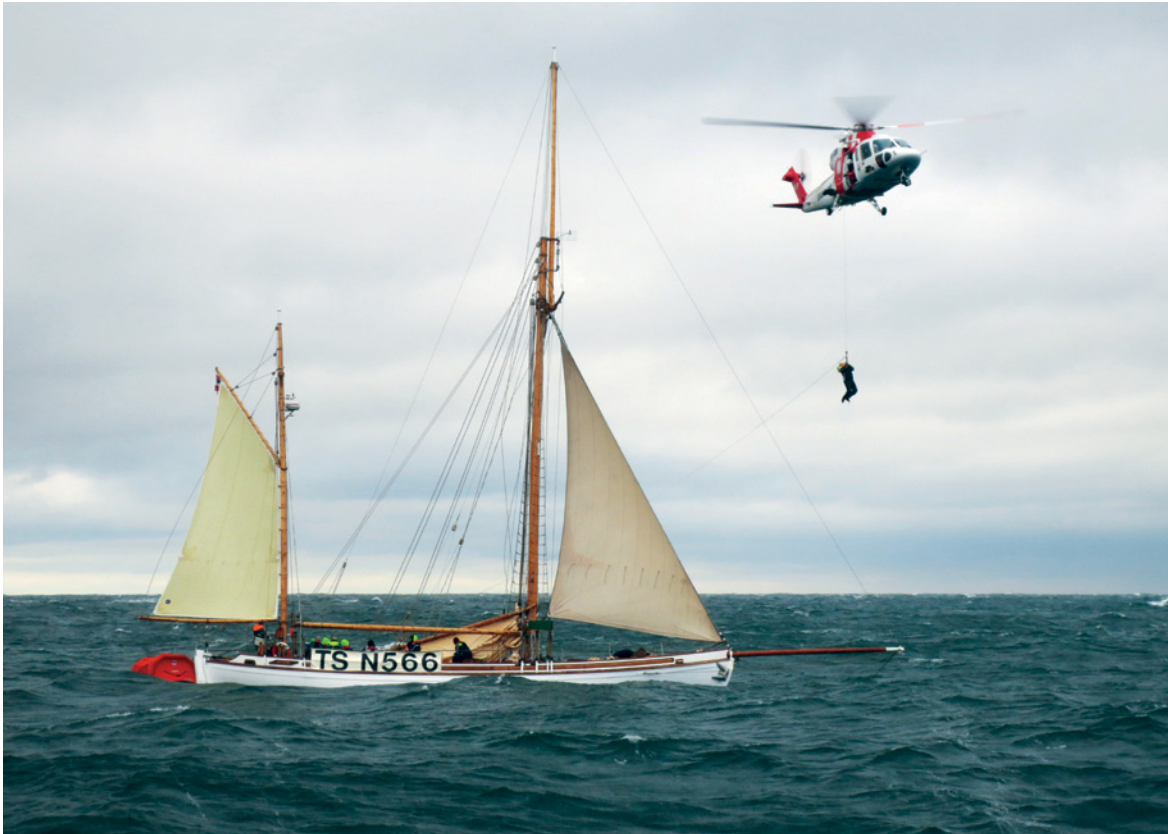
Figure 4: Evacuation of the crewmembers. (Source: Crew of the Wylde Swan)

The crew of the Wyvern finally decided to evacuate, because the water level on board continued to rise. At around 08:20 hours the last crewmember was rescued by helicopter. The Swedish Maritime Administration (JRCC) then officially declared the emergency situation ended.

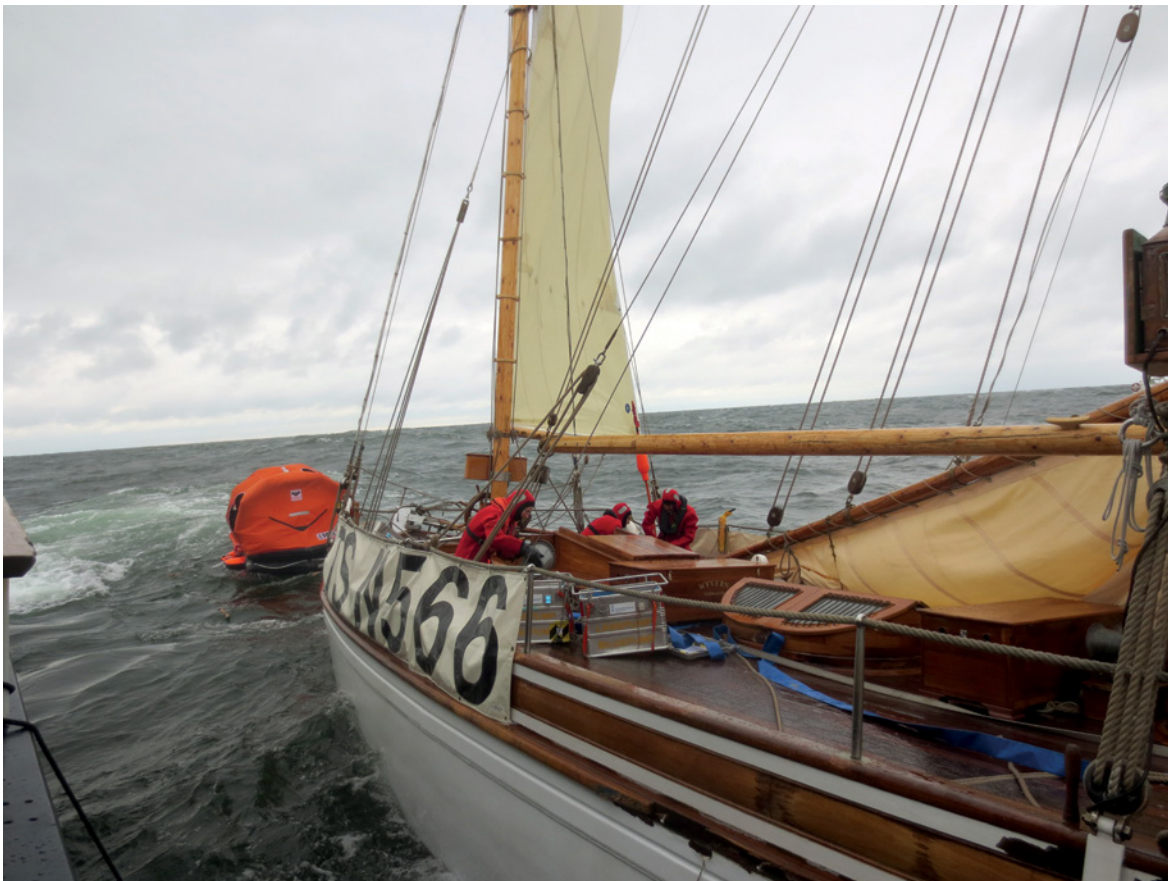
Figure 5: Volunteers on the deck of the Wyvern. (Source: Crew of the Wylde Swan)

They soon started one of the pumps. They also bailed the water from the cockpit using buckets. The volunteer responsible for communications also took part in this. All of the actions took place on deck. Statements showed that they could not go further below deck because of the water level and the loose objects floating around inside the ship. They broke the starting cord on the second pump, as a result of which the pump could no longer start. The crewmembers had the impression that the water level in the Wyvern's cockpit was dropping. They reported this over the ship's radio to the owner and captain of the Wylde Swan.

However, a high wave suddenly washed over the deck and ended up in the cockpit. They then immediately decided that the situation on board was now becoming too dangerous and that it was time to leave the ship. All three of them agreed on this. This decision was communicated to the Wylde Swan over the ship's radio. A fresh wave then washed over the deck from the stern. This wave rapidly flooded the cockpit. This made evacuation even more urgent. One crewmember immediately jumped on to the life raft. When the Wyvern sank, another crewmember ended up in the water. The third crewmember was not seen again. The Swedish Sea Rescue Society recovered the two crewmembers and immediately started a search for the missing crewmember. The Wylde Swan, other vessels and two helicopters also took part in this search. It was suspected that the crewmember had become entangled in the rigging when the ship suddenly sank. The search was finally discontinued at 11:45 hours.
