DUTCH
SAFETY BOARD

Partial loss of engine power during cruise flight Robinson R44 helicopter

The Hague, June 2014

Identification number: 2012013
Classification: Serious Incident
Date, time¹ of occurrence: 21 January 2012, 14.32 hours
Location of occurrence: Oosterschelde, vicinity of Yerseke
Aircraft registration: PH-WMW
Aircraft model: Robinson R44
Type of aircraft: Helicopter
Type of flight: Passenger flight
Phase of operation: Cruise
Damage to aircraft: None
Cockpit crew: One
Passengers: Two
Injuries: None
Other damage: None
Lighting conditions: Daylight

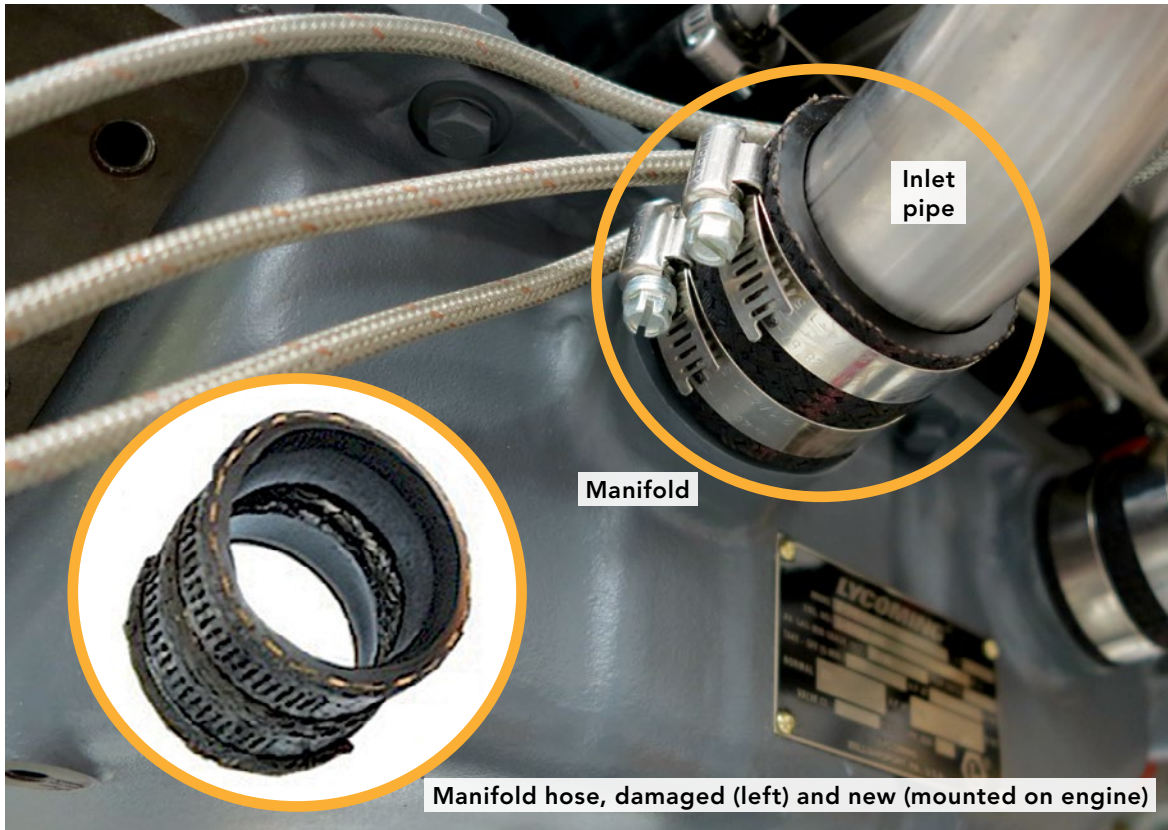
The helicopter engine was inspected at the maintenance facility in Belgium. The inspection showed that the CHT sensor located on cylinder #2, had melted away. Also, the hoses connecting the manifold to the cylinder intake pipes (inlet manifold hoses) showed extensive wear of the rubber, which resulted in at least one porous hose. A leaking hose can cause a lean fuel/oxygen mixture, resulting in high temperatures during combustion, and possible overheating of pistons and cylinders.

Figure 4: Damaged (left) and mounted inlet manifold hose. (Source: Robinson helicopters)

The partial power loss was the result of an overheated engine, which caused the CHT indicator to fail. The probable cause of the overheating was a leaking inlet manifold rubber hose, causing an excessively lean air/fuel mixture.

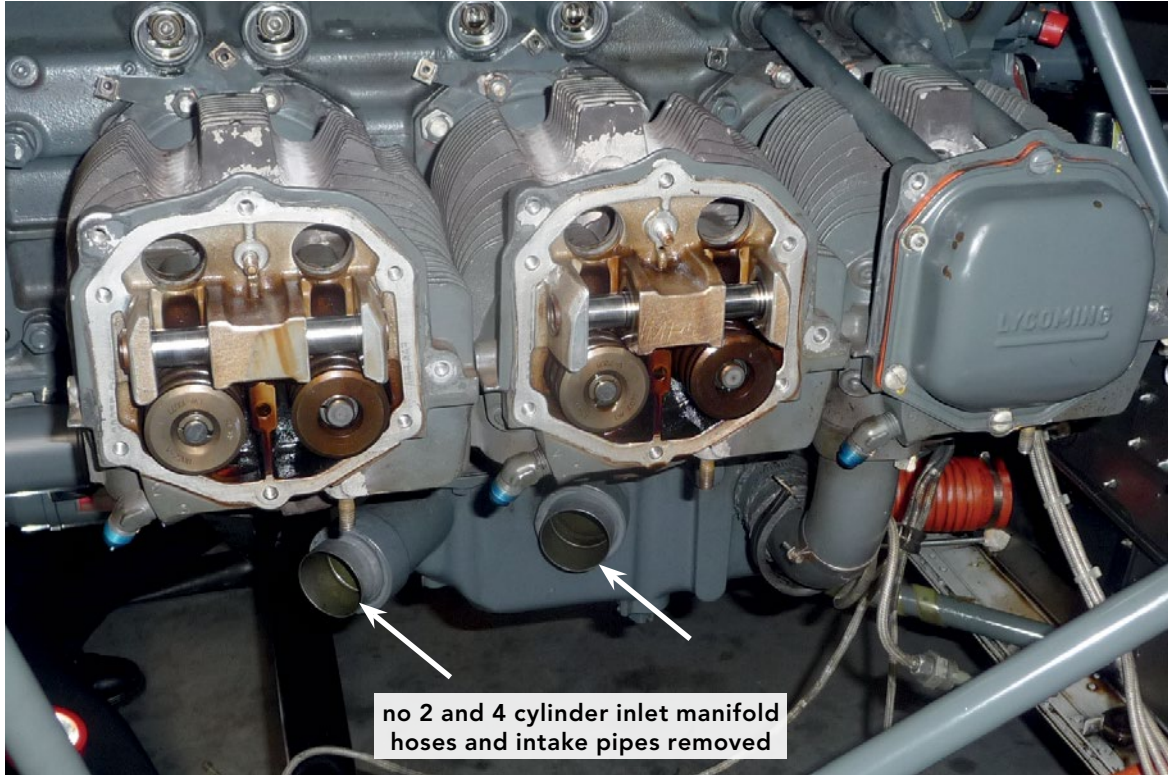
Figure 5: PH-WMW engine. Hoses and intake pipes of cylinder 2 and 4 removed. (Source: Dutch Safety Board)

The engine was removed from the helicopter and investigated. Two cylinders were found to have overheated (numbers 2 and 4) which probably caused the failure of the CHT-sensor and the partial power loss.

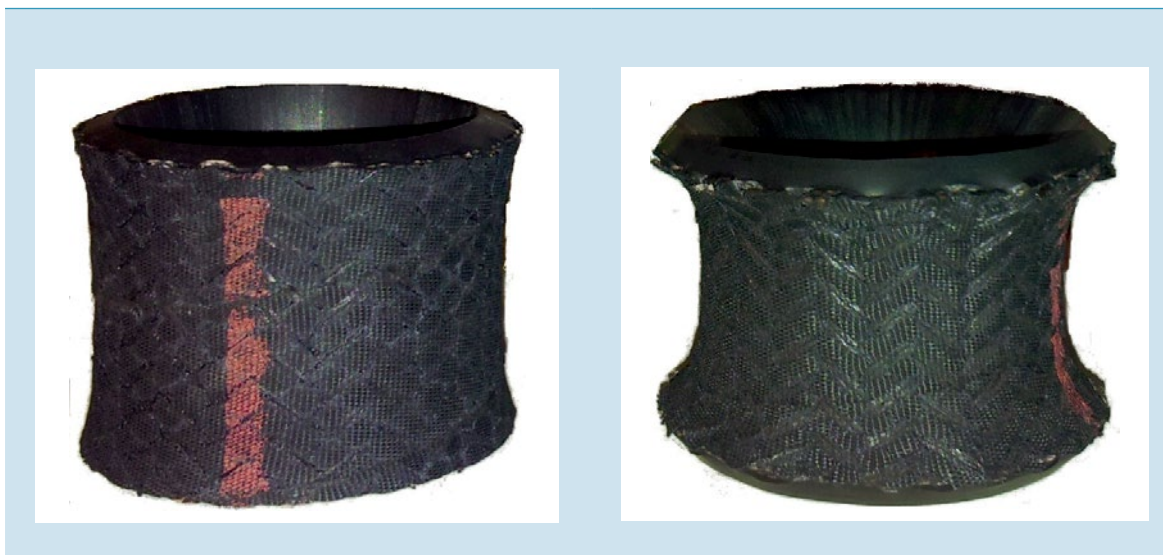
A test was performed to determine the possible influence of Avgas and Mogas on the rubber hoses. Two new hoses were used. Laboratory tests revealed that the volume change properties of the new hose met the requirements according to MIL-STD-6000.⁹ The hoses were exposed to respectively Avgas and Mogas for 24 hours to examine the effects on the hoses. The hoses have reinforcement webbing at the outside, which has limited expandability. The picture below shows that Mogas 'inflates' the rubber hose where Avgas causes only a slight increase in volume. The outer webbing effectively limits the possibilities for length increase of the rubber as a whole. The volume increase is limited outwards, and so the volume increase is vectored towards the ends of the hose where it causes the characteristic concave shape as seen below.

Figure 6: Inlet manifold hose after 24 hours in Avgas (left) and after 24 hours in Mogas (right). (Source: Dutch Safety Board)

⁹ Average of three samples in Mogas for 24 hours: 70,6 % volume change. In Mogas + 5 % Ethanol: 80,7 % change. Requirement MIL-STD-6000: max 85 % change.

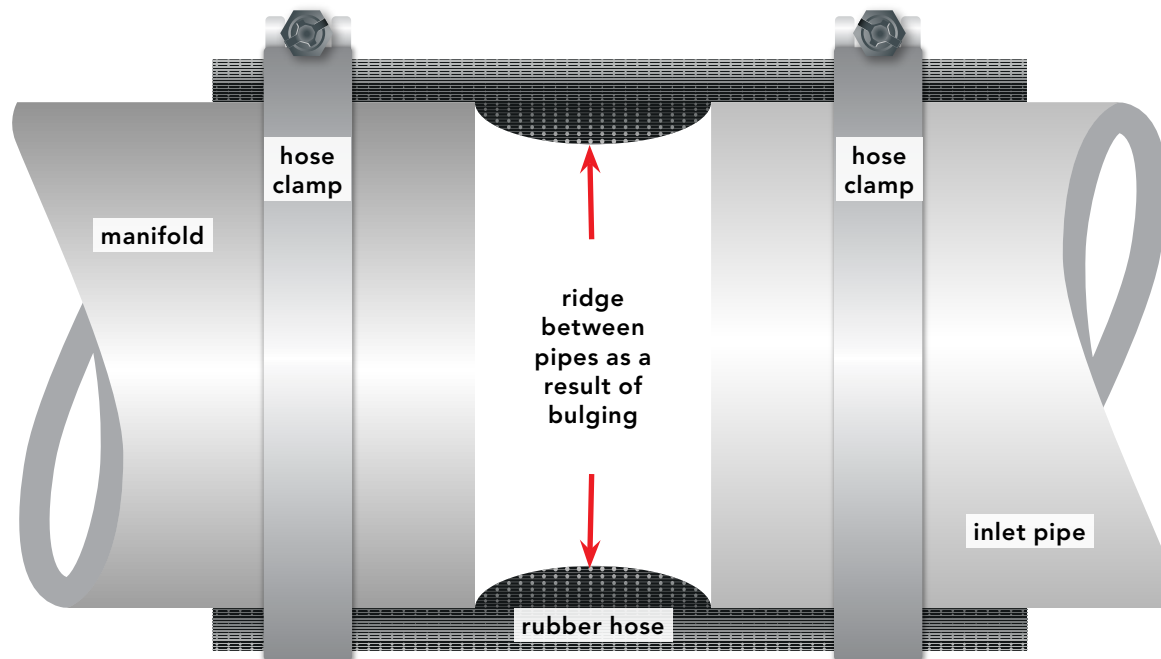
On the aircraft, the rubber is generally encased by webbing, pipes and clamps. Therefore it can only expand (bulge) in one direction, which is inwards in between the two pipes.

Figure 7: Drawing of ridge in inlet manifold hose between two pipes. (Source: Dutch Safety Board)

As a result, a ridge is formed in the hose, between the two pipes. It is concluded that the ridge as found in the hose of PH-WMW was caused by the (long term) use of Mogas.

The long term use of Mogas most probably caused the bulging of the inlet manifold rubber hose between the two metal connecting pipes of the manifold and the cylinder intake pipes.

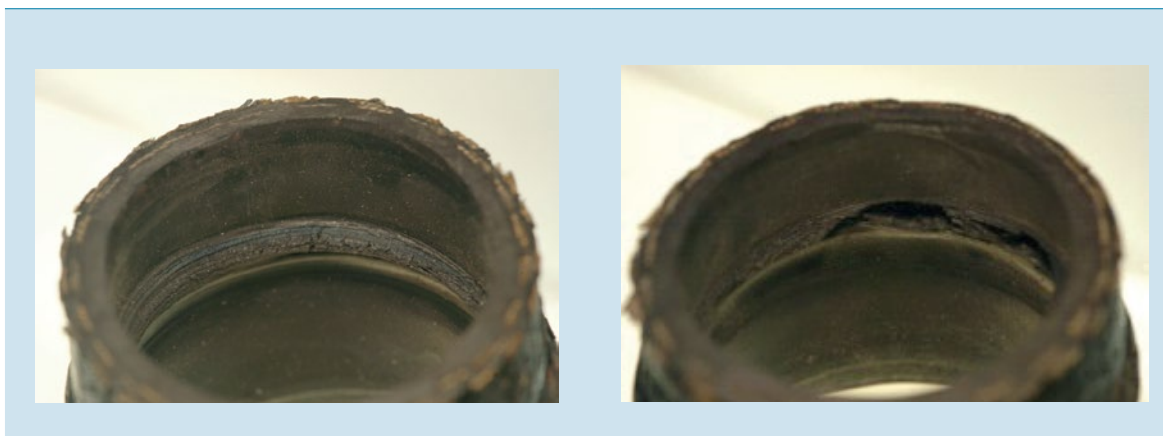
During the investigation a maintenance organisation provided the Safety Board with a hose that was removed from a fixed wing aircraft that was operated on Mogas for a considerable time. This hose showed the result of bulging between the two pipes, a ridge was clearly visible. Approximately 75 % of the ridge was undamaged, in the remaining part, pieces had broken away. It was concluded that this hose showed a stage of the degradation process prior the stage as found on PH-WMW.

Figure 8: Hose with ridge, partly undamaged (left) and damaged (right). (Source: Dutch Safety Board)

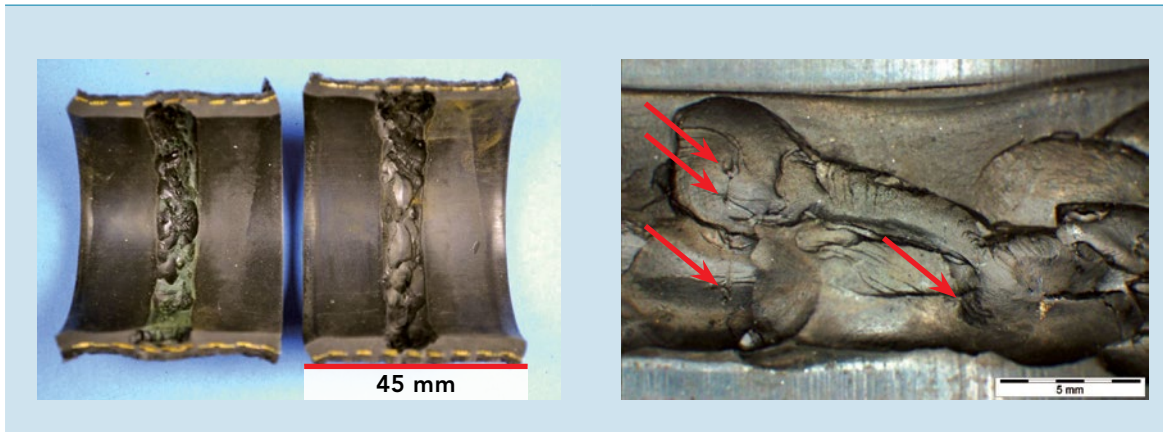
Figure 9: Inside of the hose with broken out material. (Source: Element)

Figure 10: Detail of broken out material. (Source: Element)

The laboratory concluded that the main cause of the failure was a fatigue mechanism.

The use of Mogas generated bulging, causing increased stress levels at the rubber surface between the pipes, resulting in fatigue. This fatigue mechanism was evidenced by initiation points and broken out rubber. The arrows in figure 10 show the initiation points. The alternating stresses caused by vibration and (internal) material stress due to bulging, in combination with the temperature, were contributing factors to the fatigue mechanism. As bulging hardly occurs when the engine is operated on Avgas, this phenomenon is only present when Mogas is used for a relatively long time. For details see appendix.

The main cause of the failure of the inlet manifold hose was a fatigue mechanism. The broken out rubber particles are a result of fatigue initiated on small particles in the rubber.

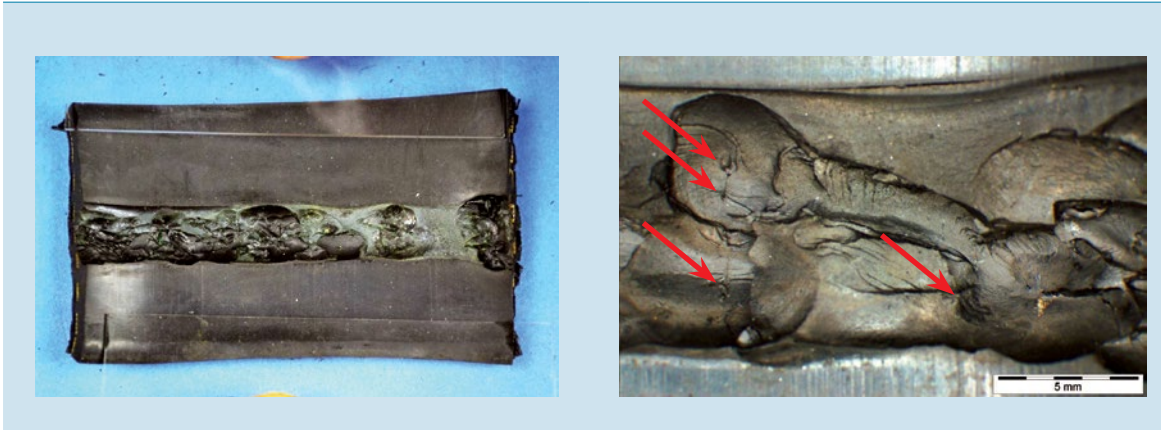
Figuur 11: Track with broken out material.
(Source: Element)

Figuur 12: Detail of broken out material. (Source:
Element)

The arrows in figure 12 point to the initiation points.

The alternating stresses in combination with the heat generated in the rubber caused the fatigue cracks in the bulged part. The small particles in the rubber acted as stress initiators. As a result the fatigue cracks initiated at the particles. As bulging hardly occurs when the engine is operated on Avgas, this phenomenon is only present when Mogas is used for a relatively long time.

It was concluded that the main cause of the failure was a fatigue mechanism. However, the use of Mogas caused the bulging between the pipes, which resulted in increased stress levels of the surface. The broken out rubber particles were a result of fatigue initiated on small particles in the stressed surface of the rubber. The alternating stresses caused by the (internal) material stress due to the bulging in combination with the temperature were a contributing factor to the fatigue mechanism.
