DUTCH  
SAFETY BOARD

# Quarterly Aviation Report

## October - December 2017

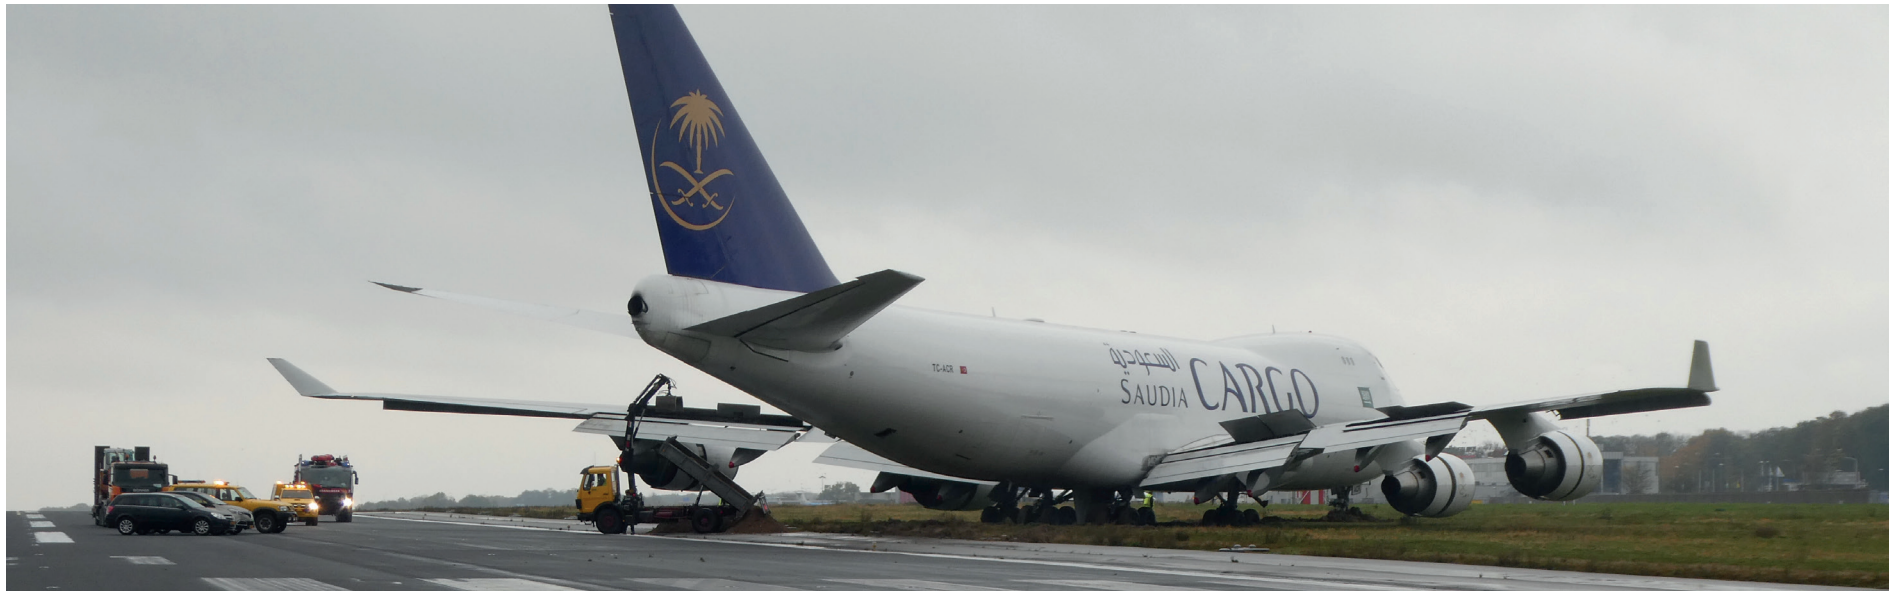
The Boeing 747-400F cargo aeroplane, with four people on board, departed from Maastricht Aachen Airport on a flight to King Abdulaziz International Airport in Saudi Arabia around 22.30 hours. After the aeroplane had been lined up at the beginning of runway 21, the captain selected full power for take-off. Shortly after this, the aeroplane pulled to the right. The crew aborted the take-off with a speed of about 45 knots, but was unable to keep the aeroplane on the runway. The aeroplane ended up in the grass to the right of the runway. The persons on board the aeroplane were not injured. The Boeing 747-400F sustained damage to the fuselage.

The Boeing 747-400F after the runway excursion.

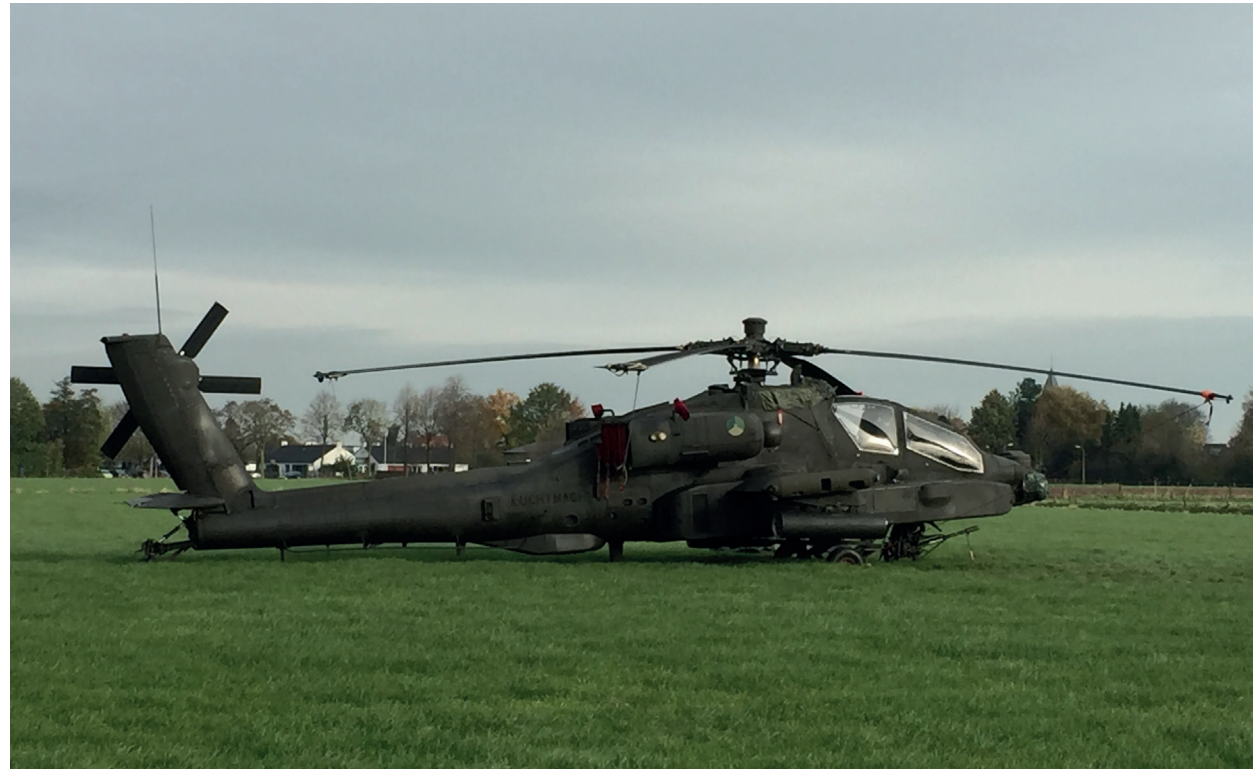
An Apache helicopter of the Royal Netherlands Air Force Command hit the lightning rod cables of a high-tension line around 19.00 hours. The accident occurred in a low-level flying zone that had temporarily been designated as a military training area. The flight was executed as part of a military flying exercise. For a large number of households in the surroundings, the collision with the high-tension line resulted in a power outage which lasted for a couple of hours. Nobody was hurt in the accident. The helicopter was substantially damaged and was transported over land to Gilze-Rijen Air Base the next day, for further investigation.

*The Apache helicopter after the occurrence.*

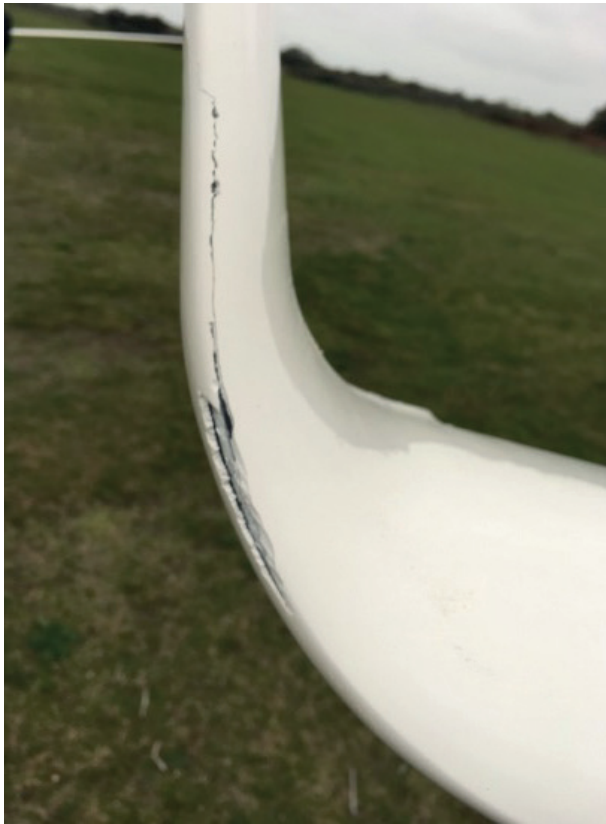
At 16.01 hours, while flying about three kilometres to the south of Zandvoort over the foot of the dunes in southerly direction, at a height of about thirty metres, the right wing of D-KLEP, an Antares 20E glider, was hit by something. The pilot heard a loud bang, but was unable to see what hit the glider. He then slowed down his flight and checked the control system of the plane. This check demonstrated that everything was still in working order. A little later, the glider landed on Langeveld glider airfield. On inspection after the flight, a tear with a length of about twenty centimetres was discovered in the right winglet. The edges of the tear were jagged, which might indicate that it had been in contact with a propeller. There was no sign of blood or feathers. Based on the damage pattern, it is not unlikely that a collision with a drone had occurred. However, no remains of a drone were found in the winglet.

Damage to the winglet of D-KLEP. (Photo: owner)
