DUTCH
SAFETY BOARD

Fatality during mooring operation in lock

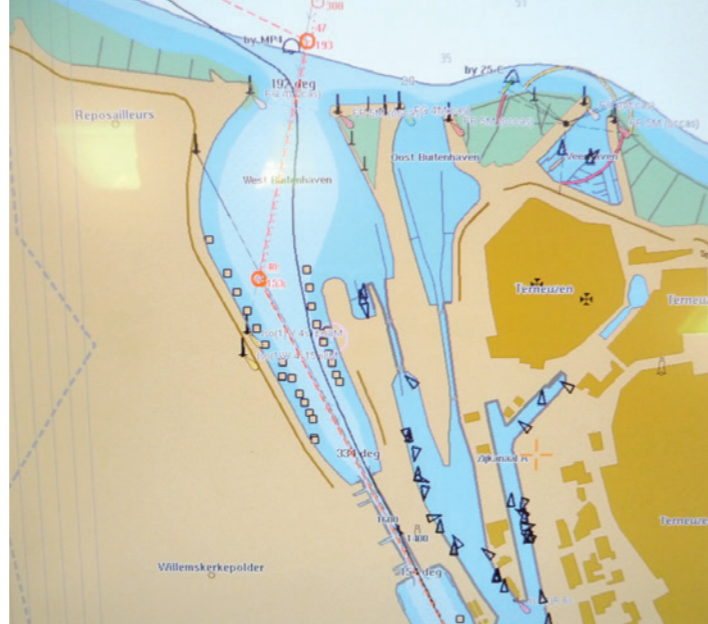
Figure 2: Image of the track (in black) of the Flinter Aland on the display of the electronic nautical chart. (Source: ECS)

In order to enter the lock the Flinter Aland kept portside of the fairway (see figures 2 and 3). The ship entered the lock at around 12.32 with a ground-speed of 3-4 knots. The master later stated that the ship had not been affected by the wind but that it probably had been affected by the saltwater to freshwater effect (which may increase the ship's speed and change its heading). The master subsequently stated that he had reversed the propeller shortly afterwards to reduce speed. The lockmaster noticed the ship's high speed and called the ship by VHF 'You are entering the lock at quite a high speed.

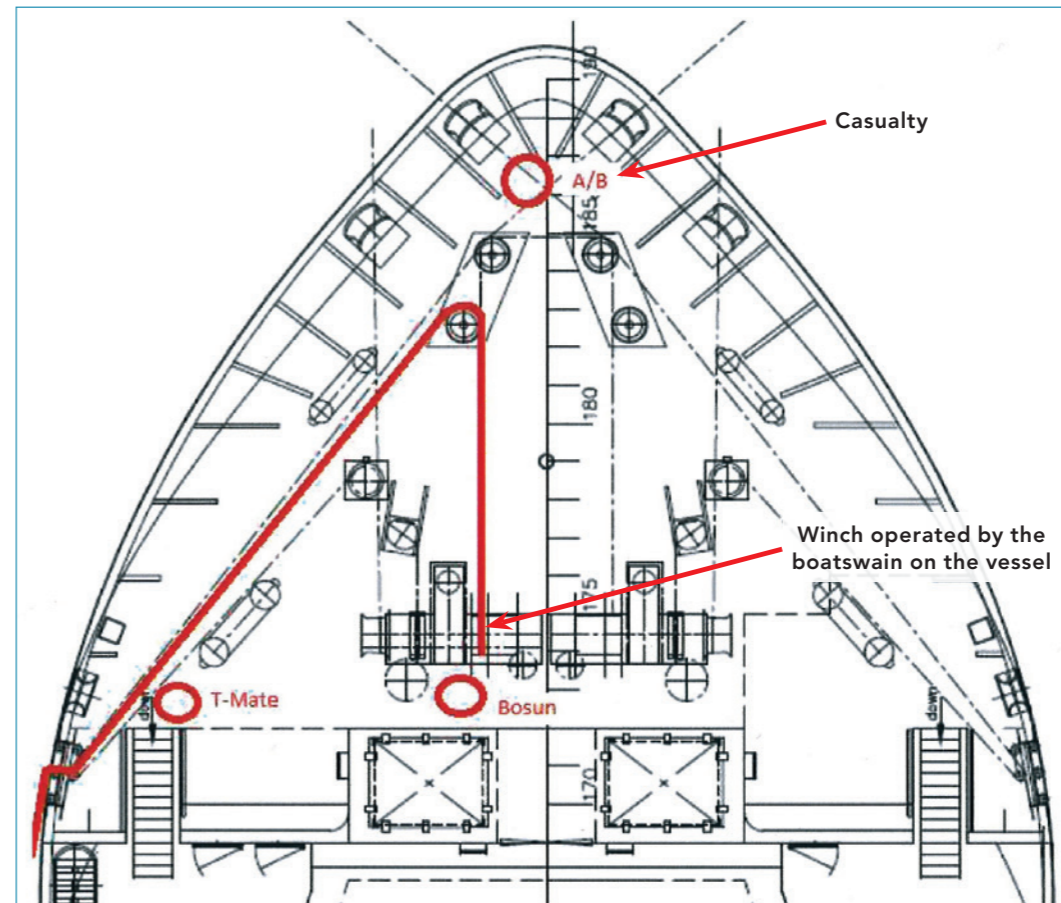
Figure 3: Location of the crew and the course of the broken mooring line. (Source: Shipping Company Flinter).

At 12.34:20 the master communicated 'in position' to the deck crew via VHF. The ship was still sailing at around 0.7 knots at that time. As the master later explained, this order meant that the crew were to fasten the mooring line winch onto the strap brake. Almost immediately after the master had given his order, the mooring line broke. The ship's main engine was

running at full astern at that time. The seaman, who had walked to the forecastle to grab hold of the heaving line, was standing in the mooring line snap-back zone. He was hit by the mooring line that had snapped back and, as later emerged, died instantly from his injuries. It was immediately clear to the crew on the forecastle and the boatswains on the quay

still moving in forward direction at the time the crew fully tightened the winch brake located on the forecastle. The mooring line broke without any prior (audible) warning. The third mate, the boatswain (the winch operator) and the seaman were therefore unaware of the immediate danger they were facing. Just before the mooring line broke, the seaman was located in the mooring line snap-back zone, where he got hit by the mooring line that had snapped back.

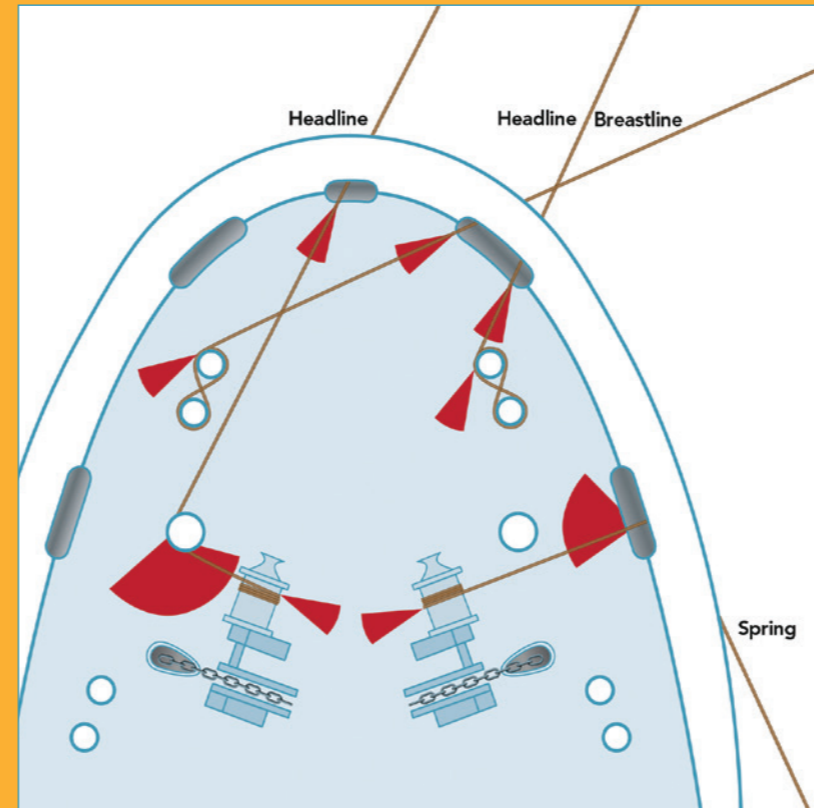
Figure 4: Illustration of the snap-back zones (coloured red) in the Health and Safety Instruction Sheet. (Source: Royal Association of Netherlands Shipowners and Nautilus International Trade Union)

To warn crew members of the hazards arising in the event of a mooring line breakage on board a ship, snap-back zones have been identified. The Royal Association of Netherlands Shipowners (KVNR) and the Nautilus International trade union have incorporated these zones in the *Mooring and Unmooring Operations Health and Safety Sheet* for the purpose of informing the sector of the regulations that must be complied with when mooring and unmooring vessels. The Dutch Safety Board is of the opinion that the zones

Comparison between the two snap-back zones figures shows that the snap-back zones according to the latest insights (figure 5) are longer, and even extend almost the entire length of the foredeck

defined in this sheet provide ships' crews with insufficient insight into the actual risks they are exposed to in the event of mooring line breakage. For instance, the angle shown at which the broken mooring line can snap back is too narrow. Furthermore, only a limited number of breakage locations have been defined (see figure 4). The seaman was standing at a location that had not been identified as a danger zone in the Health and Safety Sheet. Lastly, the highly simplified illustration of the forecastle does not do justice to the often complex situation on board seagoing vessels where mooring lines are run around capstans. This means that the

- The snap-back zones identified in the *Mooring and Unmooring Operations Health and Safety Sheet* do not provide with crews sufficient insight into the risks they face as a result of snap-back caused by mooring line breakage.

Revise the *Mooring and Unmooring Operations Health and Safety Instruction Sheet* and to that end, use the latest insights into the risks inherent in

working with mooring lines. Encourage your members to adopt the insights in their Safety Management System. In this context, particular emphasis should be placed on the mooring lines snap-back zones.

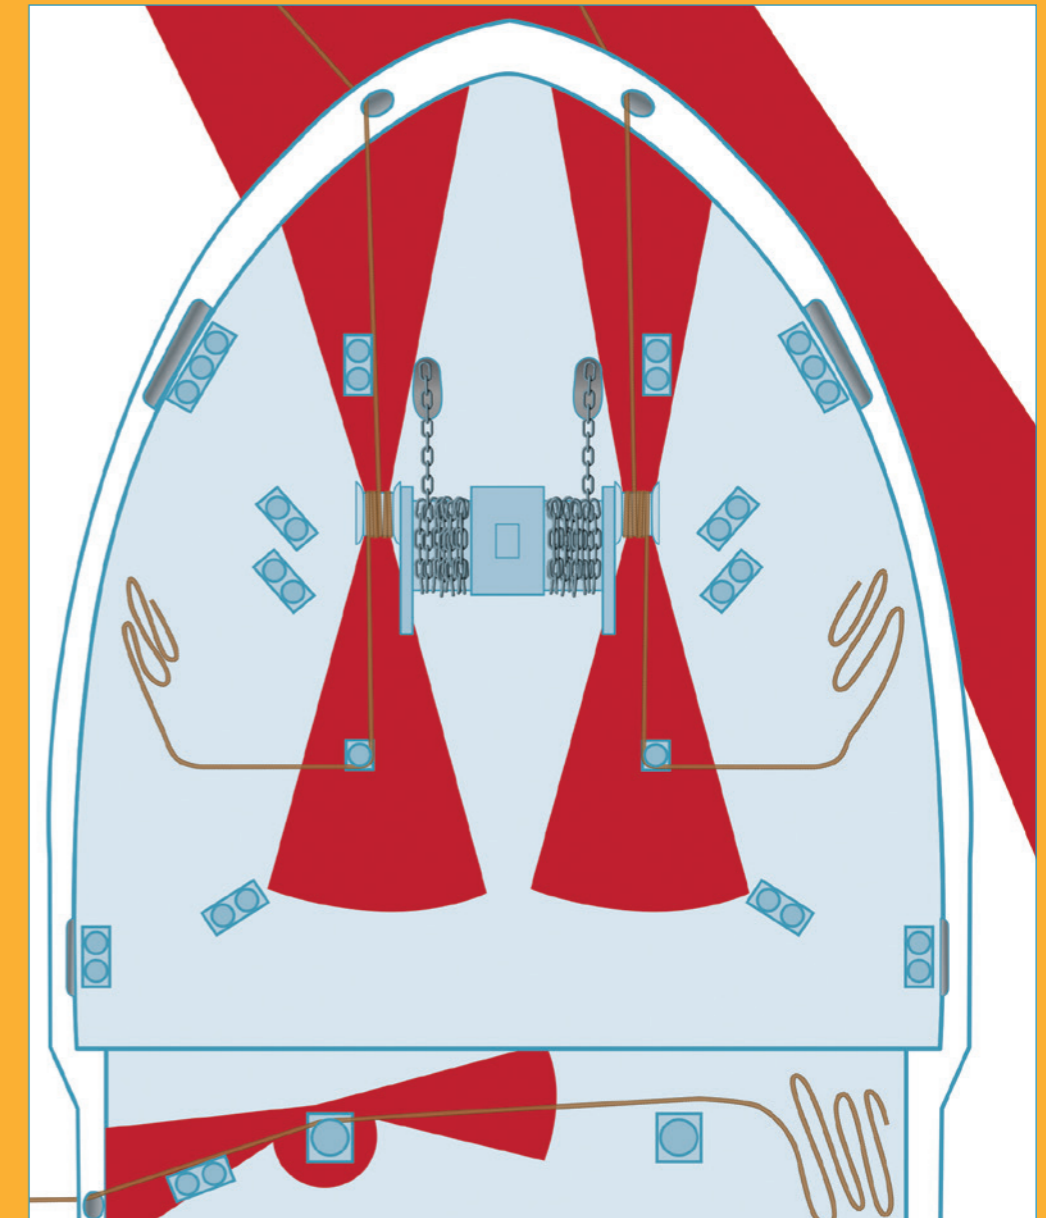
Figure 5: Illustration of snap-back zones (coloured red) according to the latest insights. (Source: Seahealth Denmark)

snap-back zones are significantly larger. For a more accurate picture and the risks associated with snap-back zones, the Dutch Safety Board refers to publications such as those of the English Nautical Institute and Seahealth Denmark (see figure 5).

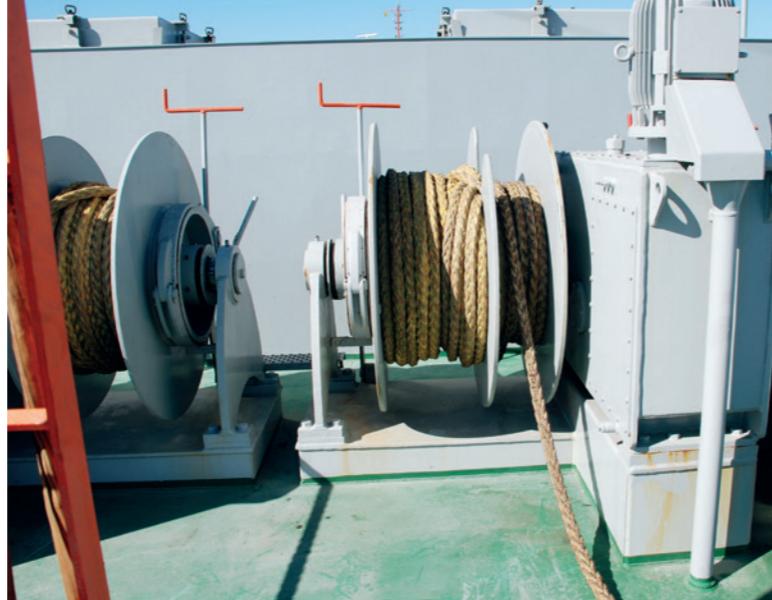
Figure 8: Winch on foredeck ms Flinter Aland. (Source: Dutch Safety Board)

day of the incident. The first measure relates to the ship mooring line itself. The crew on board the *Flinter Aland* regularly inspected the mooring lines. These periodic inspections focussed on the mooring line's visual features. The one-year old mooring line was certified and was in good condition, visually. The second measure for preventing mooring line breakage is the winch brake. The brake's holding force must be less than that of the ship mooring line.

According to the certificates the winch's holding force was 240 kN and that of the mooring line 378 kN. The shipping company stated that it had planned to have an expert company test the holding force of the winch in the scheduled port of arrival. Due to the fact that the ship's destination had been changed, such a test was not carried out.

- The mooring line on board the Flinter Aland broke because the forces exerted on the mooring lines became excessive. The ship was still moving in forward direction at the time the crew fully tightened the brake of the winch located on the forecastle.

Identify the risks involved in working with mooring lines and take measures to minimise these risks as far as possible. In this context, particular emphasis should be placed on the mooring lines snap-back zones, the winch brake's holding force and

communications. Implement these procedures in the safety management system and ensure that crews comply with these procedures.
