DUTCH
SAFETY BOARD

Fatal Fall Overboard During Loading Activities

MS Clipper Champion, Rotterdam

MS Clipper Champion, Rotterdam, 1st May 2014

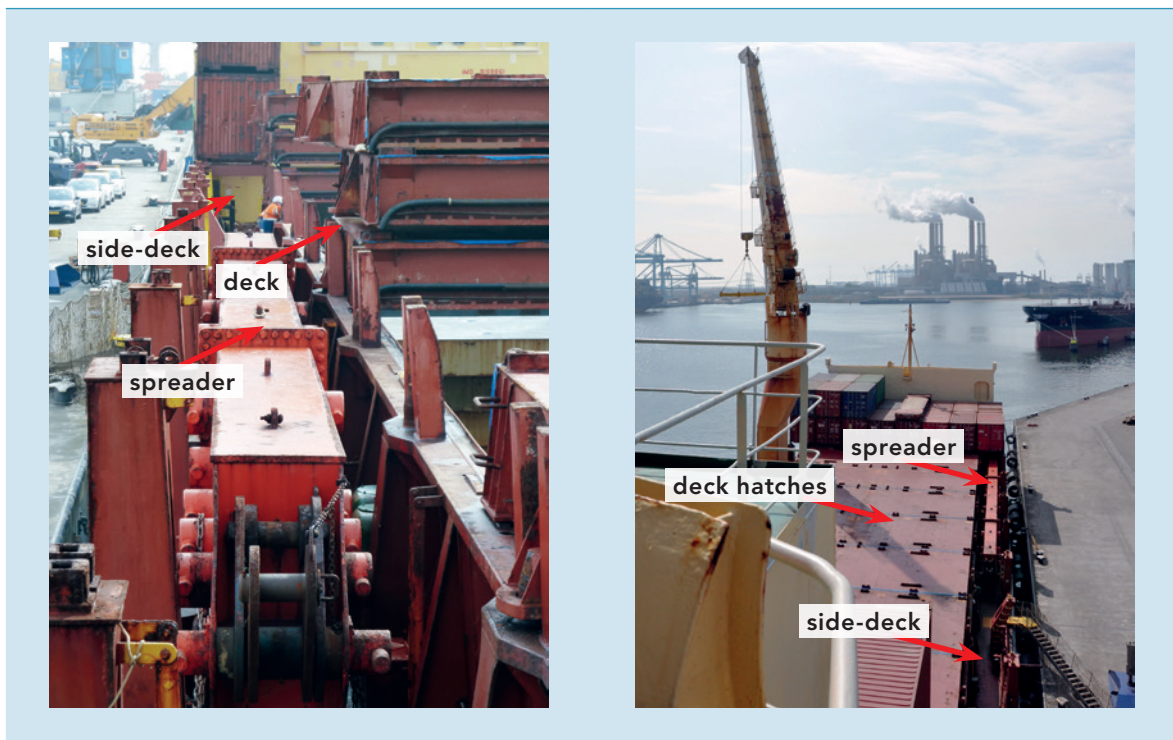
Figures 1 & 2: Hatches, spreader and side-deck. (Figure 1: Source IL&T, figure 2: Source: Dutch Safety Board)

busy doing other work.³ Whilst one of the sailors was walking forwards, he was blocked by a spreader placed on the side-deck on the starboard side. The 42 tonne spreader was there to help hoist heavy loads using both ship's cranes and the starboard side-deck was its default storage location. In order to guide the hatch further towards the bow, the sailor climbed on top of the spreader. He was holding the rope that was attached to the deck hatch cover.

- The top side of the spreader on board the Clipper Champion was painted with fluorescent paint and has had anti-slip material applied.
- The accident was discussed by the safety committee.
- A safety audit¹⁰ was held on board and extra training was given. The emphasis was on keeping up with the ongoing safety campaigns of the ship owner, including the 'take-five' safety programme and development of a safety culture on board.
- Fall protection has been provided by installing a safety net and fitting a guardrail near the spreader.

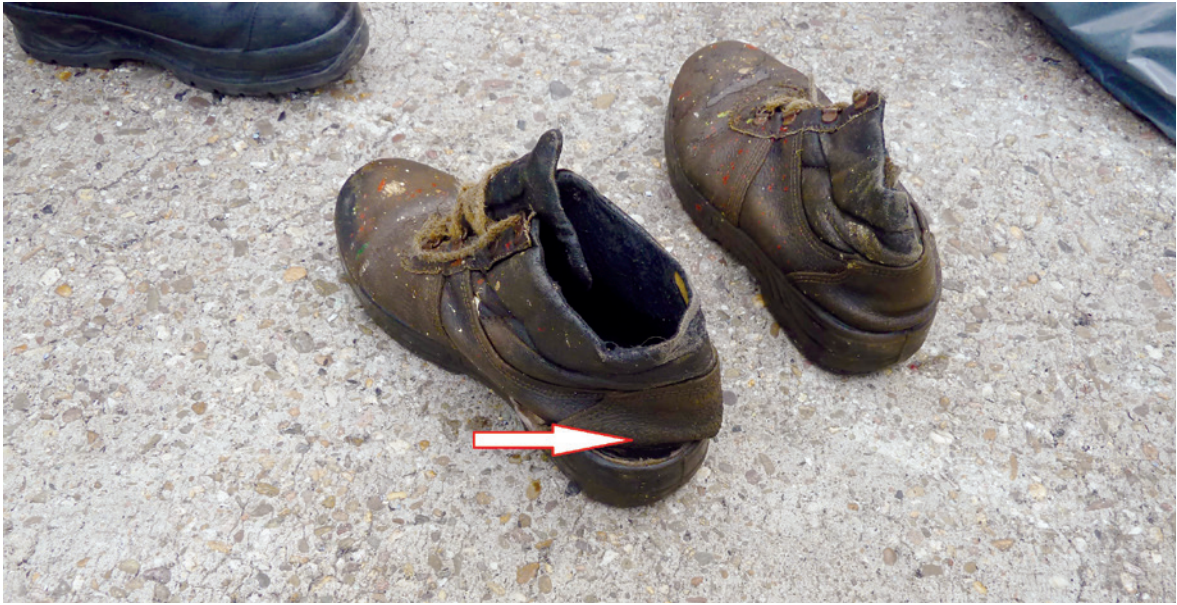
The SMS states that each crew member is responsible for wearing appropriate personal protective equipment. The ship owner is responsible for providing this equipment. The standard equipment supplied to the ships consists of coverall, safety shoes, earmuffs, gloves, safety goggles, safety harness, crash helmets and a gas detector. Life jackets are not provided to each individual but are part of the ship's equipment. If it becomes evident that more personal protective equipment is needed on board, the safety officer can order this from the shipping company. According to the SMS, people should call each other to account when they notice they are not working safely. Witness statements and photos show that the sailor was not wearing a safety harness or a helmet. The sailor's coverall was in bad condition and his footwear was worn out. Neither the officers on board nor his immediate colleagues talked to the sailor about this.

Figure 4: Work shoes of deceased sailor. (Source: IL&T)

- The shoes of the sailor were worn-out.
- Morning dew on the steel deck that did not have anti-slip paint.
- The uneven surface of the spreader. This surface is not designed to walk on.
- The spreader was not fitted with effective protection to protect the sailor against a 14 metre fall.
