HELICOPTER CRASH DURING A PHOTO FLIGHT

Incident number:	2010042
Classification:	Accident
Date and time of incident:	27 June 2010, around 12.55 hours ²
Location of incident:	Maasvlakte, municipality of Rotterdam
Registration:	PH-ECJ
Aircraft model:	Eurocopter EC 130 B4
Aircraft type:	Helicopter
Flight type:	Photo flight
Flight phase:	Hover
Damage to the aircraft:	Completely destroyed
Number of crew members:	One
Number of passengers:	Four
Injuries:	Four people died, one person was severely injured
Other damage:	Environmental damage
Light conditions:	Daylight

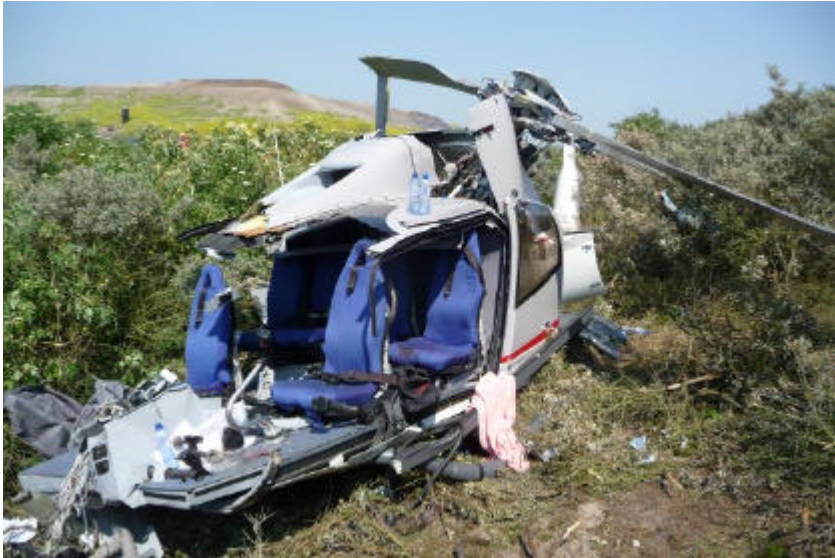
Figure 1: the PH-ECJ after the accident.

Help arrived almost immediately due to the cycle race. Those who were first to arrive at the scene stated that the person who had been sitting in the front right seat of the helicopter was lying next to the helicopter, while the remaining occupants were still inside the helicopter. Three occupants died during or shortly after the accident, the two others were severely injured and were taken to the hospital where one later died. The helicopter was completely destroyed (see figure 1).

The helicopter's landing gear was severely damaged. The entire front of the helicopter was knocked off; only the bottom plate was left. The dashboard, the fuel shut-off handles and the rotor brake in the cockpit were consequently missing, amongst other things.

The main gear box and main rotor head system⁴ had been partly torn loose from the fuselage and was leaning over to the left. Three of the four gearbox supports were broken. The three main rotor blades were severely damaged and partly broken, and the rotor blade suspension system on the rotor mast was also severely damaged.

The tail and the tail rotor sustained relatively minor damage. The tail was cracked at the junction with the fuselage and was bent to the right in relation to the fuselage. The underside of the tail was knocked away to the right at the level of the tail rotor.

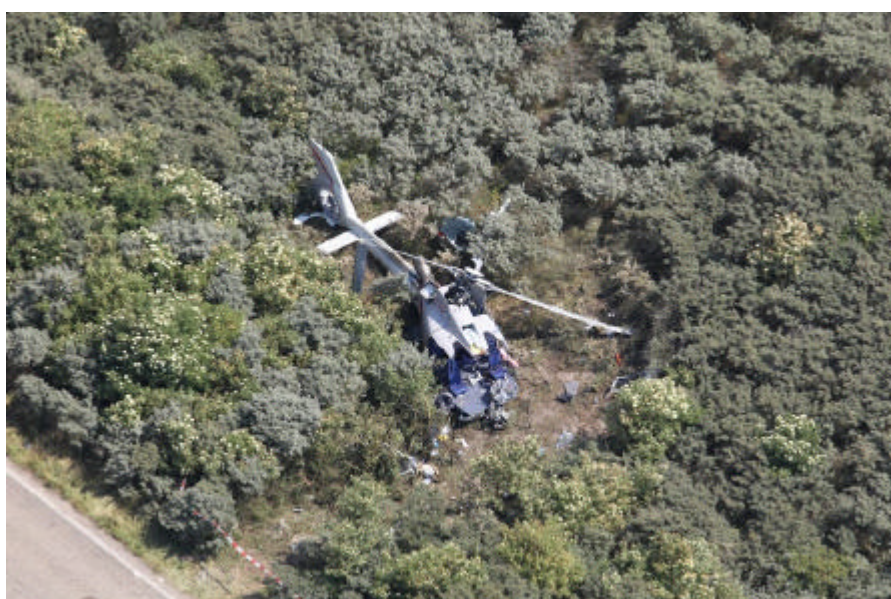
The helicopter crashed into a dune area next to the road. This area was covered with low bushes. These bushes were knocked away in a circular sweep to the left and front of the helicopter.

Figure 3: aerial photograph of the accident site (source National Police Services Agency [KLPD]).

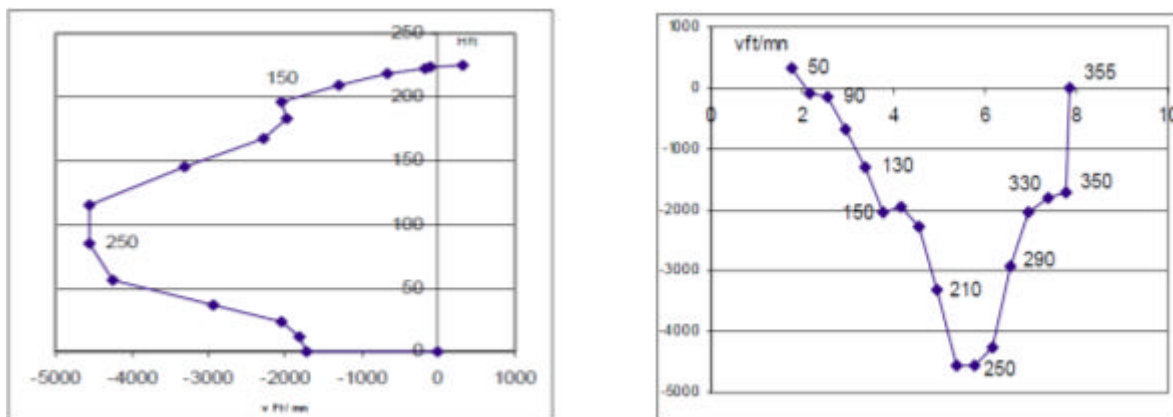
- After around 6.5 seconds the speed of descent fell again to around 1700 feet per minute (frame 350).
- The impact then occurred.
- The speed of rotation fell during the descent.

Figure 4: vertical speed in feet/minute relative to the altitude (l) and time (r).

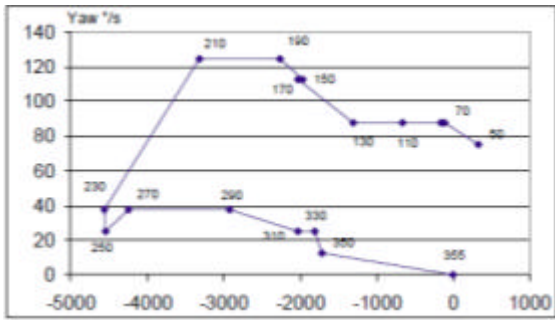
- The helicopter rotated a total of 440 degrees.

Figure 5: the rotation speed in degrees/second in relation to the vertical speed.
