DUTCH
SAFETY BOARD

Electrocution in tank

Atlantic Dawn, Red Sea, 17 October 2016

The Hague, August 2017

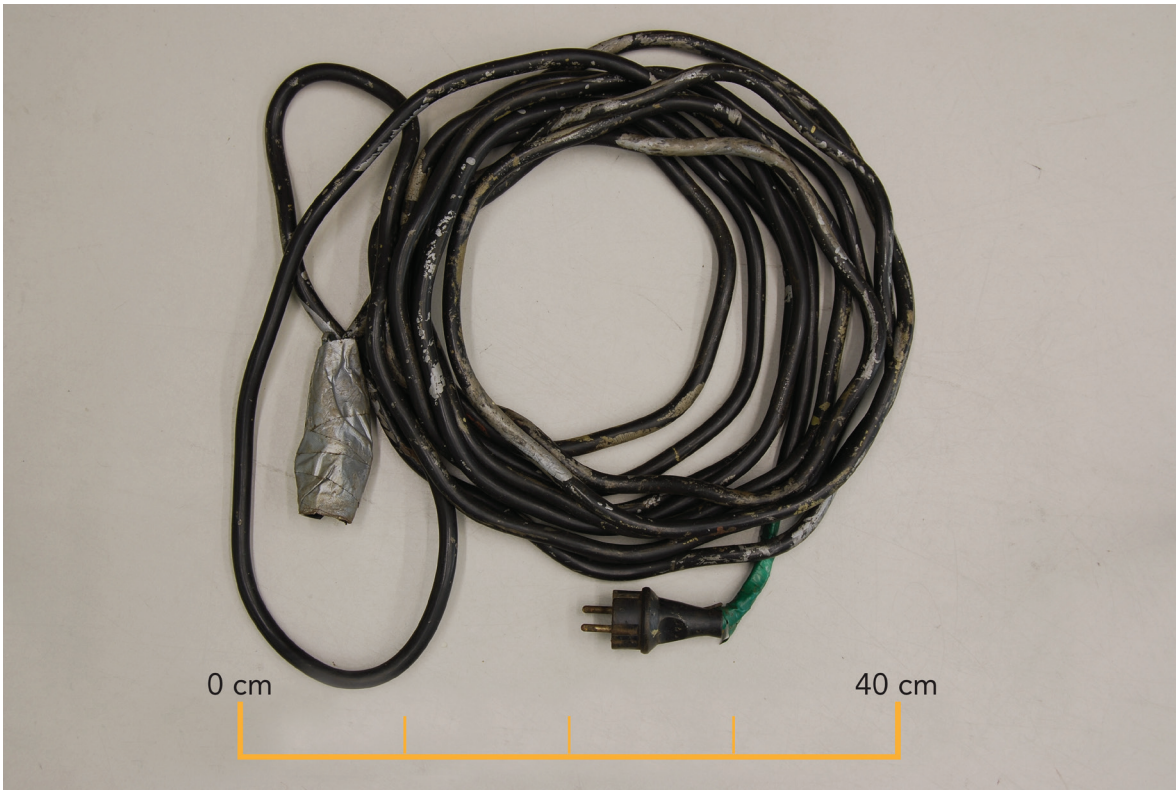
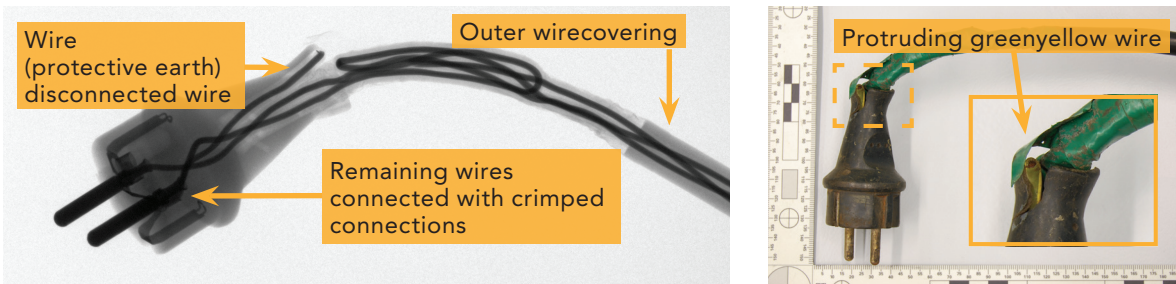
Figure 2: Cable used in tank (Source: NFI)

Two wires of the cable connected the pins in the plug to the cable. The plug's protective earth was interrupted and was protruding. The cable's outer casing was partially missing and wrapped in green insulation tape (see figure below).

Although other causes cannot be ruled out entirely, based on the following findings the Board deems that the victim probably died as a result of electrocution from direct contact with the phase of the electricity network (from the opening in the wire):

The victim probably died as a result of electrocution. He had a home-made cable to which he had affixed a fitting and a plug; this construction had been assembled in an unsafe manner. The victim probably made contact with the phase through an opening on the fitting. Safe voltage was not used.

Furthermore the use of safe voltage is recommended in a confined space to prevent a fault resulting in electrocution. This means:

1. In principle movable electrical equipment has an integrated power source.
2. If an integrated power source is not possible, the movable equipment must be fitted with extra low voltage, namely:
 - a. alternating current maximum 50 Volts, provided the circuit is separated from the main circuit by an isolation transformer or
 - b. DC voltage maximum 120 Volts provided the DC circuit is separated from the main circuit by an isolation transformer.

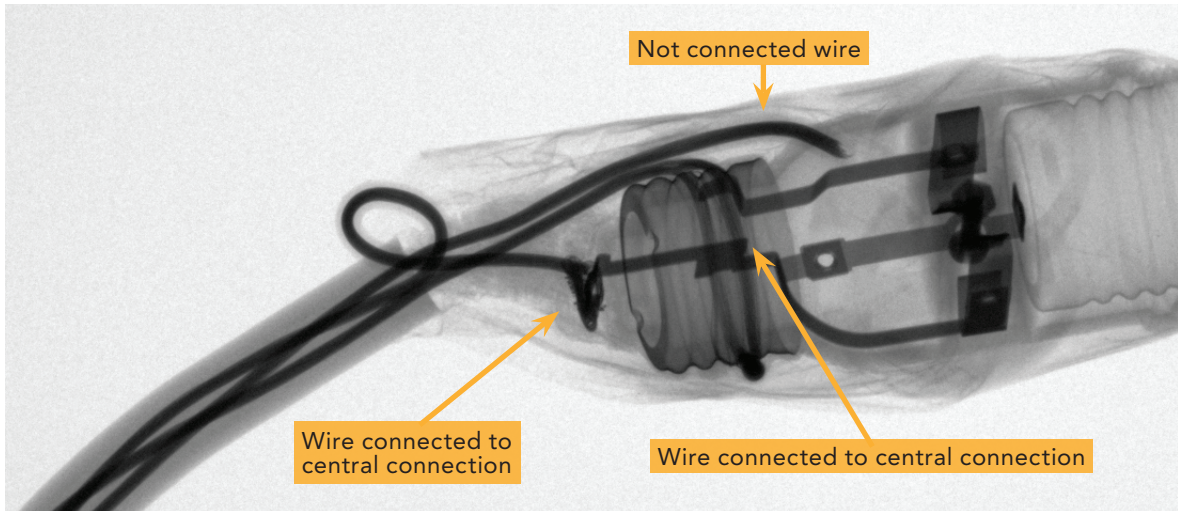
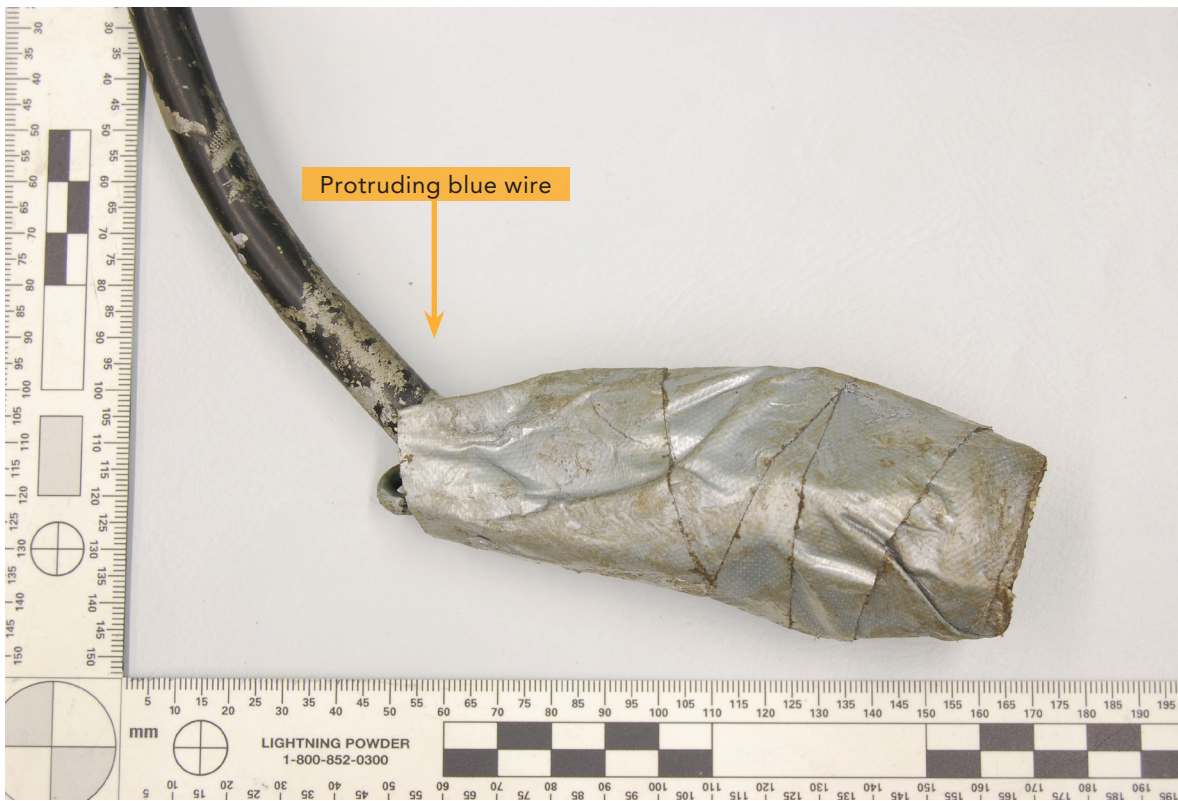
Figure 3: Fitting as connected to cable (Source: NFI)

At the other end of the cable a fitting extension with a double socket had been attached as a lamp fitting. The lamp fitting and the connection to the cable were completely wrapped in silver-grey tape. Part of the blue wire protruded just outside the tape in a loop. Red insulation tape was also visible underneath the silver-grey tape at the other end where the cable was attached to the lamp fitting. One of the cable's wires was connected to the bottom central connector and the other wire was wrapped around the bottom screw fitting. A third wire was ragged and ended at an angle; it was not connected. A piece of plastic was missing from the front end of the lamp fitting and the adhesive side of the tape was visible (see figure below).

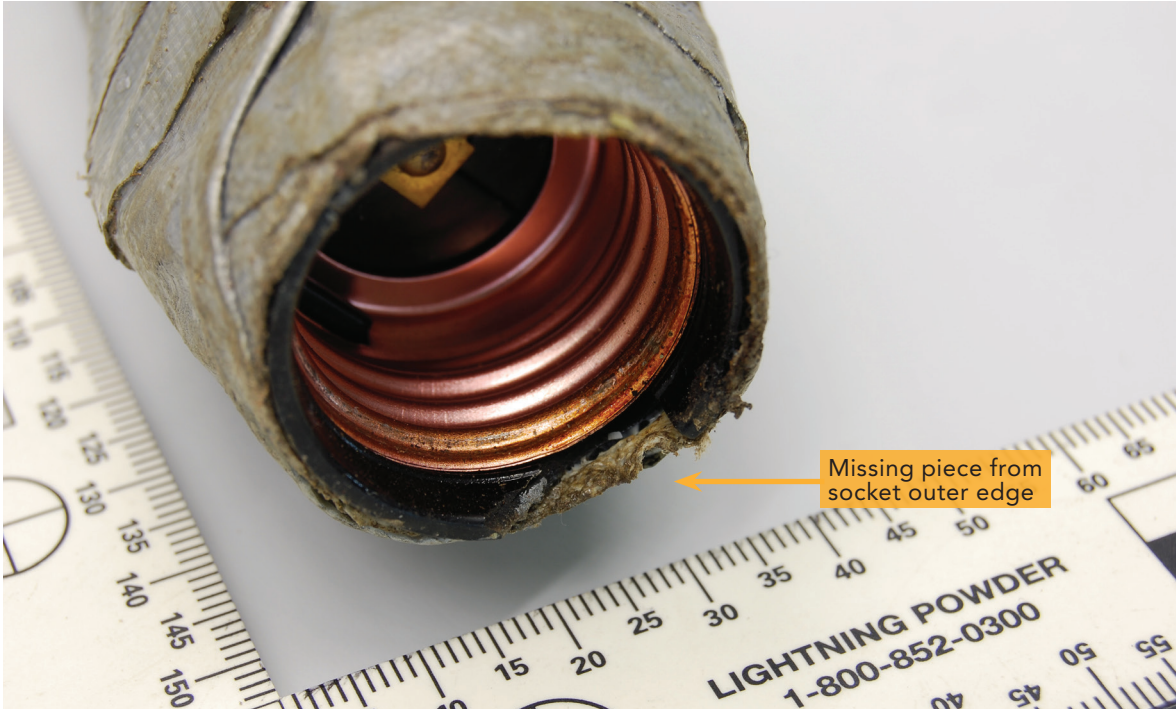
Figure 4: Lamp socket (Source: NFI)

At the transition from the lamp fitting to the lamp the construction of the power cable and the lamp had an opening that was large enough to provide contact between the conductive parts and the bare hands. Therefore this construction was also faulty and unsafe for use.

- Technical examination of this home-made construction⁷ revealed that there was an opening at the transition from the lamp fitting to the lamp, large enough for bare hands to make contact with the conductive parts.

- Skin tissue was found on the lamp at the opening near the lamp fitting.
- There was no short circuit, because the 16A fuse was not triggered.
- If a person comes into direct contact with the phase, the current could pass through that person. Any moisture on the skin increases the effectiveness of the conductivity.
