DUTCH
SAFETY BOARD

Shipping Occurrences Report

May - October 2016

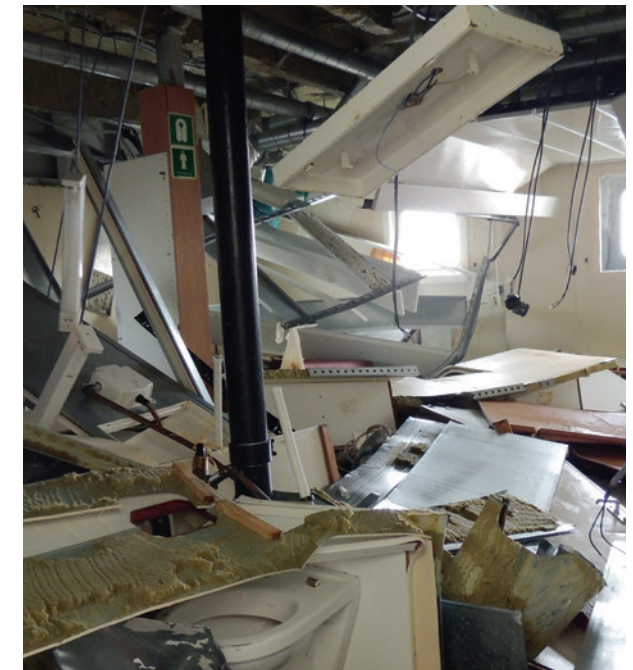
Interior of the Flinterstar after the collision.

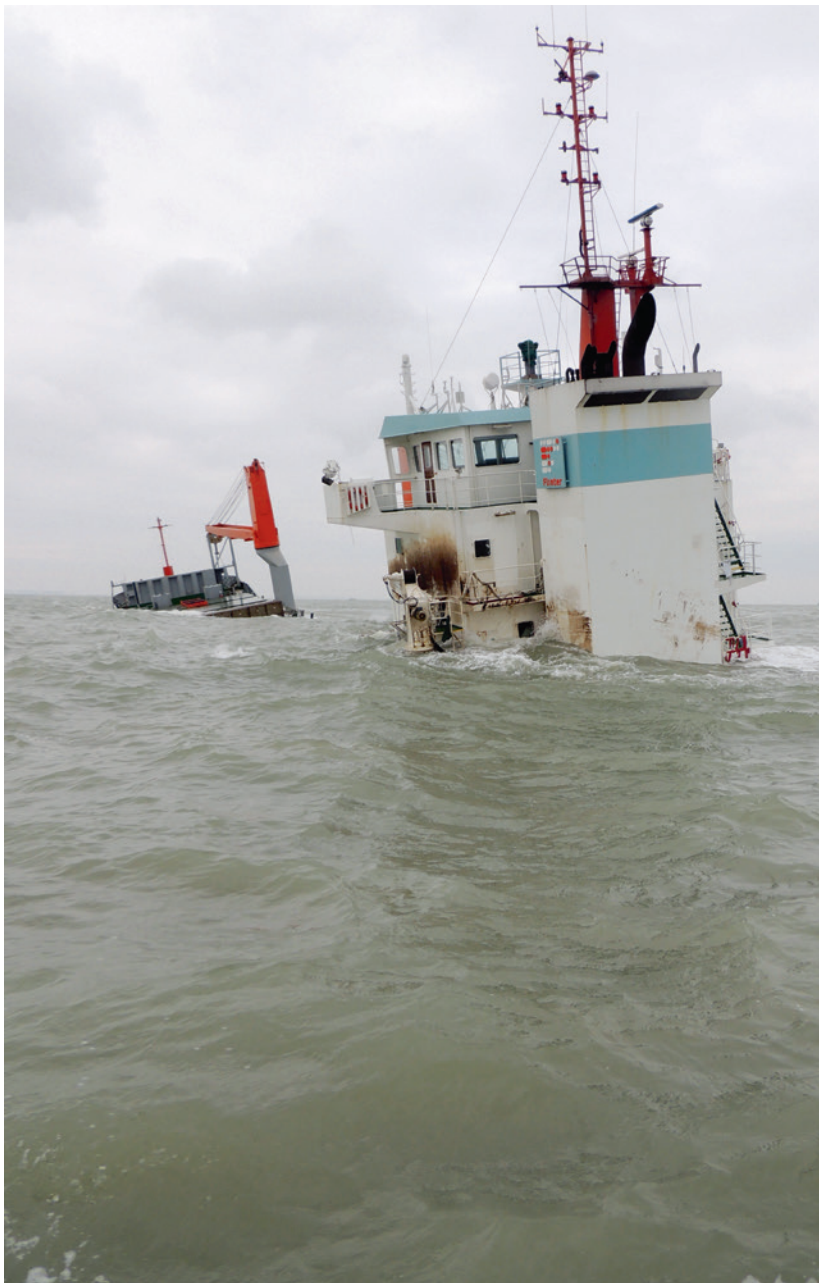
The bridge of the Flinterstar after the collision.

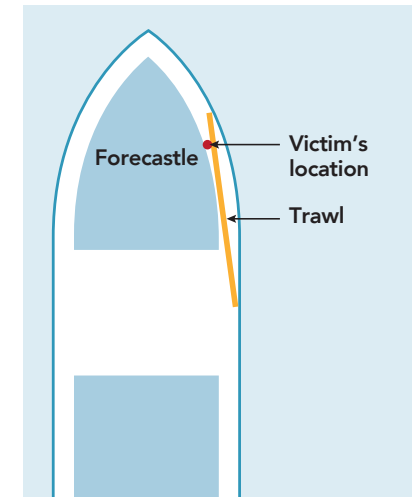
One of the crewmembers was busy repairing the pulse rig; he was standing between the beam trawl and the wall of the forecastle. The ship unexpectedly heeled to port. This caused the beam trawl to fall to the starboard side against the wall of the forecastle. The crewmember was trapped between the forecastle's ladder and the beam trawl. This happened around 2 a.m. on Friday 20 November. The skipper on the bridge moved the port rig using the crane from which the fish rig was suspended, causing the starboard beam trawl to roll back and upright itself. This freed the crewmember who slumped to the deck and died later that day from internal injuries.

The victim's location during the accident.

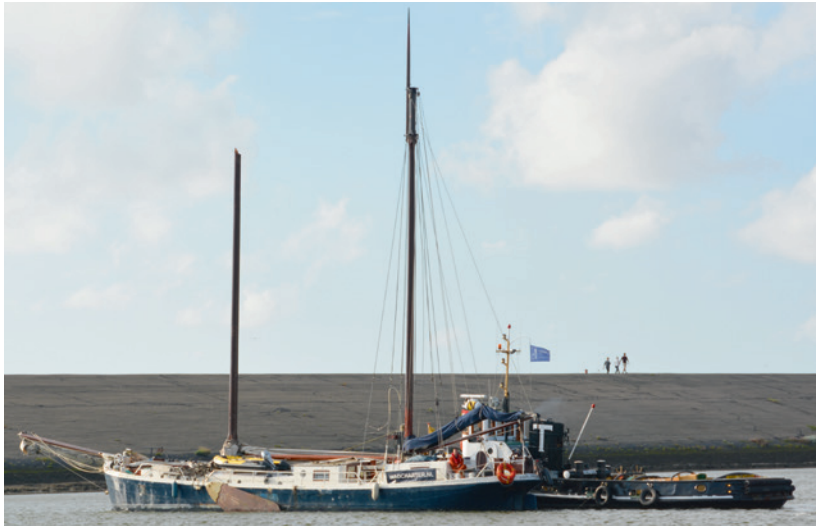
On 21 August, a Dutch sailing ship was sailing into the port of Harlingen when part of the fore mast suddenly broke off and fell on to the deck. Three German passengers lost their lives as a result. The sailing ship is part of the 'brown fleet'. These are historic ships that can be chartered for (day) trips and journeys with paying passengers.

The sailing ship in the port of Harlingen. (Photo: KLPD- National Police Services Agency)

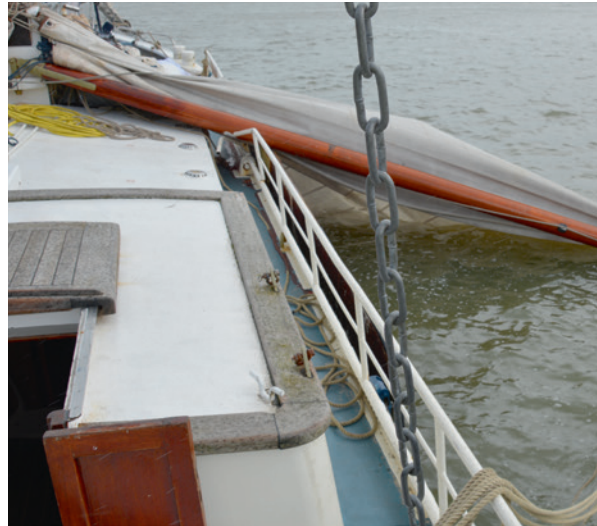
The boom of the mast overboard. (Photo: KLPD - National Police Services Agency)

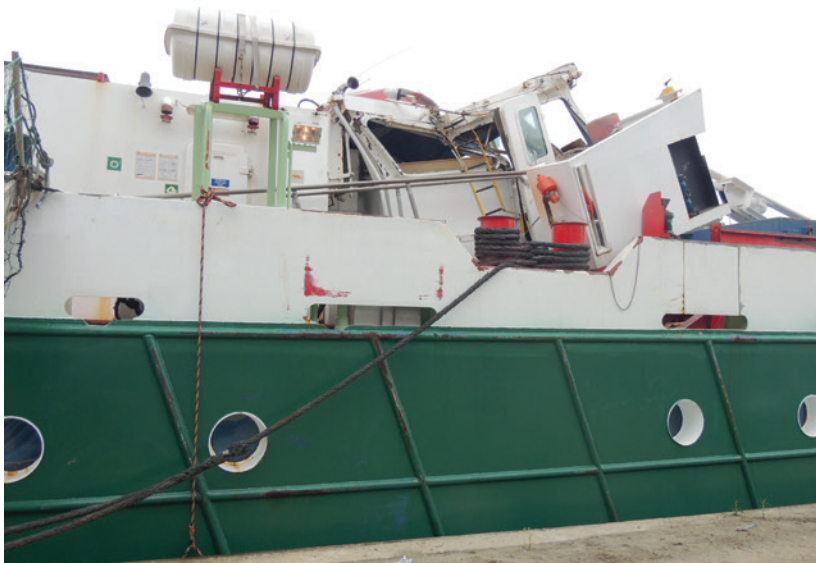
Left and right the damage to the wheelhouse of the Amadeus Amethyst.

on the Albert Canal in Antwerp (Belgium). As a result, the ship's wheelhouse was completely destroyed. The captain and the river pilot were in the wheelhouse at the time. The captain suffered minor injuries as a result of flying glass caused by the collision. The river pilot was seriously injured as a result of becoming trapped. After being checked over in the hospital, the river pilot appeared to have suffered a fractured pelvis.

The Dutch Safety Board carried out an initial investigation at the site. It found that the height-adjustable wheelhouse on the Amadeus Amethyst was not lowered to its lowest position. If this had been the case, the ship would have been able to sail under the bridge with a margin of one metre. In coaster shipping this is considered to be a safe margin.

The captain stated that the wheelhouse descended to the lowest setting slower than usual. This could indicate a technical malfunction related to the wheelhouse's lifting column.

The shipping company subsequently conducted a further technical investigation of the vessel along with the certification agency. It revealed that there was a defective

hose-rupture security feature. As a result, the height-adjustable wheelhouse lowered slower than usual. As an additional security measure, the shipping company decided to install an emergency lowering feature on this and its sister vessel. This feature is regularly applied in shipping and means that in an emergency the wheelhouse lowers immediately with one push of a button. It is only used in an emergency given the speed with which this happens in such cases.

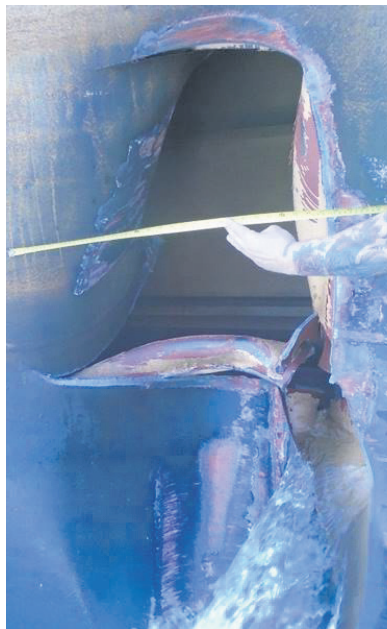
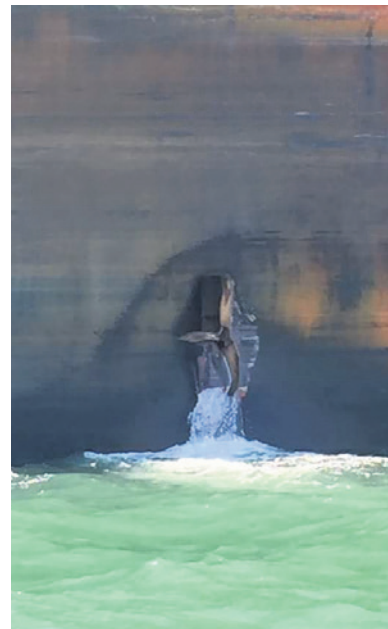
On Monday 25 July, at approximately 4.24 pm, a collision occurred in Algeciras Bay between the manoeuvring Turkish chemical tanker Dicle Deniz and the moored Dutch flagged ship Hanze Gendt. This caused damage to the Hanze Gendt's ballast water tank. It is suspected that the Dicle Deniz experienced engine problems. The shipping company Hanzevast Shipping dispatched a technical specialist; the Hanze Gendt will be out of action for a week for repairs to be carried out.

Left and right: Damage to the Hanze Gendt.

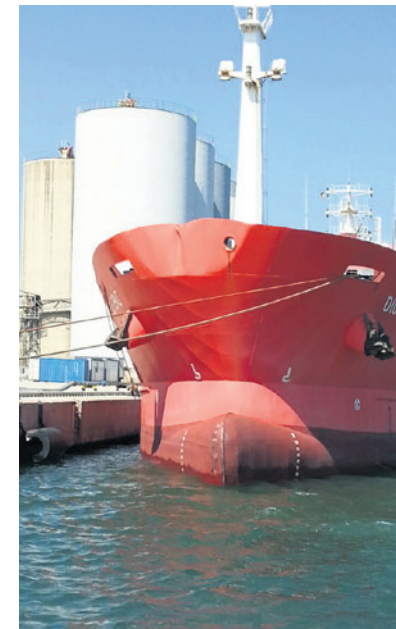
Damage to the Dicle Deniz.

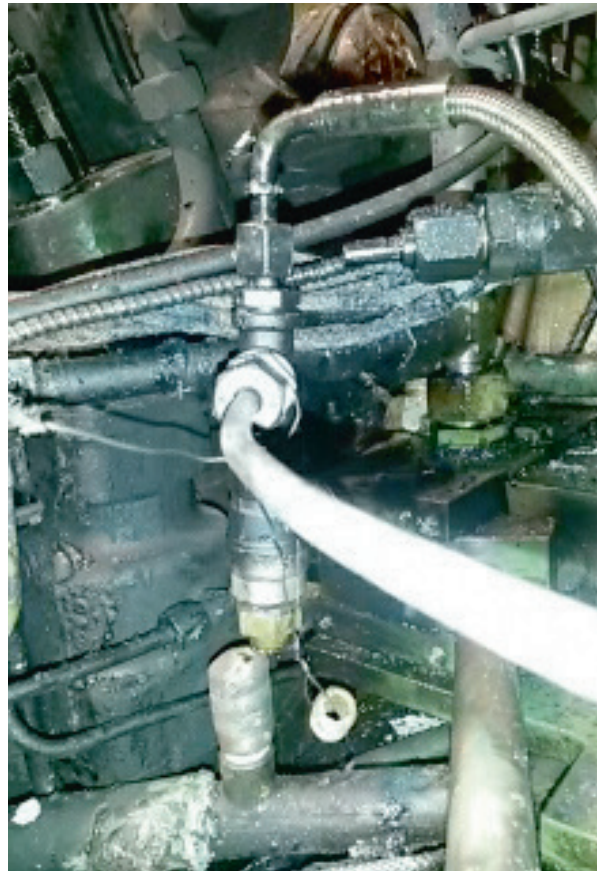
Broken fuel line.
