ONDERZOEKRAAD
VOOR VEILIGHEID

Collision in anchorage area

MS Arklow Rambler & MT Atlantic Jupiter, Maas
Approach, 8 February 2016

The Hague, February 2017

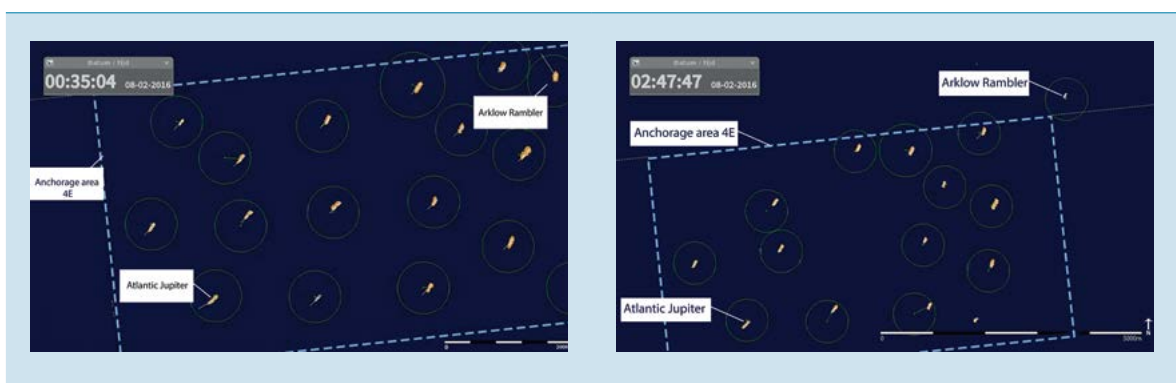
At 00:30 hours, the Arklow Rambler reported to Maas Approach VTS that the ship was anchored. At that time, it was almost spring tide.³ Because of this, the water was flowing at a speed of ± 2 knots in a northeastern direction. This, combined with the powerful southeastern wind, caused the Arklow Rambler’s anchor to begin to drag. At 02:09 hours, the Arklow Rambler, while being dragged, was blown out of the anchorage area in a northeastern direction into the nearby traffic lane (Figure 2).

Figure 2: Initial anchor position of the Arklow Rambler and the Atlantic Jupiter (left). After some time, the Arklow Rambler’s anchor began to drag and it ended up in the traffic lane north of the anchorage area (right) (Source: Radar images from the VTS Port of Rotterdam).

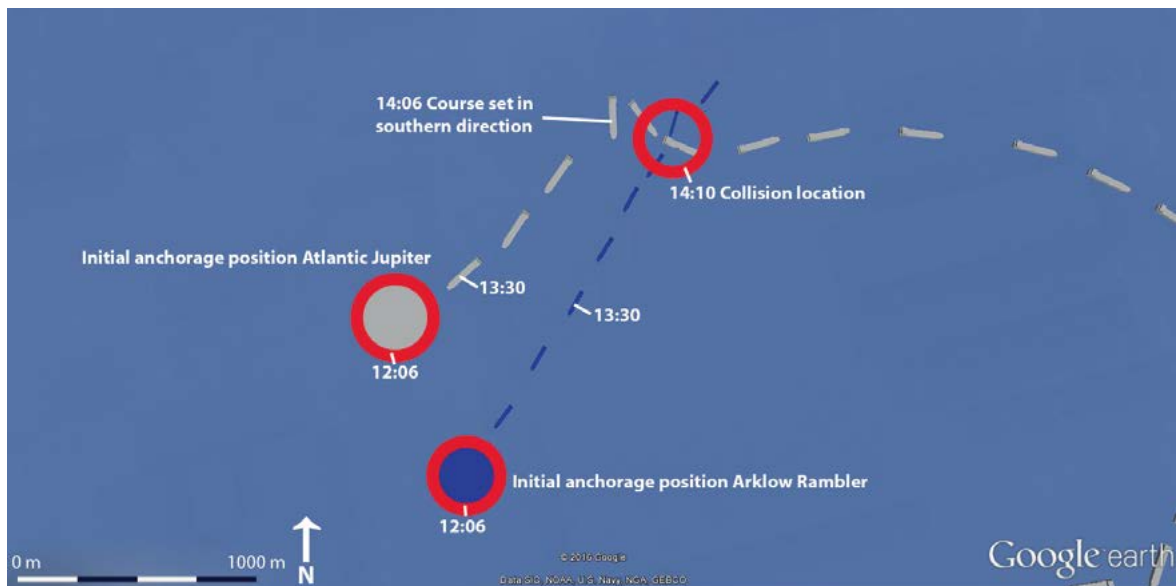
Figure 3: The ships were dragged backwards out of the anchorage area, after which the Atlantic Jupiter hoisted anchor and planned to sail south. While executing this manoeuvre, the Atlantic Jupiter hit the Arklow Rambler. (Source: Google Earth)

The Atlantic Jupiter and the Arklow Rambler were dragging parallel with one another in a northeasterly direction. The Atlantic Jupiter was dragging at a greater speed than the Arklow Rambler. This brought the Atlantic Jupiter to a position even with the Arklow Rambler. The Atlantic Jupiter felt that it was drifting too far; it was decided to raise anchor and sail to the south of the anchorage area. Because the VDR of the Atlantic Jupiter was not operating at the time of the accident, it is not known exactly what happened on board the Atlantic Jupiter. It is clear that the Atlantic Jupiter, immediately after the anchor was on board, attempted to sail in a southerly direction. This brought the Atlantic Jupiter into a lateral position with regard to the wind and current in front of Arklow Rambler, at a low forward speed. Because the ship was empty, it had a lot of surface area that caught the wind and it was subsequently blown in the direction of the Arklow Rambler, after which the stern of the Atlantic Jupiter hit the bow of the Arklow Rambler.

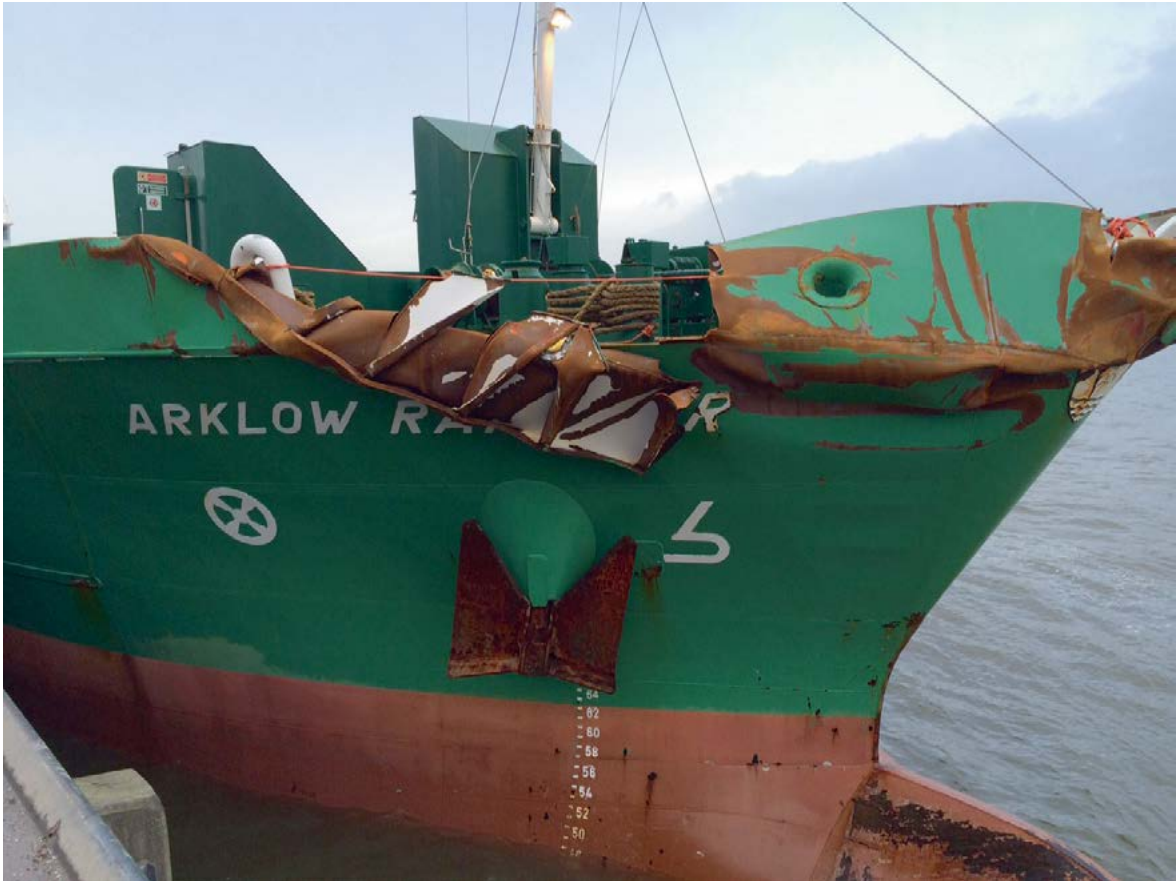
At 14:10 hours, the stern of the Atlantic Jupiter hit the bow of the Arklow Rambler. The bow of the Arklow Rambler was dented and small holes appeared above the waterline (Figure 4). The blow tore open the hull of the Atlantic Jupiter at the level of the machine room, causing a 15-metre long horizontal gash above the waterline (Figure 5).

Figure 4: Damage to the bow of the Arklow Rambler. (Source: Dutch Safety Board)

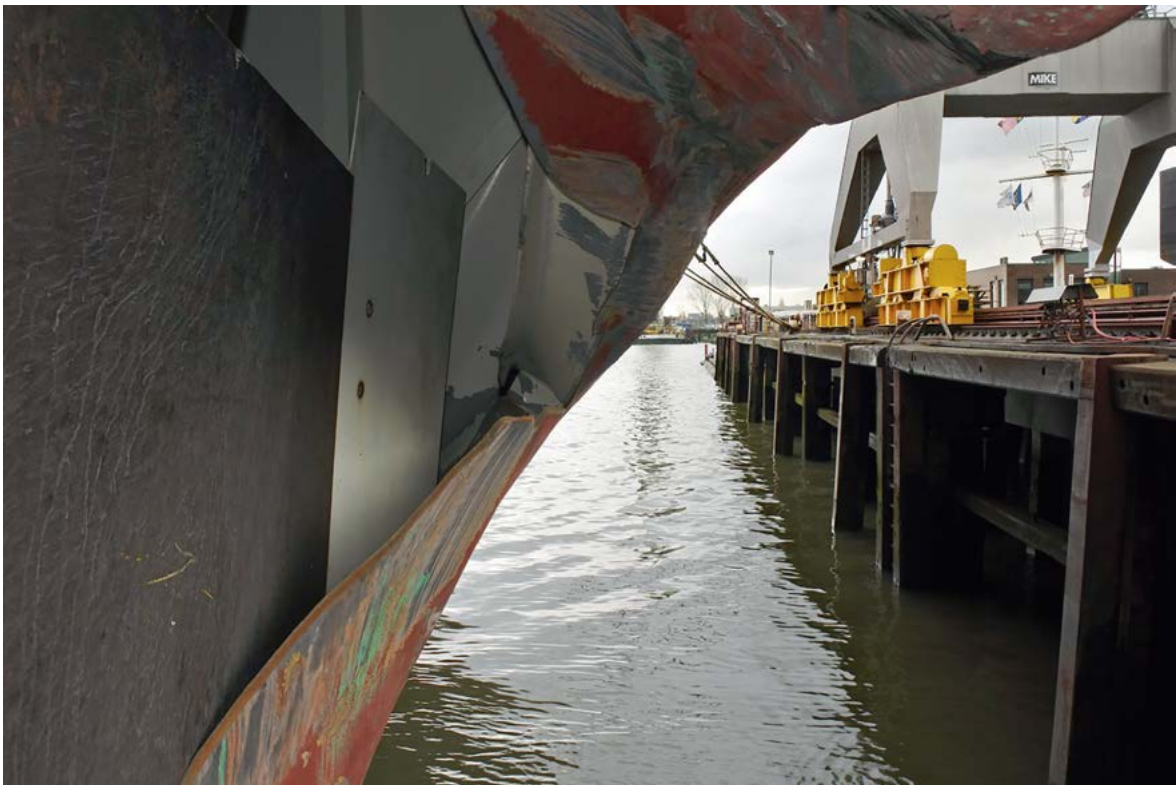
Figure 5: From inside the Atlantic Jupiter, looking out through the 15-metre long gash. (Source: Dutch Safety Board)

Because of the size of the hole, the crew of the Atlantic Jupiter was unable to close the hole in their ship and they ran the risk of taking water. Yet they did not feel it any urgency to enter the port. After the accident, the crew sailed with a hole in the ship for nine and a half hours. Despite the state of the ship, the crew did not feel they were unsafe. The main reason was that the hole was above the waterline.

However, given the turbulent weather, the hole in the Atlantic Jupiter did pose a risk. The Port of Rotterdam has procedures for cases where a ship is in need. Despite the fact that the Atlantic Jupiter had not followed the standard registration procedure - it had not been planning to enter the Port of Rotterdam - with the emergency procedure it would have been able to acquire a spot in the port if the urgency had been communicated clearly. Moreover, according to the SMPEP,⁶ it is customary for a ship that has incurred damage after a collision to sail (if it still can) to a suitable location for repairs.

- Take no unnecessary risks by continuing to sail with major damage to the ship: find a safe port as soon as possible. Extra costs associated with this should not outweigh the safety of the crew.

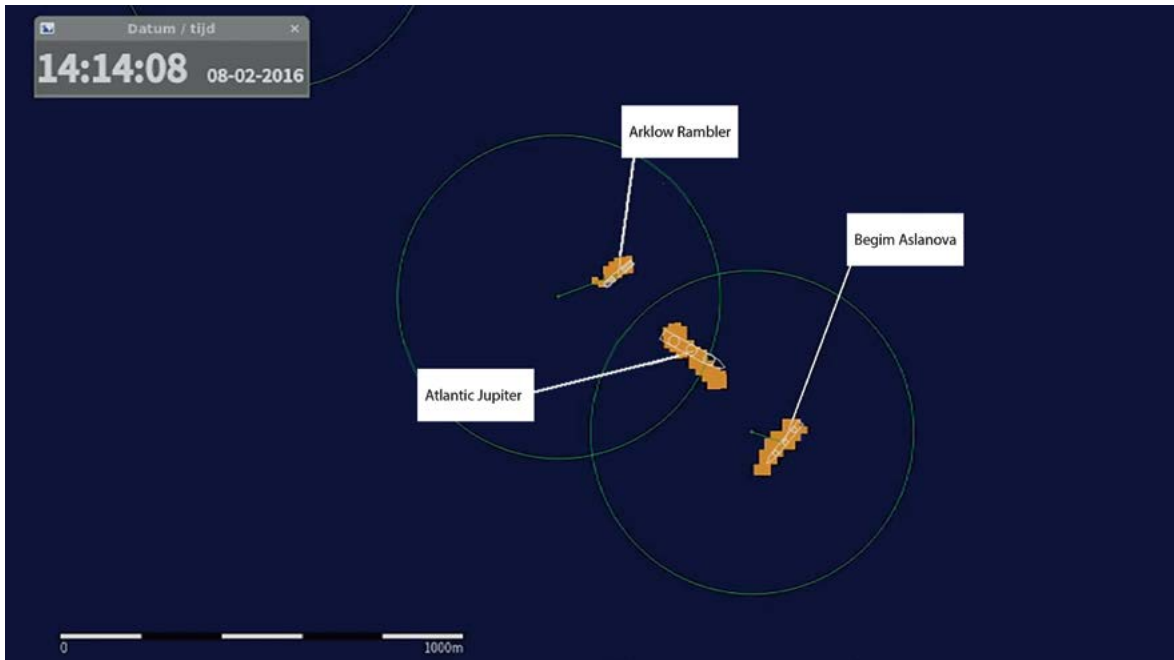
Figure 6: The Atlantic Jupiter is headed toward the Begim Aslanova after an earlier collision with the Arklow Rambler. (Source: Radar images from the VTS Port of Rotterdam).

At 14:12 hours, a nearby ship (the Begim Aslanova), also anchored there, hailed the Atlantic Jupiter on the Maas Approach VTS working channel and requested that the Atlantic Jupiter pass behind (Maritime radio conversation 1). There was no response. The concerned ship made three subsequent calls on maritime radio channel 16. Maas Approach VTS also attempted to make contact with the Atlantic Jupiter at 14:13 hours. The Atlantic Jupiter responded to this and confirmed that it would navigate behind the Begim Aslanova. At approximately 14:16 hours, the Atlantic Jupiter passed behind the Begim Aslanova at a distance of 0.1 nautical miles.

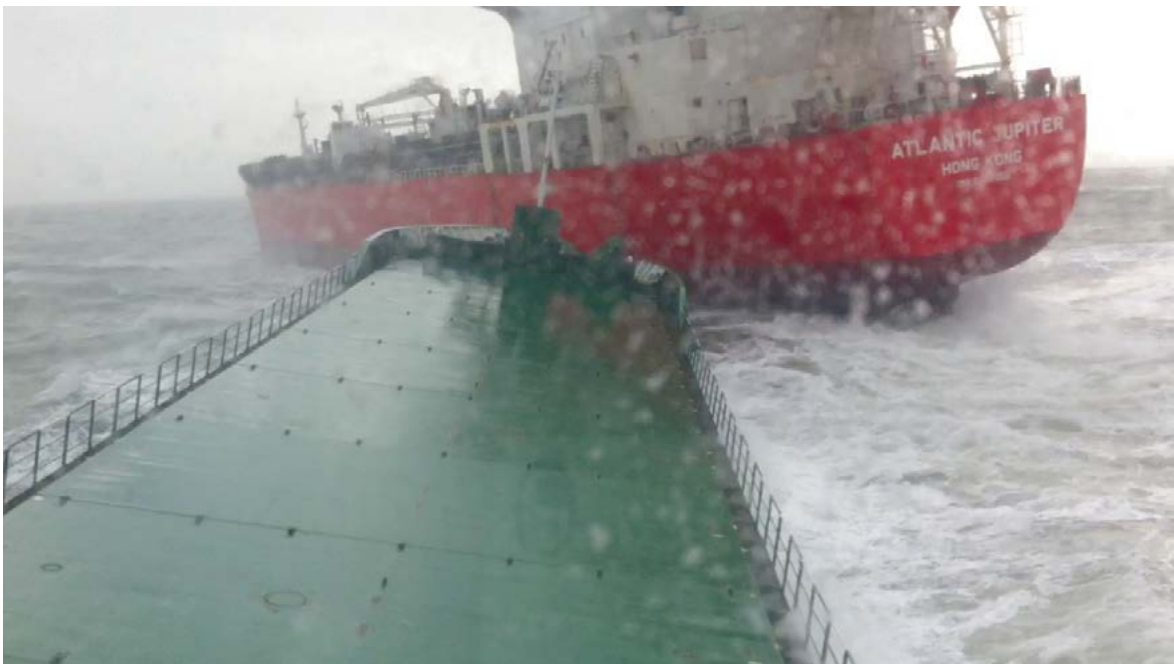
Figure 7: Just prior to the collision, viewed from the bridge of the Arklow Rambler. (Source: Arklow Shipping)

At the time of the collision, the Arklow Rambler was still at anchor, with its engine on stand-by. Although the crew of the Arklow Rambler saw the accident coming approximately 3 minutes beforehand, the captain decided not to send his crew forward to lift anchor because the Atlantic Jupiter was going to hit the Arklow Rambler at that point of the ship and he did not want to put his crew into danger. In addition, the chance that they would be in time to avoid the collision was small.
