Date: November 18, 2013

UNEXPECTED AUTOPILOT BEHAVIOUR ON ILS APPROACH

Potential severe pitch-up upset when intercepting the instrument landing system (ILS) glide slope from above, which can lead to (approach to) stall conditions.

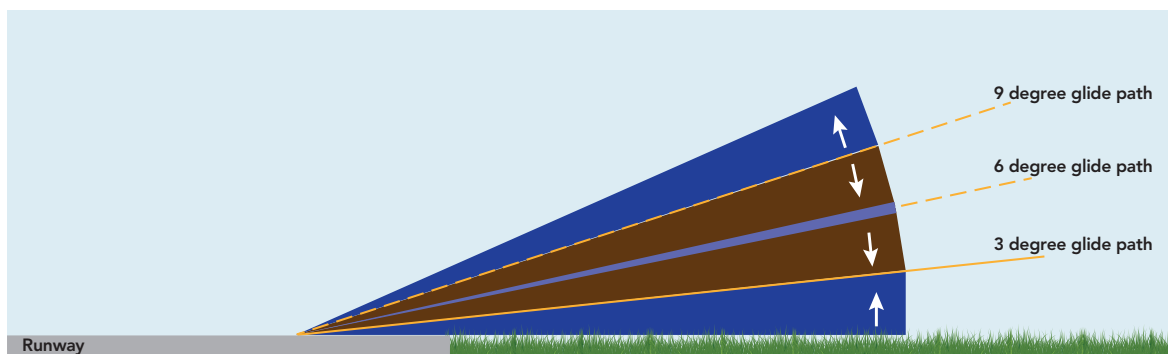
1. A signal reversal was always present at approximately 9 degree glide path.
2. A signal reversal was sometimes present at approximately 6 degree glide path.¹

Figure 1: Cross section view of the M-array ILS antenna system. Schematic overview of the "Fly up"(blue) and "Fly down"(brown) indication.

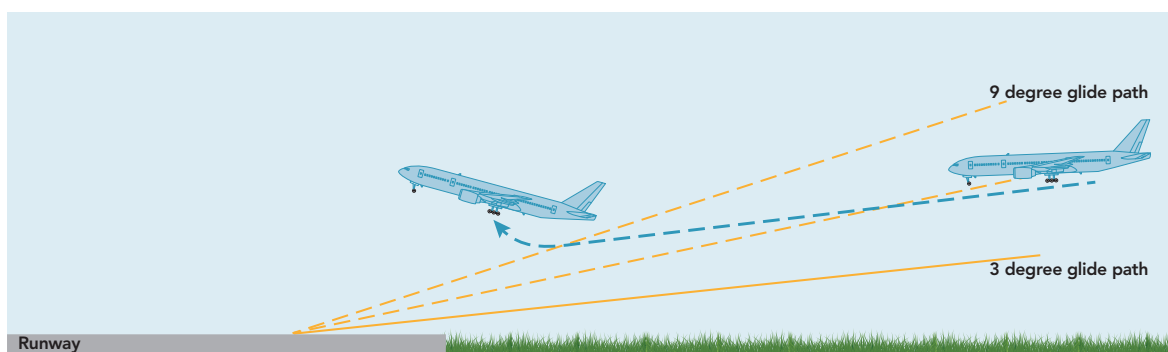
Figure 2: Example of glide slope capture with a pitch upset above 3 degree glide path.

Depending on the glide slope field, signal reversal occurs occasionally at 6 degree, and always at the 9 degree glide path. This reversal activates the glide slope capture mode after which the autopilot follows the glide slope signal without restrictions. During flight tests the reversal resulted in the automatic flight control system commanding a severe pitch-up. Immediate flight crew intervention was required to regain aircraft control.

Pilots should be aware of the ILS glide slope signal characteristics and the dangers accompanying flying in the area above the 3 degree glide path during the approach. In particular the aircraft behaviour while flying on autopilot with the glide slope mode armed should be noted.

Operators should consider the need to implement additional operational procedures or provide additional guidance in order to mitigate the risks of unexpected autopilot behaviour when on ILS approaches.
