DUTCH
SAFETY BOARD

Traffic in vicinity of departing commercial traffic

Airspace Eindhoven Airport, March 2012

The Hague, September 2013

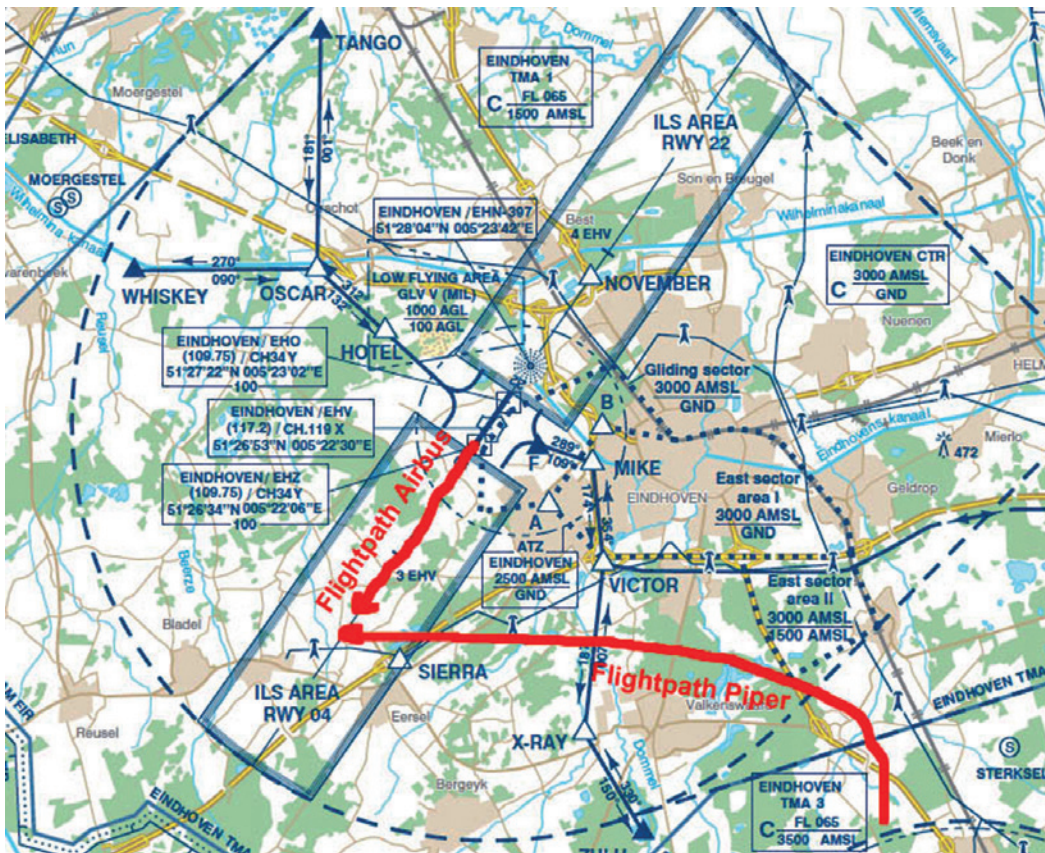
Figuur 4: Routes of traffic involved.

Because of the heading of D-IBGC the ATC controller ordered HA-LWK to keep flying on runway heading (southwest) and to climb to FL090 initially, given they had visual contact on D-IBGC. Just before crossing the Eindhoven runway, D-IBGC made a left turn towards the west in the direction of Seppe airfield. The Dutch Mil ATC controller did not notice this turn initially.

After HA-LWK switched radios to Dutch Mil Info, both aircraft were on different frequencies and were unable to form a mental picture of the position of the other traffic. The ATC controller then noticed that D-IBGC had turned to the left and was now flying a westerly course, causing it to cross the flight path of HA-LWK. The controller informed both crews on separate frequencies about the presence of the other aircraft and ordered D-IBGC to fly a heading of 360, a heading that seemed most logical to him at the time. He then ordered HA-LWK to stop the climb at 3000 feet if the crew did not have visual contact with D-IBGC. The ATC controller preferred not to give explicit orders to turn because he thought it would be best if the crew reacted to what they saw themselves.

Both flight paths were crossing. HA-LWK received the instruction to maintain 3000 feet unless they were visual on the other aircraft, flying at 3500 feet. Because they were visual, the crew continued the climb and then received a TCAS RA warning to which they reacted. The minimum separation distance was 0,5 nm (0,9 km) laterally and 300 feet vertically.

The ATC controller was unaware of the freedom of movement of D-IBGC within the SRZ, and the potential danger and closing speeds of the two aircraft. He instructed D-IBGC to make a right hand turn to the north, causing it to fly directly towards HA-LWK. The crew of D-IBGC did not see HA-LWK until they had changed their heading. They then warned the ATC controller that the heading change to the north was not such a good idea.
