DUTCH
SAFETY BOARD

Quarterly Report Aviation

July-September 2016

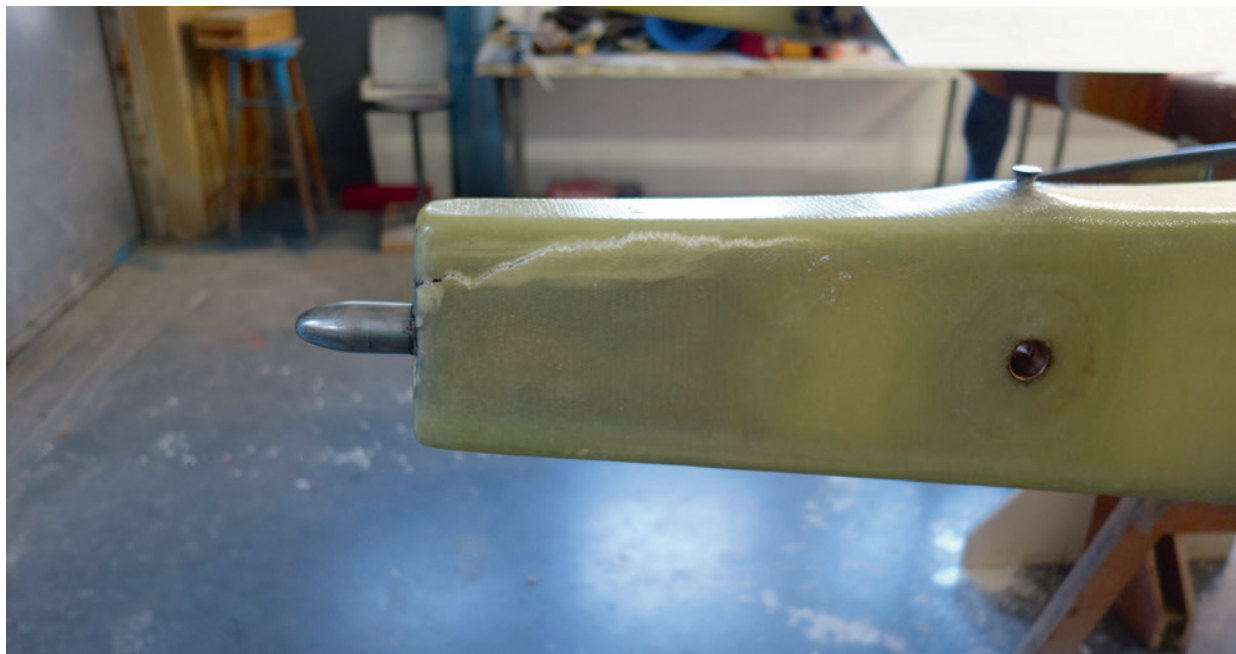
After a flight of more than an hour, the pilot decided to perform several loopings. At that point, the glider was at an altitude of approximately 700 metres. The pilot stated that he increased speed to 180 km/hr and gradually initiated the looping. The first looping went without incident. He then initiated the second looping in the same manner. During the last phase of this looping, when the aircraft was flying horizontally once again, the pilot heard a loud bang behind him. However, the pilot still had full control over the glider, so he flew an alternative circuit before landing safely. A subsequent inspection revealed damage to the left wing spar.

The tear in the left wing spar of PH-1006. (Photo: Flying club)

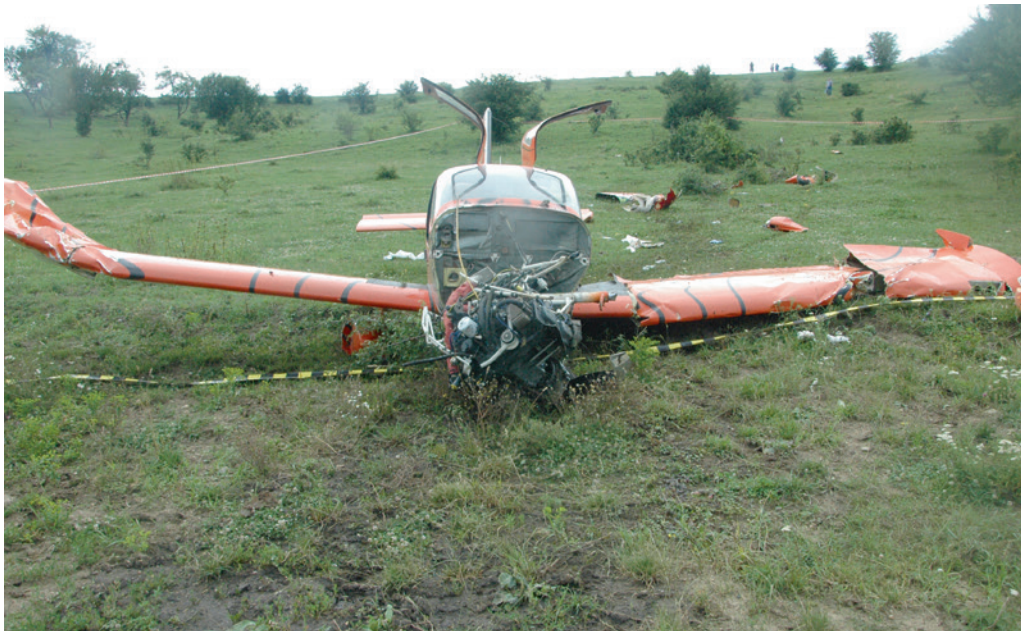
During the take-off for a local flight from Magura airport (Romania), the single engine, propeller aeroplane failed to leave the ground in time and came into contact with vegetation at the end of the runway. The aeroplane then came to a stop beyond the end of the runway, and suffered serious damage. Of the four occupants (the pilot and three passengers), one of the passengers sustained an injury.

PH-BRT after the accident. (Photo: CIAS)

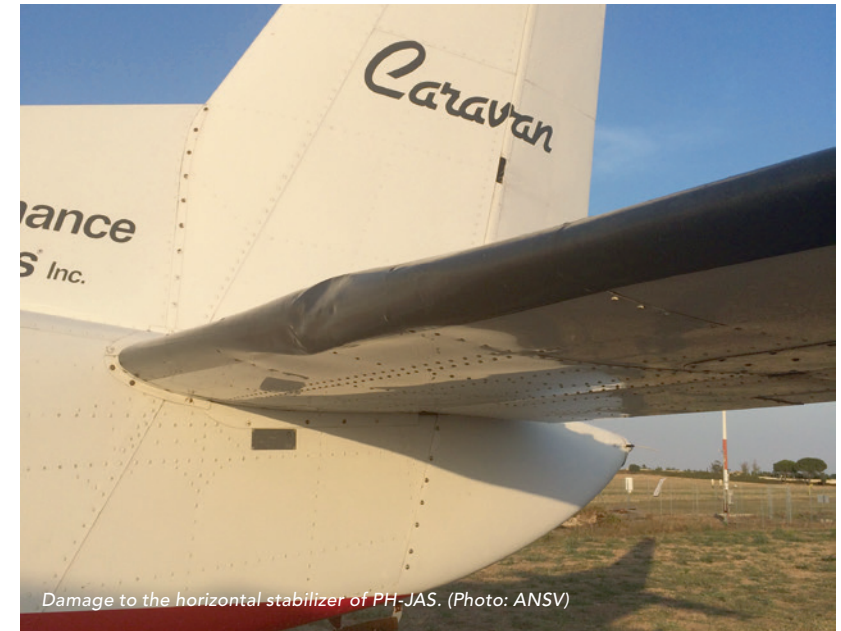
The Cessna C208 had taken off on a local flight, to drop parachutists. While a parachutist was leaving the aircraft, his main parachute opened prematurely, causing him to be pulled out of the aircraft. As a result, he hit the left horizontal stabilizer and broke a leg. The aircraft landed normally, but a subsequent inspection revealed damage to the left horizontal stabilizer.

Damage to the horizontal stabilizer of PH-JAS. (Photo: ANSV)

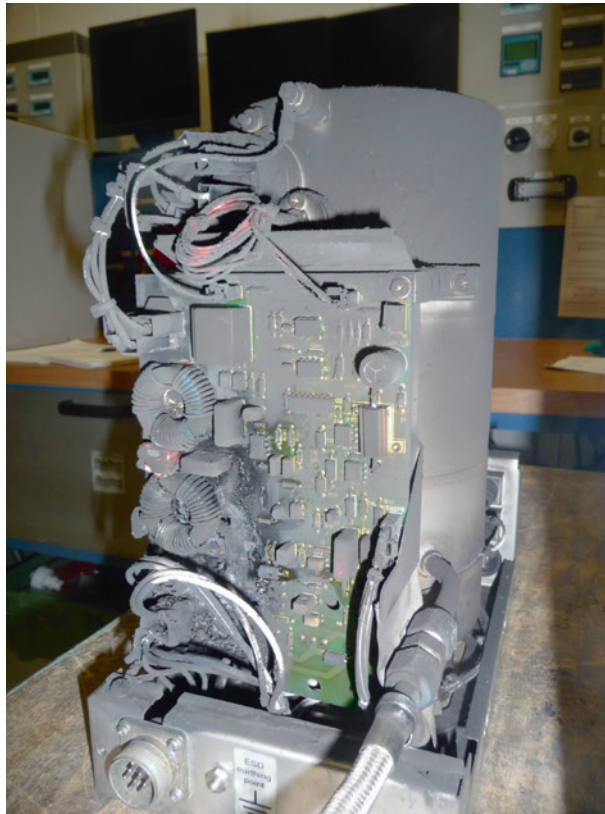
During the cruise phase of flight, from Taichung (Taiwan) to Macau (China), a crew member saw smoke emerging from part of the rear galley of the Airbus A320. She also smelled something burning. The crew member discovered that the smoke was coming from a water heater and decided to pull the fuses of the water heater and other cooking appliances in order to shut off the power. A halon fire extinguisher was then used at the point from which the smoke was emerging. Following these actions, no more smoke emerged and the flight continued to Macau airport, where the aircraft landed safely.

Damage to the water heater.

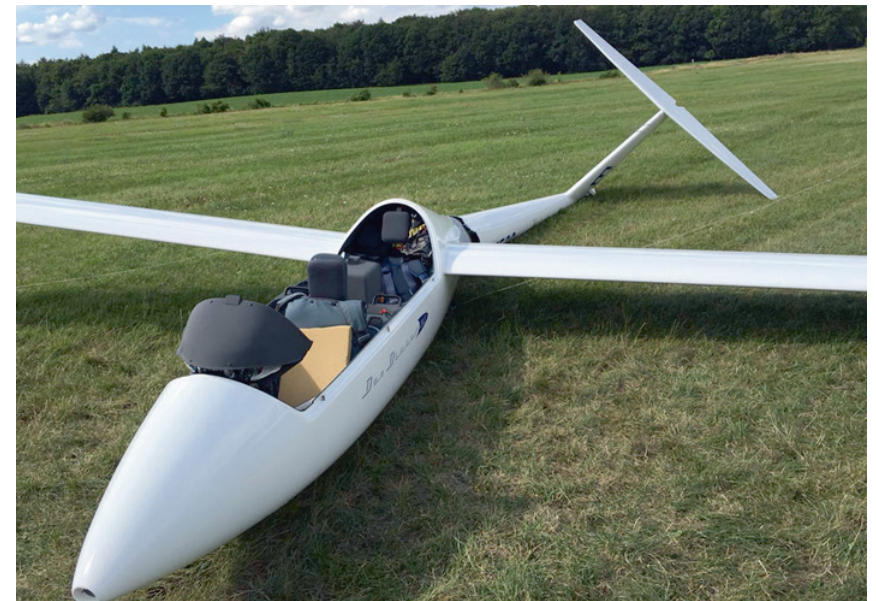
During a winch launch, airspeed fell quickly at low altitude causing the glider to stall and make a hard landing. The person sitting in front, who was also the pilot, suffered serious back injuries as a result. The person sitting in the rear seat was uninjured. The glider was badly damaged.

PH-1529 after the accident. (Photo: Gliding club)

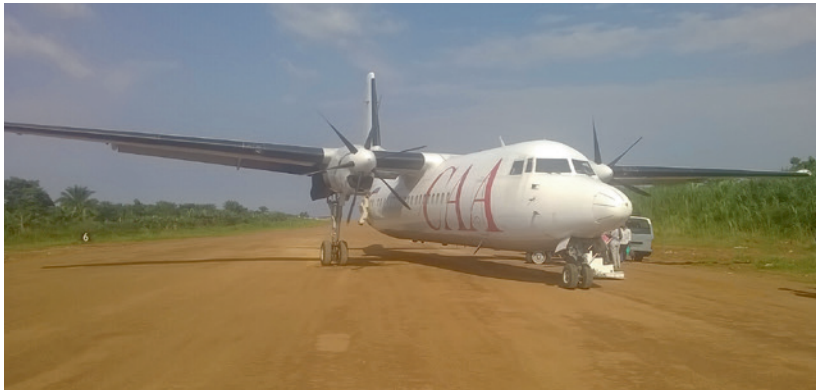
9Q-CBL after the occurrence. (Photo: BPEA)

During the roll-out after landing, the crew experienced brake problems, after which the aircraft lurched to the left and came to a stop on the runway. None of the occupants were injured. The aircraft suffered damage to the left main landing gear.

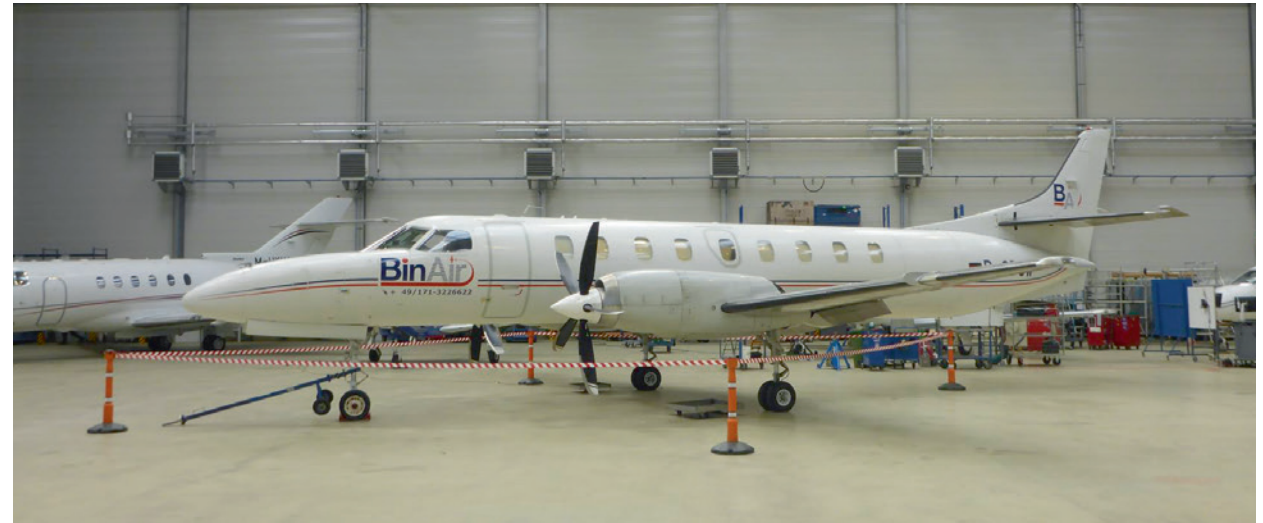
The Metro III in a hangar after the occurrence. (Photo: BFU)

At the end of a flight from Skopje (Macedonia) to Cologne Bonn Airport, the aircraft experienced a runway excursion after landing, suffering slight damage. Both crew members, who are Dutch nationals, were unharmed.

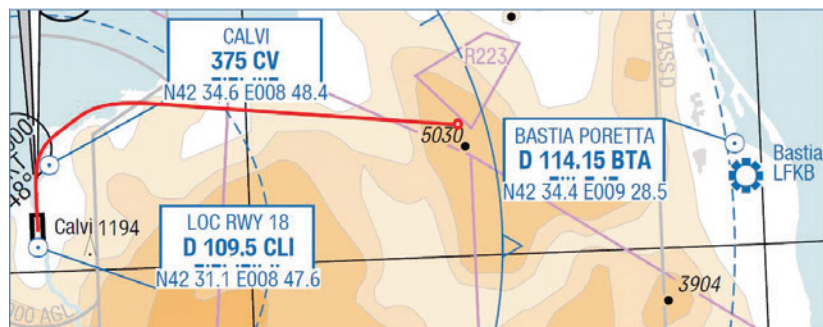
The flight path (red line) of N717ND.
(Photo: BEA)

The direct cause of the accident was the pilot's decision to continue the flight into the clouds, without being aware of the height of the terrain. At the site of the accident, visibility was almost zero, and the highest elevation in this area (which is marked on the VFR map) is 5,036 feet.

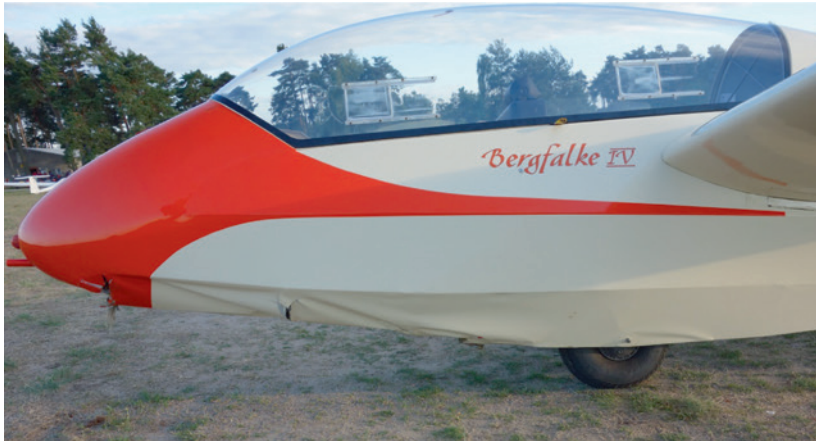
The underside of the nose was bent, back as far as the main wheel, and ten-centimetres-long tears were visible in both wings, at the edge of the air brake housing. The elevator pushrods and the air brake control mechanism were also damaged.

Damage to the nose of the Bergfalke. (Photo: BFU)

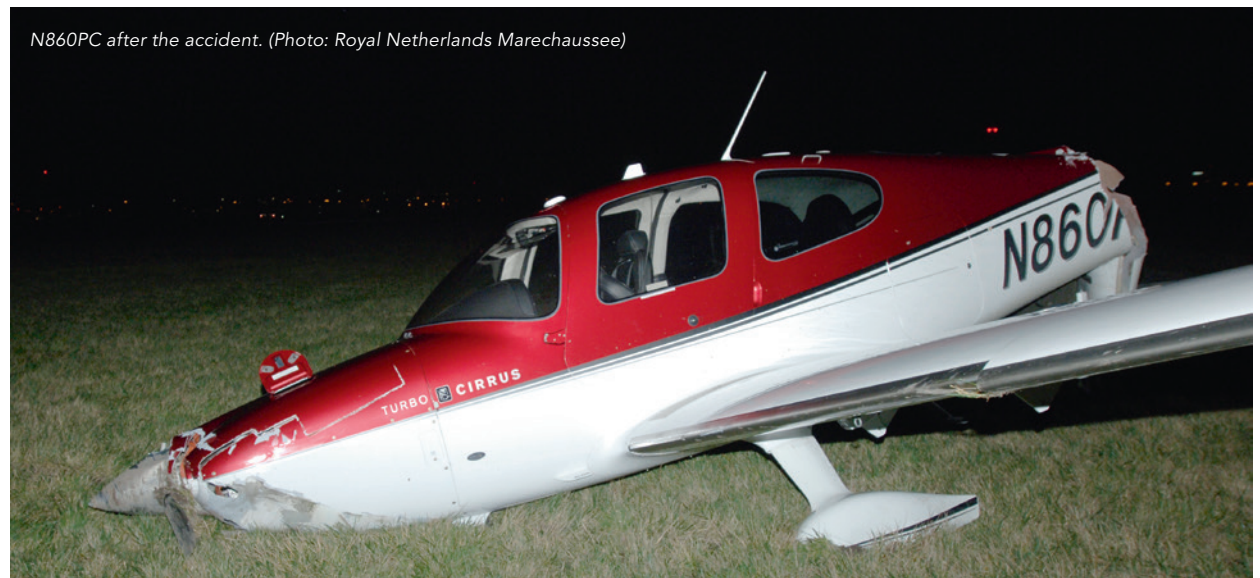
to initiate a go-around. During this go-around, the airspeed fell below the stall speed and the pilot made insufficient use of the rudder pedals to compensate for the yawing effect generated by the propeller's prop wash. The pilot then tried a stick displacement in an effort to stop the yawing motion. However, this failed to have the desired effect. The left wing and left main landing gear contacted the runway, and the aircraft eventually came to a stop about 50 metres south of the runway. As a result, the aircraft was irreparably damaged.

N860PC after the accident. (Photo: Royal Netherlands Marechaussee)

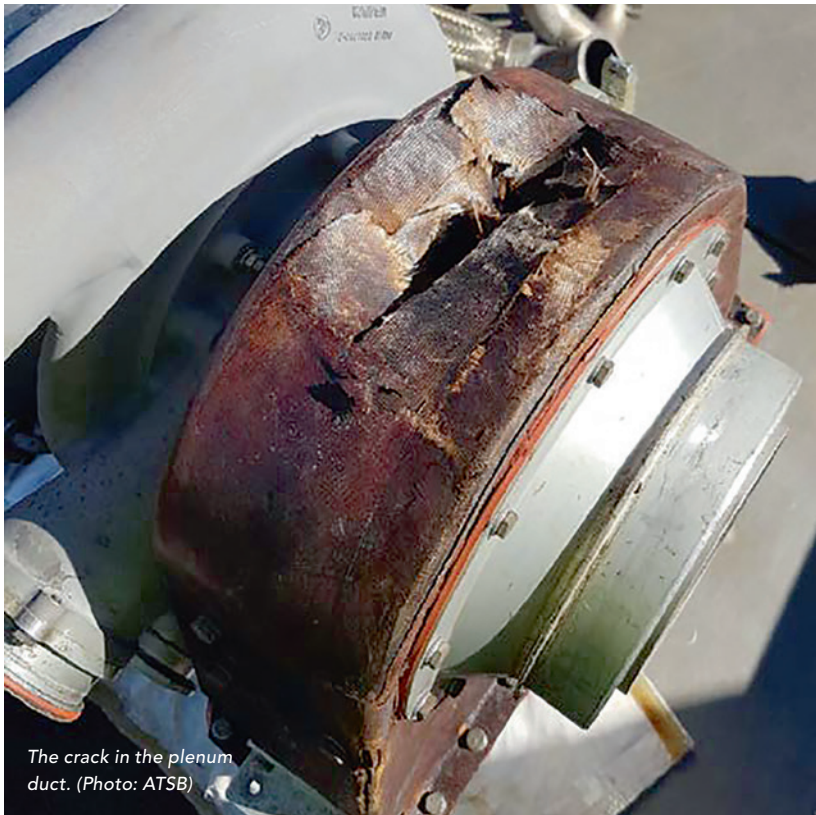
In tests conducted by a maintenance crew, the piping of pack 2's recirculation system was found to have developed a leak. As a result, Pack 2 was not able to maintain cabin pressure altitude at the correct level. A crack was found in pack 1's plenum duct. This led to an outflow of overly warm air from pack 1. This, in turn, activated the compressor outlet overheat switch, causing pack 1 to switch itself off. The plenum duct developed a crack at FL305, which caused the whooshing sound. As Pack 1 is located beneath the cockpit, near the forward toilet, this seemed to be the source of the problem. The captain stated that the whooshing sound was very similar to the sound that he had heard in flight simulator exercises involving decompression scenarios. The flight crew stated that, having completed practice sessions in flight simulators, involving scenarios of this kind, they had sufficient mental capacity to deal with other complications during the flight.

The crack in the plenum duct. (Photo: ATSB)

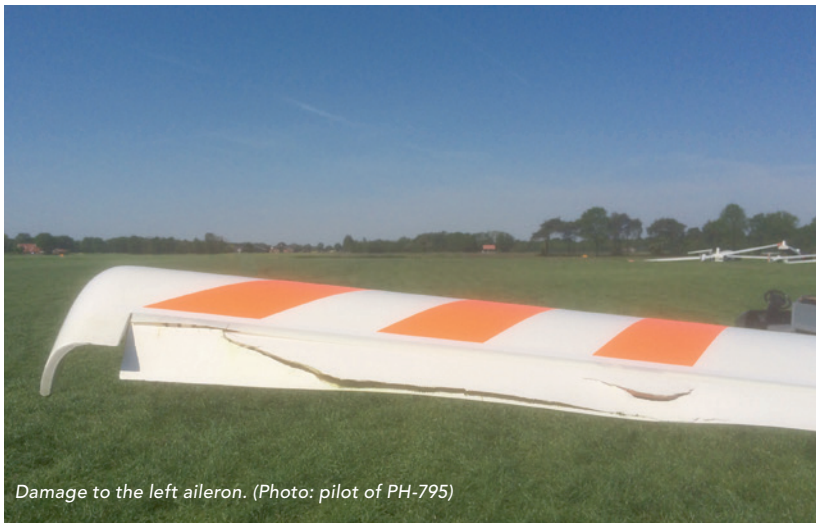
The pilot had completed a local flight, lasting about 10 minutes, after which he joined the circuit pattern. The wind was blowing from a direction of 000-020, at a speed of 12 to 13 knots, and was occasionally gusty. The landing direction was eastwards. On the final approach leg, the glider encountered turbulence. The landing was normal but, during the roll-out, the gusting crosswind caused the pilot to lose control of the aircraft. The wind caused the glider's nose to swing to the left, resulting in a ground loop during which the aircraft turned through 180 degrees and came to a stop with its nose pointing in the opposite direction. During the ground loop, the left aileron was damaged and the tail skid was ripped off. The pilot was uninjured.

The pilot stated that the ground loop was most likely caused by a strong gust of wind, at exactly the moment the aircraft landed or shortly thereafter, which could not be corrected for, even with full rudder.

Damage to the left aileron. (Photo: pilot of PH-795)

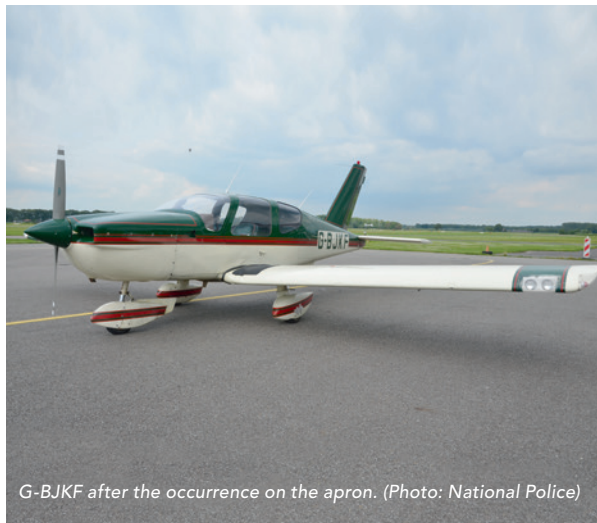
G-BJKF after the occurrence on the apron. (Photo: National Police)

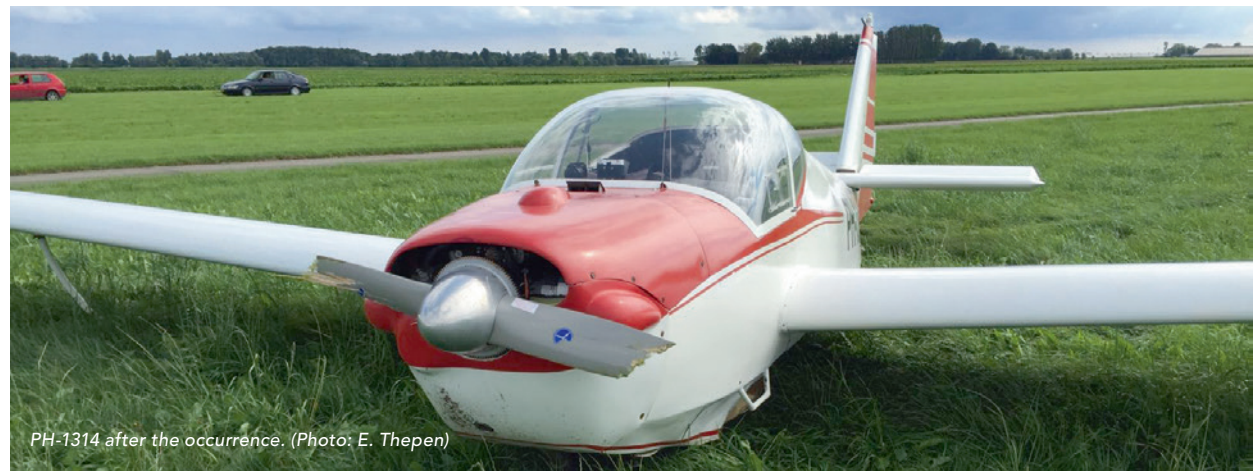
the air-brake handle. Using his right hand, he selected engine power. In this type of aircraft, when the air-brake handle is released, aerodynamic pressure and a spring system cause the air-brakes to fold down. However, as the go-around was initiated, airspeed had fallen to the point that, as he selected engine power, the pilot felt the aircraft sink and, moments later, it hit the ground hard. This resulted in damage to the propeller and to the main wheel. The pilot was uninjured.

PH-1314 after the occurrence. (Photo: E. Thepen)

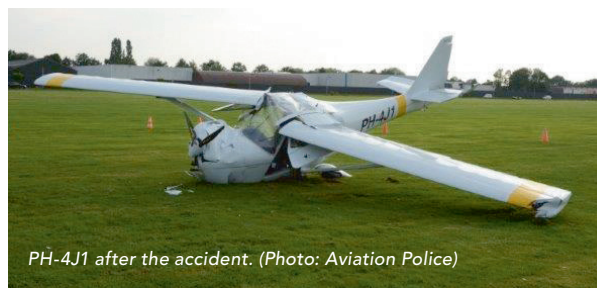
PH-4J1 after the accident. (Photo: Aviation Police)

the MLA was bumping along the grass runway, after which he tried to push the stick forward to gain speed. Next, according to him, the aircraft took off and climbed too quickly. The owner stated that the MLA rotated at too low a speed and too high a pitch attitude. He attempted to regain control, by taking over the stick, but this had no effect. At a low height the aircraft's right wing stalled. The aircraft turned approximately 180 degrees and came to a forceful stop in the opposite direction, on the grass runway. Both occupants were injured. The aircraft was badly damaged.

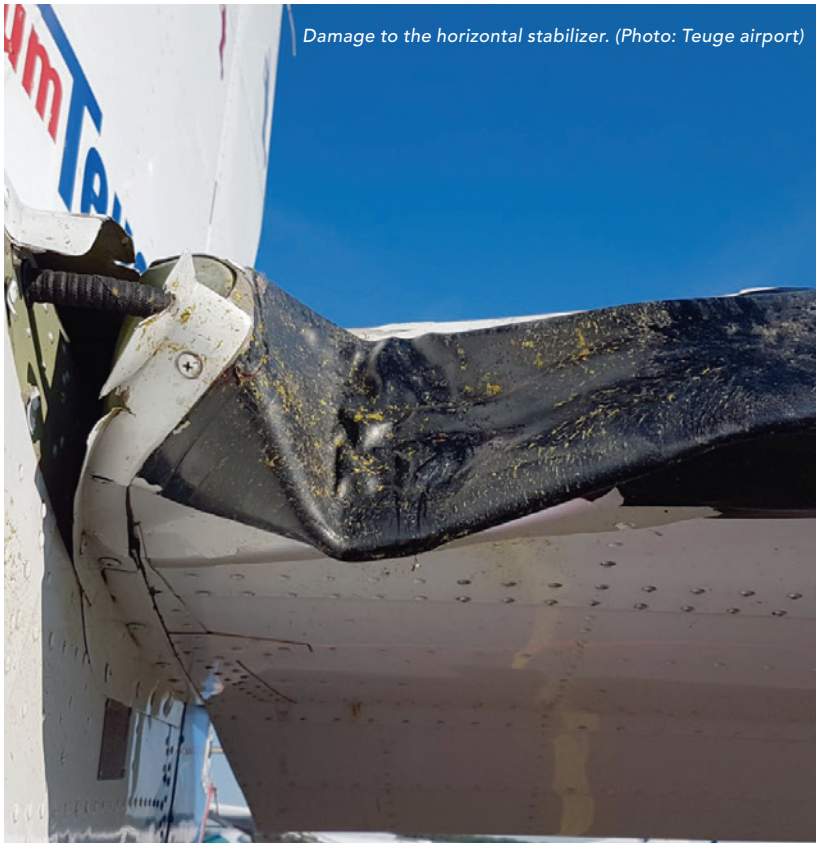
The Cessna 208 Caravan took off in the morning, from Teuge Airport, with a pilot and six parachutists on board. The purpose of the flight was to drop these parachutists near the airport area. The aircraft was monitored during take-off by the airport's Airside Operations Manager. The latter observed a flock of geese flying across the runway, just after the aircraft became airborne. One of the geese hit the aircraft and dropped onto the runway. The pilot of the Cessna 208B was contacted and informed that he had suffered a bird strike. Airport operations advised him not to put unnecessary strain on the aircraft, as the severity of the damage was still unknown. After dropping the six parachutists, the Cessna landed safely at Teuge and taxied directly to a maintenance hangar. It was found to have suffered damage to the left horizontal stabilizer.

Damage to the horizontal stabilizer. (Photo: Teuge airport)
