DUTCH
SAFETY BOARD

Airproxes near Lelystad Airport

The Hague, February 2022

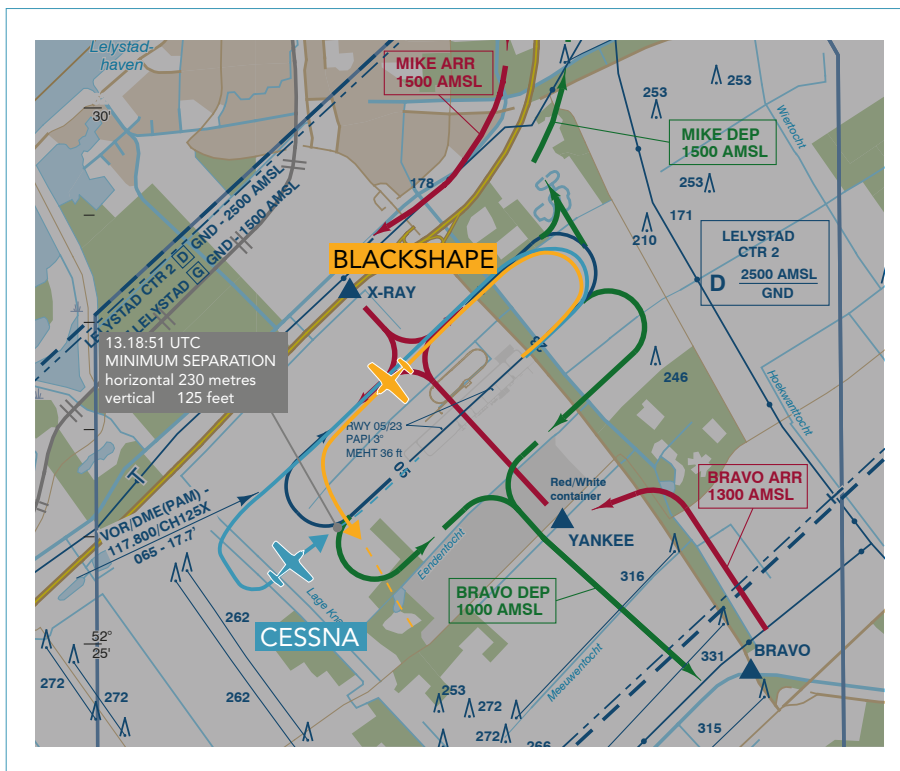
Figure 3: Occurrence 1, on final Runway 05. (Source chart: AIP Netherlands)

Special VFR conditions²⁶ were in effect. It was busy on the tower frequency. The pilot of the Blackshape reported on downwind for Runway 05, to which ATC replied to expect a late clearance due to traffic on the runway. The pilot replied with 'copy'. The Cessna, with an instructor and student on board, flew an extended downwind for Runway 05. There were two other aircraft (Socata TB 10 (PH-DFE) and Socata TB 9 (PH-AIS)) on final in front of the Cessna. The air traffic controller used the same sounding abbreviations for the call signs of the Blackshape (ISA) and the Socata TB9 (AIS). When the Cessna flew on final and was still maintaining 500 feet, ATC cleared the aircraft, being number one, for a touch-and-go. At the moment the crew wanted to descend, the Blackshape had turned to base leg and crossed underneath the Cessna. The Blackshape's pilot reported: 'Proceeding straight ahead, traffic on final in sight.' The instructor, on board the Cessna, estimated the vertical separation between both aircraft to be 200 feet. As an evasive manoeuvre, the Blackshape continued his heading in a south-easterly direction. The Cessna made a touch-and-go. See Figure 3.

The Dutch Safety Board classified this occurrence as a *serious incident*, because there was an acute risk of collision between the two aircraft and one of the pilots had to make an evasive manoeuvre.

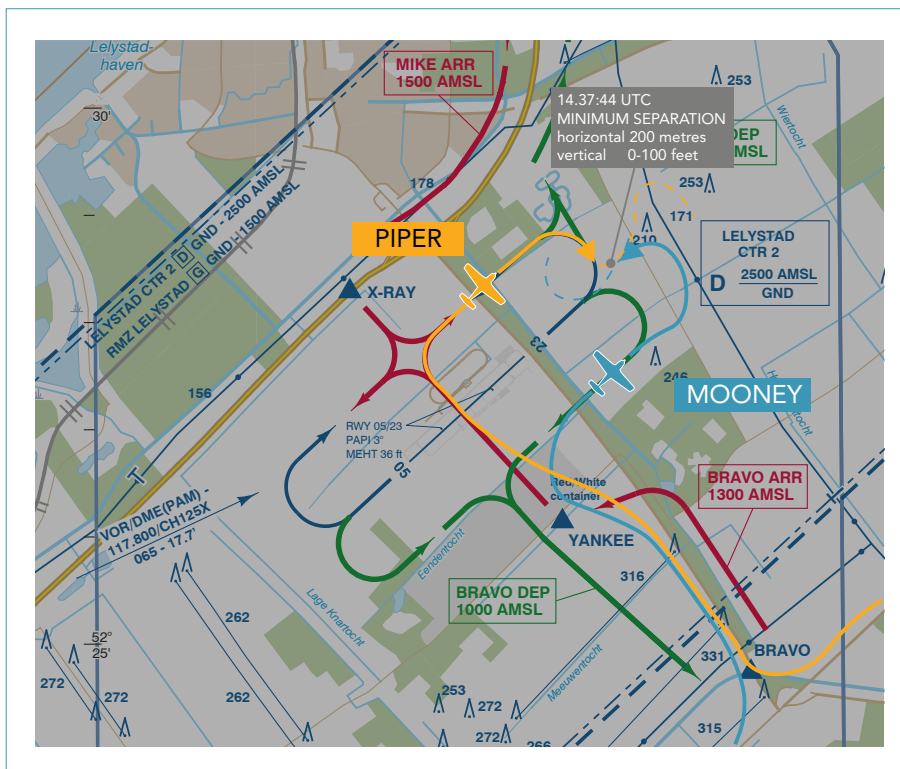
Figure 4: Occurrence 2, on final Runway 23. (Source chart: AIP Netherlands)

Runway 23 with a right-hand circuit was in use. Both aircraft were cleared for the BRAVO arrival route. The Piper, flying in front, flew via point YANKEE over the runway and flew the prescribed right-hand circuit (see orange line in Figure 4), as cleared. The Mooney started its descent from 1,300 to 1,000 feet between BRAVO and YANKEE. Then it made a right turn immediately after point YANKEE and flew a left-hand circuit (see blue line). The next part of a radio call was partially blocked: '(...) traffic who is opposite me on same altitude also on downwind²⁷.' At the moment ATC observed the Mooney on final, it was instructed to make an orbit over right. Other traffic on downwind was then instructed to make a left-hand orbit. The Piper's pilot reported he was turning to base leg. He mentioned that the Mooney was flying towards him in the opposite direction, made an evasive manoeuvre and decided to leave the circuit and set course to BRAVO. The Mooney continued on final and made a safe landing. The minimum horizontal separation between both aircraft was approximately 200 metres at an almost equal height.

The Dutch Safety Board classified this occurrence as a *serious incident*, because there was an acute risk of collision between the two aircraft and one of the pilots had to make an evasive manoeuvre.

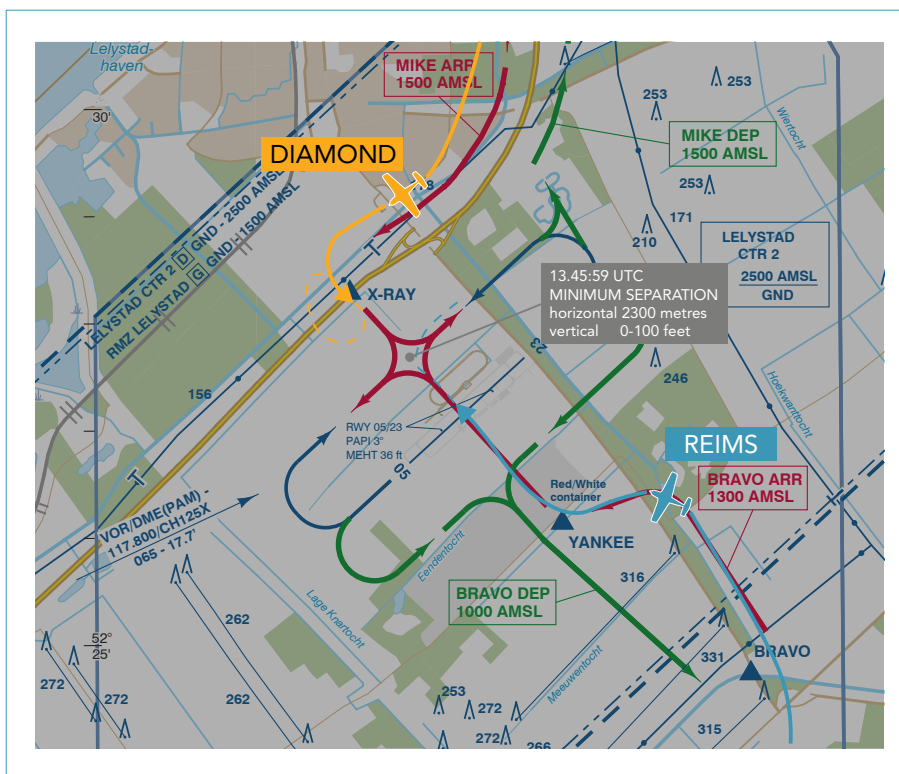
Figure 5: Occurrence 3, intersection MIKE and BRAVO arrival. (Source chart: AIP Netherlands)

Runway 23 with a right-hand circuit was in use. The Diamond entered the control zone via the MIKE arrival route (see orange line in Figure 5) and the Reims via the BRAVO arrival route (see blue line). The Reims's pilot reported overhead YANKEE and received a clearance to cross in the middle and join a right-hand downwind for Runway 23. The pilot then descended to the circuit altitude of 1,000 feet. The Diamond's pilot reported overhead point X-RAY. Then the Diamond's pilot started a descending left-hand turn towards downwind, but the pilot noticed the Reims approaching in the opposite direction and decided to make a right turn and fly a 360 degrees orbit, near point X-RAY. When he reported that he was overhead X-RAY (for the second time) and making one orbit over the right for oncoming traffic, he was cleared to join the right-hand downwind for Runway 23.

The Dutch Safety Board classified this occurrence as an *incident*, because the horizontal distance between the two aircraft was approximately 2.3 kilometres when the Diamond started the orbit. There was no immediate risk of collision between the two aircraft.

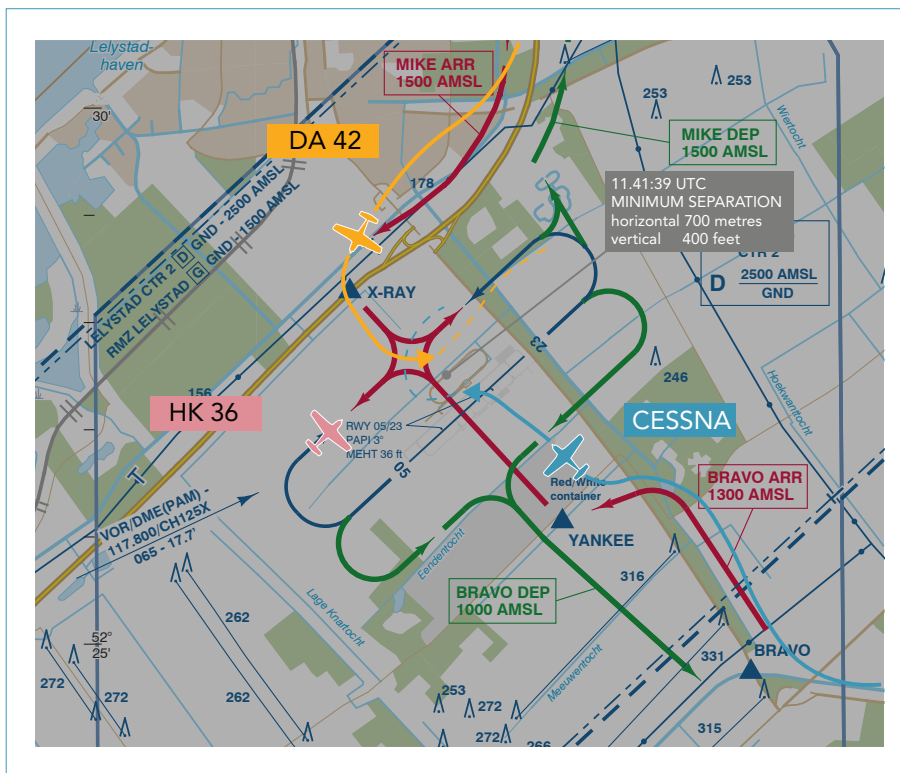
Figure 6: Occurrence 4, intersection MIKE and BRAVO arrival. (Source chart: AIP Netherlands)

Runway 23 with a right-hand circuit was in use. The DA 42 (orange line in Figure 6) flew the MIKE arrival route and the Cessna (blue line) flew the BRAVO arrival route. The HK 36 was flying in the training circuit at an altitude of 500 feet. ATC cleared the DA 42 to join a right-hand downwind from point X-RAY. The Cessna received the instruction from point YANKEE to 'cross in the middle' and join a right-hand downwind for Runway 23. The Cessna also received traffic information about the DA 42, which was flying in an opposite direction. The Cessna's pilot had visual contact with the DA 42 and got the instruction to follow that aircraft. The pilot made a left turn to position himself behind the DA 42. The pilot of the DA 42 observed the Cessna making this turn and thought it was making an evasive manoeuvre to avoid a collision.

The Dutch Safety Board classified this occurrence as an *incident*, because the aircraft flew at different heights at sufficient distance from each other and therefore there was no risk of collision between the aircraft.

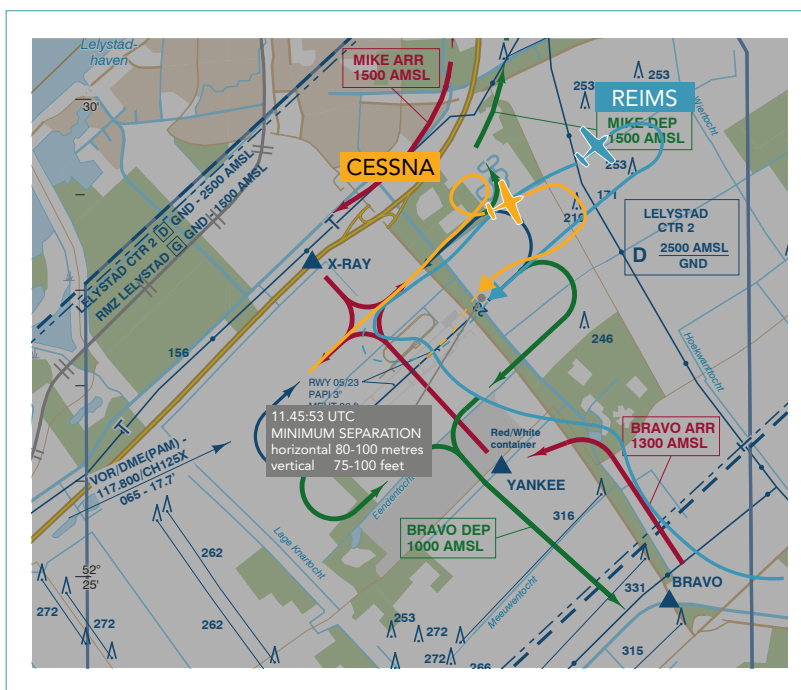
Figure 7: Occurrence 5, on final Runway 23.³⁰ (Source chart: AIP Netherlands)

Runway 23 with a right-hand circuit was in use. All aircraft flew in the circuit. The Cessna and Dimona flew at the training circuit altitude of 500 feet. The Dimona flew in front, followed by the Reims and then the Cessna. The Reims's pilot reported he was flying at 1,300 feet for better visibility conditions. At the request of ATC, the Reims and the Cessna both extended downwind and the Cessna made a left-hand 360 degrees orbit (see orange line in Figure 7). Thereafter, ATC reported to the Cessna: 'number 3 behind Katana... correction C172 at 2 NM final', which was read back by the pilot. Because the visibility had deteriorated on the extended downwind leg and the cloud base had dropped, the Cessna's pilot then turned right and joined base leg. The pilot reported that the end of extended downwind was all IMC.²⁸ When the Cessna flew on final, ATC instructed the Reims, who was also flying on final (see blue line) and above the Cessna, to make a go-around. Both aircraft came close to each other.

The Dutch Safety Board classified this occurrence as a *serious incident*, because there was an acute risk of collision between the Cessna and Reims.

In the extension of downwind of Runway 23, the weather conditions had deteriorated. In order to prevent flying into the clouds, the pilot of the Cessna decided to turn to the right, after he was told that he was number three in the circuit. By doing so he was unable to maintain sufficient separation with the preceding Reims (number two in the circuit). ATC instructed the Reims, that was now flying above the Cessna, to go-around and thereby increase the separation between both aircraft. The weather conditions made it difficult for ATC to keep a clear view of the traffic situation.

ATC was not aware of the deteriorating weather conditions at the extended downwind leg at an early stage. Neither was the Cessna's pilot. ATC instructed the pilot to extend downwind, which caused the Cessna to enter those deteriorated weather conditions. Subsequently, the pilot was forced to turn right early. This caused him to get too close to the aircraft that was flying in front of him, forcing ATC to instruct this aircraft to make a go-around.

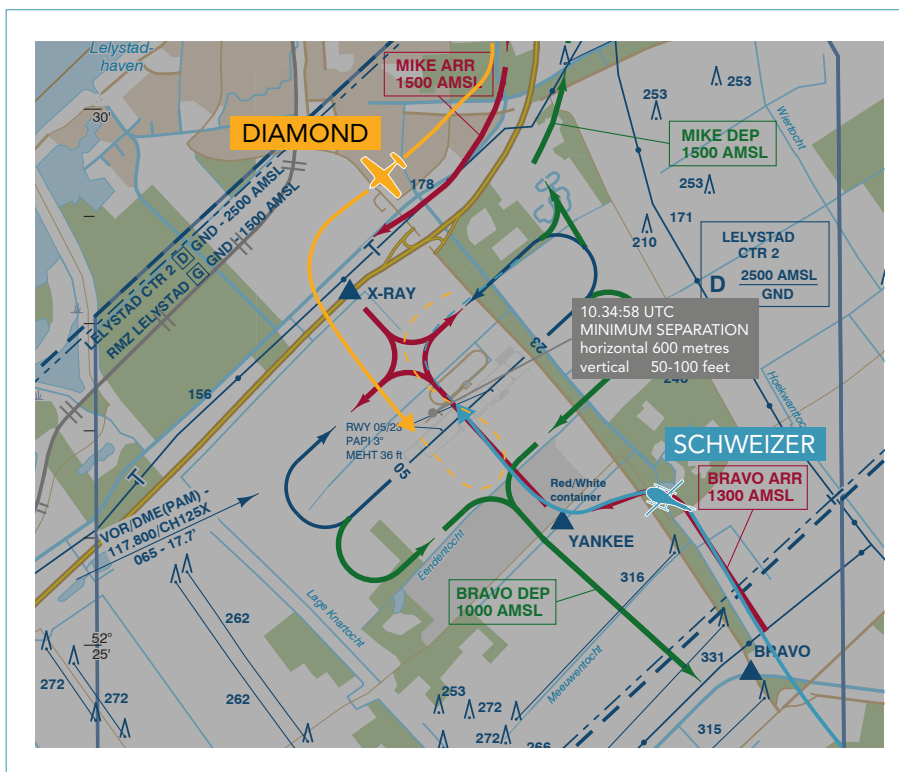
Figure 8: Occurrence 6, intersection MIKE and BRAVO arrival. (Source chart: AIP Netherlands)

Runway 23 with a right-hand circuit was in use. The Diamond (orange line in Figure 8) flew the MIKE arrival route and the Schweizer helicopter (blue line) flew the BRAVO arrival route. The Diamond flew from point X-RAY to a right-hand downwind and the Schweizer flew in an opposite direction from point YANKEE to a right-hand downwind. Both aircraft should be following traffic that was already flying on the downwind leg. ATC determined in terms of sequence that the Diamond should follow the Schweizer on the downwind leg. When the Diamond's pilot was informed, he asked for confirmation, which was then given by ATC. Moments later, the Diamond's pilot asked a second time for confirmation. At this point, ATC reversed the sequence and informed the pilot that he was now number two (number one was other traffic at the end of the downwind leg) and the opposite flying Schweizer would follow him. The Diamond's pilot replied that this was not possible anymore. He crossed the runway and made a left-hand 180 turn above the field to end up behind the Schweizer.

The Dutch Safety Board classified this occurrence as an *incident*, because there was no acute risk of collision between the aircraft. Both pilots had the other aircraft in constant sight.

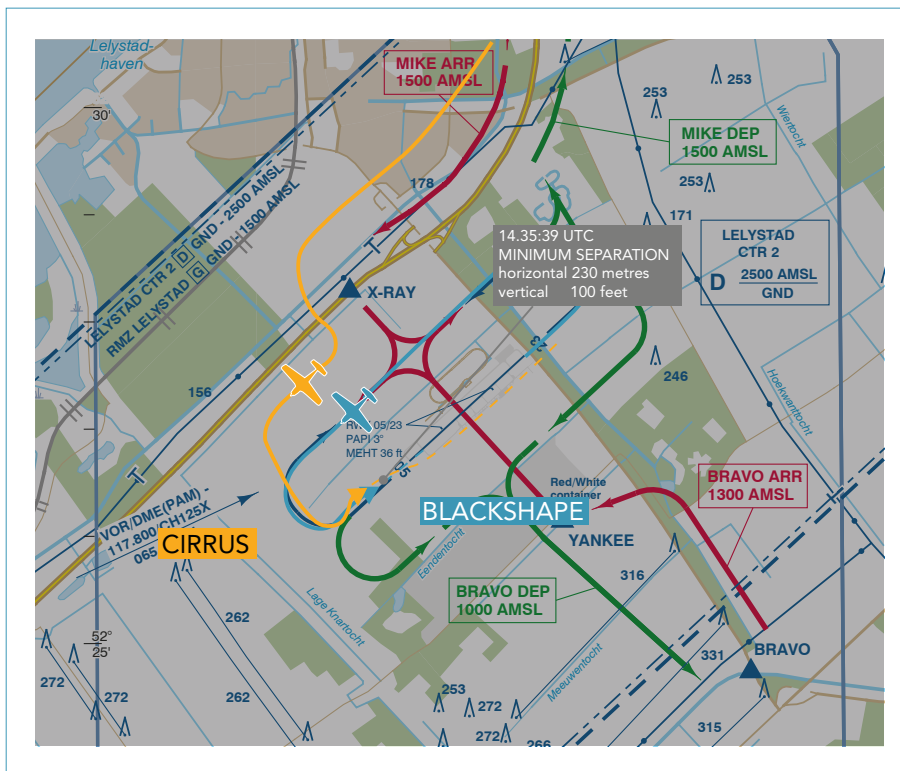
Figure 9: Occurrence 7, on final Runway 05. (Source chart: AIP Netherlands)

The Blackshape, with an instructor and student on board, had departed from Runway 05 for the training circuit at 500 feet. The Cirrus's pilot, who was inbound via the MIKE arrival, had reported X-RAY. ATC instructed the Cirrus to join a left-hand downwind for Runway 05. The Blackshape reported mid-downwind for Runway 05 for a touch-and-go, after which ATC informed them that they would be number one. Both aircraft turned to base leg and subsequently to final. The Cirrus's pilot had reported final and a few seconds later the Blackshape reported final for a touch-and-go. The instructor on board of the Blackshape estimated the position of the Cirrus at that time 5 metres above and 20 metres in front of their aircraft. ATC then instructed the Cirrus to climb to 500 feet and join the circuit and the Blackshape to make a full stop landing. See Figure 9.

The Dutch Safety Board classified this occurrence as a *serious incident*, because there was an acute risk of collision between the two aircraft.

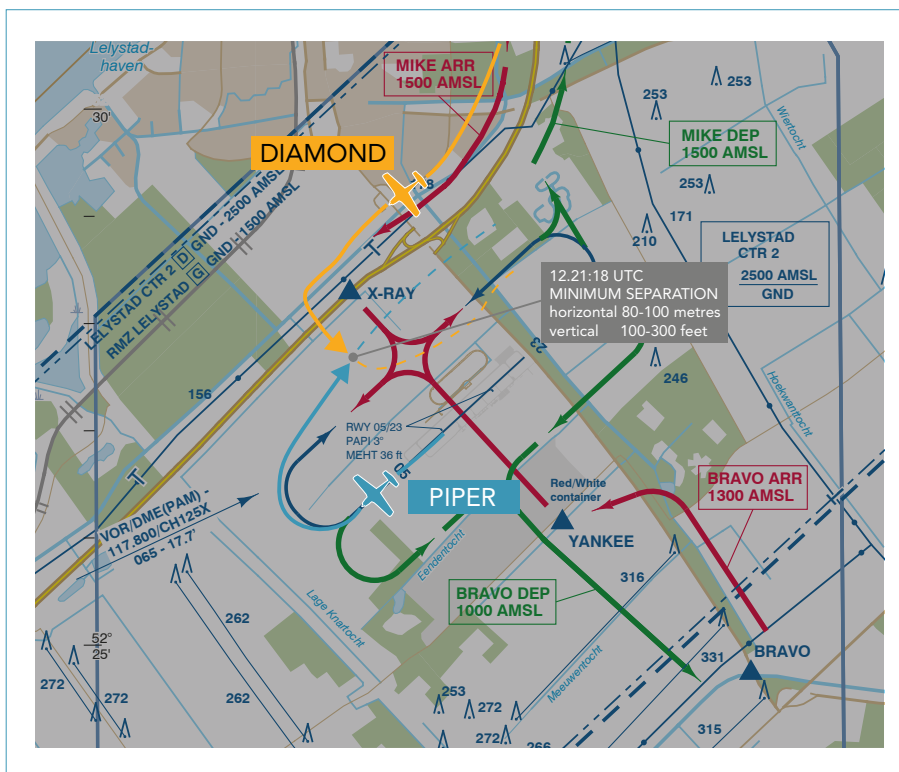
Figure 10: Occurrence 8, intersection MIKE arrival and departure.³¹ (Source chart: AIP Netherlands)

Runway 23 with a right-hand circuit was in use. The Diamond and Guimbal helicopter were inbound traffic and the Piper was outbound traffic. The Diamond and the Guimbal both flew a MIKE arrival. The Guimbal helicopter was flying in front. ATC provided both pilots with traffic information regarding the Piper that had departed and followed the MIKE departure (see blue line in Figure 10). After the Diamond's pilot reported that he was approaching point X-RAY, ATC instructed him to keep following the helicopter and to join a high right-hand downwind for Runway 23 at 1,500 feet (see orange line). The Guimbal's pilot reported that he just passed point X-RAY and was also maintaining 1,500 feet for a right-hand downwind. ATC replied in the affirmative and passed on traffic information about the Piper on his right side. The Guimbal's pilot reported to have the traffic in sight. ATC provided the Piper traffic information that two aircraft (of which one helicopter) were joining in front of him at 1,500 feet. The Piper's pilot descended to 1,300 feet and reported to have both aircraft in sight. Then ATC provided traffic information to the Diamond, whereupon the Diamond's pilot replied that he was already climbing and maintaining 1,700 feet.

The Dutch Safety Board classified this occurrence as a *serious incident*, because the flight paths of both aircraft crossed each other and the aircraft were flying at the same altitude initially. There was a risk of collision.

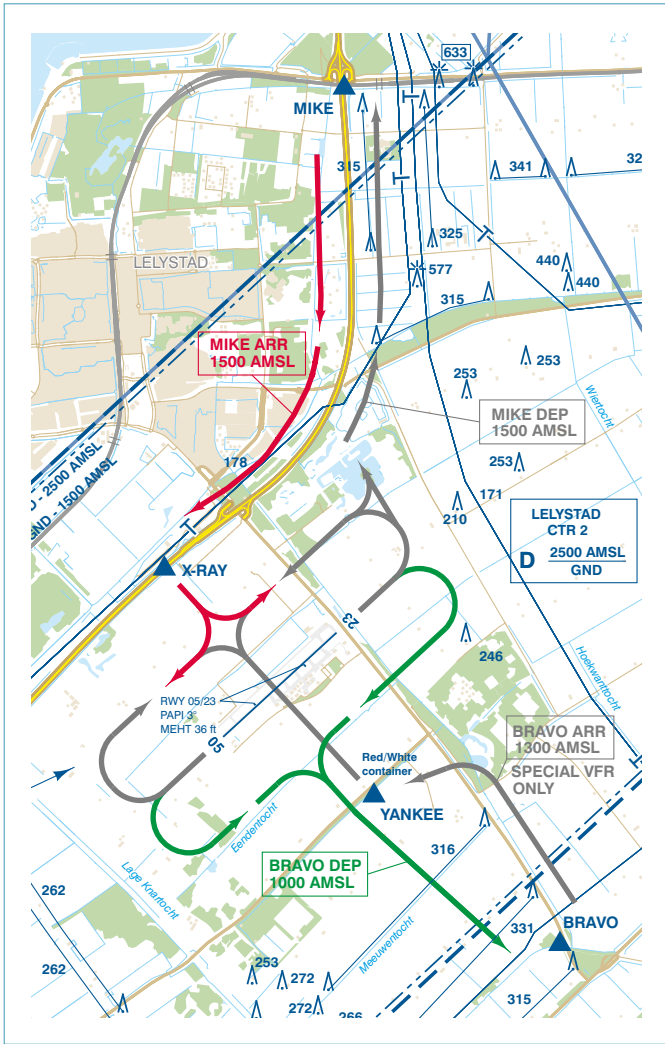
Figure 11: Situation as of 7 December 2019. (Source: AIP The Netherlands)

³⁹ These new measures ended simultaneous approaches to the airport from both sides (via BRAVO and MIKE).
