THE DUTCH  
SAFETY BOARD

**Accident with hatch crane of mv Arklow Sky, Bilbao, 21 September 2010**

The Hague, July 2011

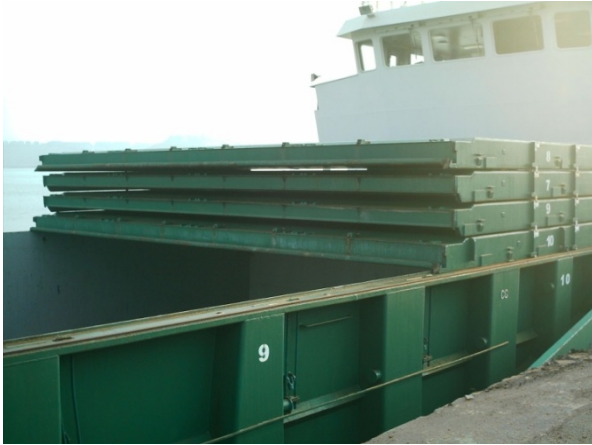
*Photo 1: The piled hatch pontoons at the back of the hold, after hatch no. 6 had been driven away by the first mate.*

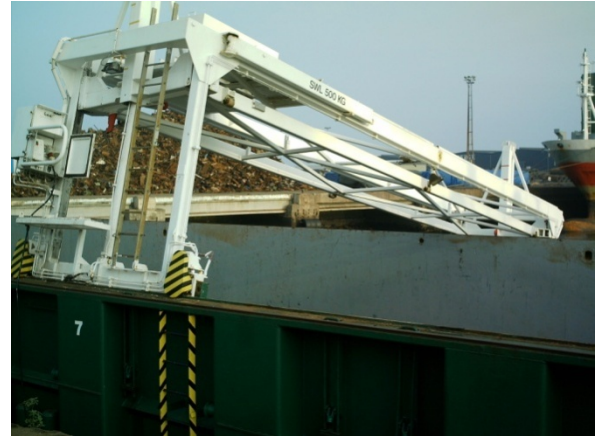
*Photo 2: The situation shortly after the accident.*

As a consequence of this fall into the hold the first mate suffered serious injuries and was admitted to hospital in a critical state. The material damage to the hatch crane and the ship was around € 25,000. This material damage consisted of, among other things:

- Indents<sup>18</sup> and penetration of the tank top<sup>19</sup> and side tanks in the hold.
- Displacement of the hydraulic plunger<sup>20</sup> of the hatch crane.
- Bending of the attachment hooks on the port side of the hatch crane.

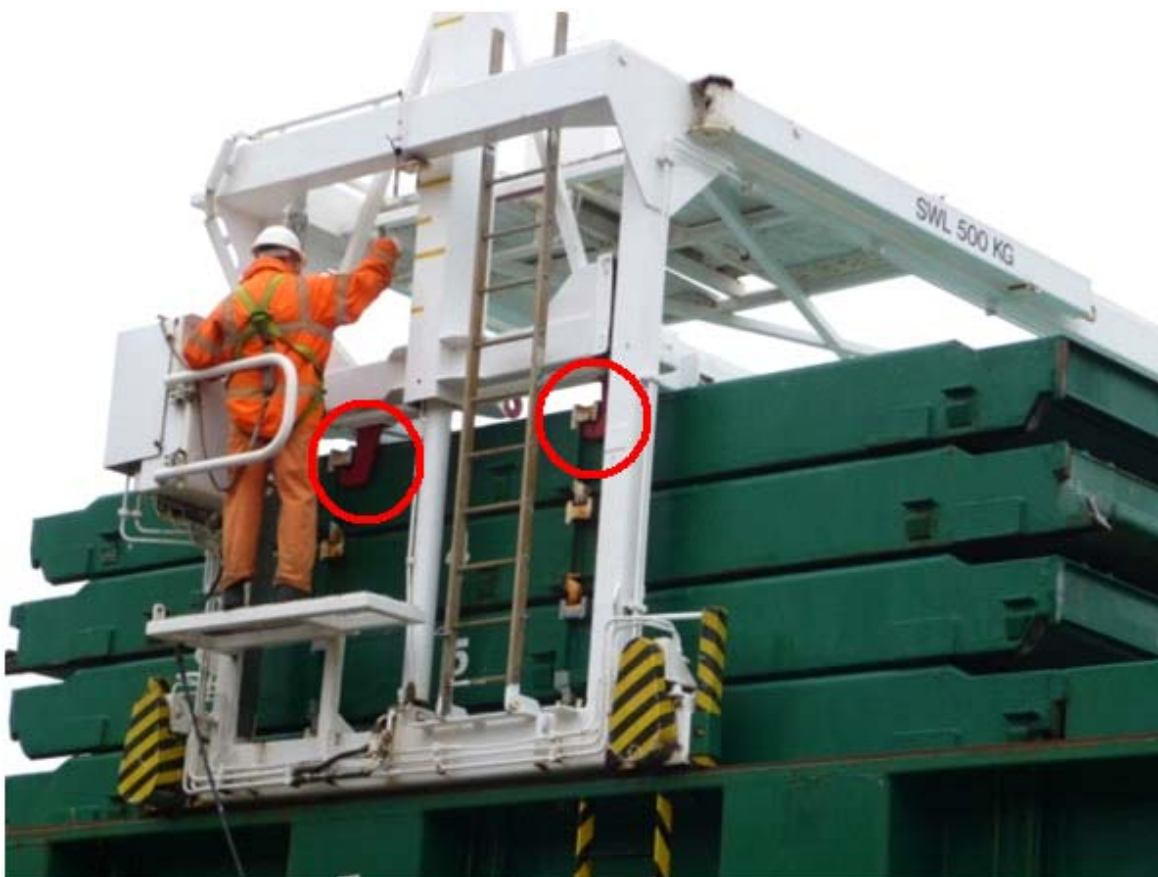
Photo 3: The hatch crane with hooked hatch (photo taken on the Arklow Sky in Sluiskil).

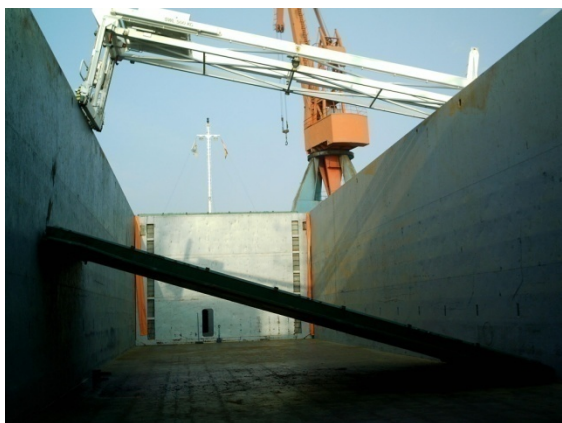
*Photo 4: Situation after the accident viewed from the hold.*

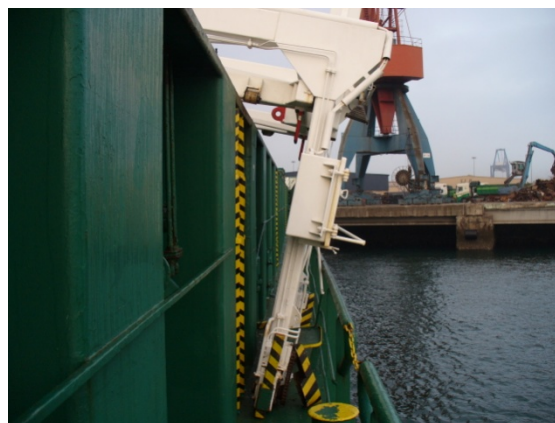
*Photo 5: Position of the hatch crane on the starboard side in the gangway.*

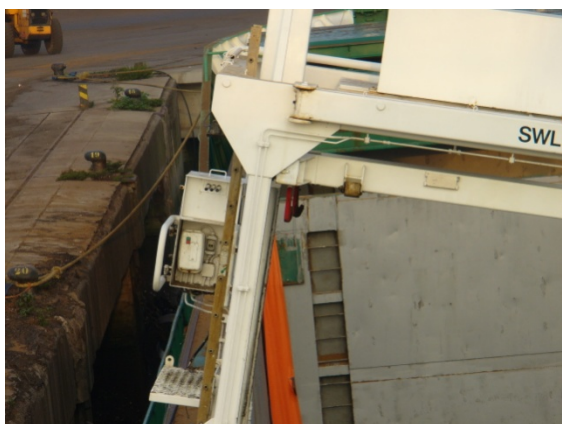
*Photo 6: Bent hooks on the port side.*

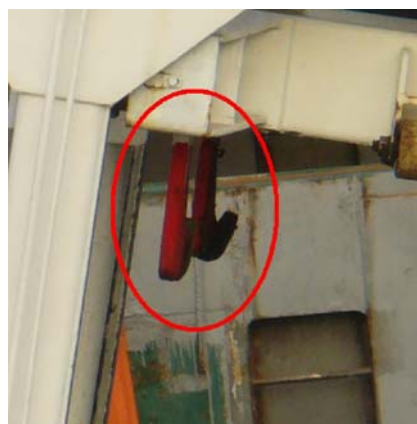
*Photo 7: Enlargement of bent hooks.*

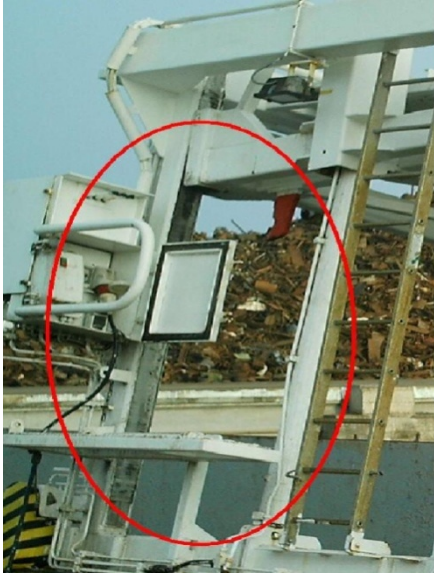
This was able to happen due to the lack of adequate anti-fall protection on the operating platform and due to the mate not wearing any personal anti-fall protection (safety harness)<sup>22</sup>.

*Photo 8: Limited anti-fall protection on the operating platform with an 'open' door (see also photo 3).*

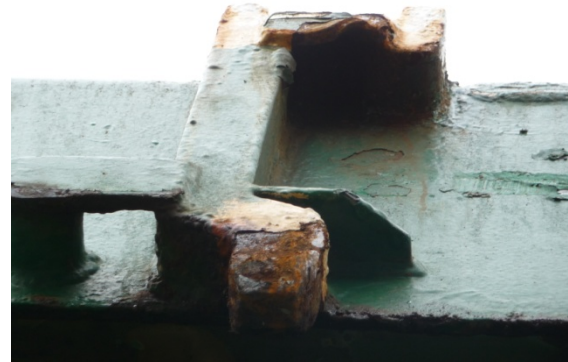
*Photo 9: Damaged attachment point of the fallen hatch.*

The accident could take place because the hooks of the hatch crane yoke on the starboard side did not connect to the hatch attachment points but to the rounded (outer) side of the attachment points. Contrary to the procedures, this was not checked by a second person. Again contrary to the procedures, the hatch was transported in a high position meaning that the hatch crane's centre of gravity remained high. The consequence was that a minor imbalance (for example when starting or stopping a movement) was sufficient to cause the incorrectly hooked-up hatch to slip off the rounded blunt sides of the attachment hooks. Moreover, the hatch's high position meant there was sufficient space for it to fall down past the hatchway coaming and into the hold. If the hatch had been moved in a low position, it would possibly have fallen onto the hatchway coaming.

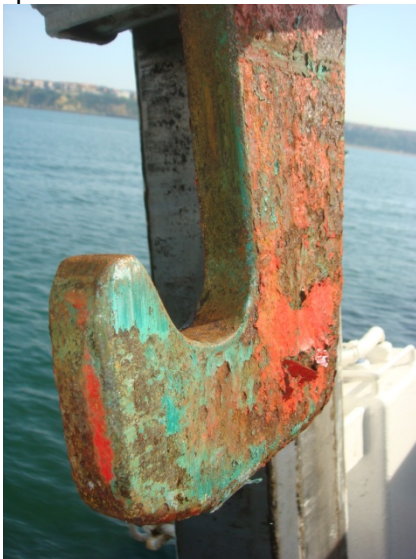
No 'hard' technical measures were implemented on board the Arklow Sky to prevent incorrect hooking. In the past one of the shipping company's vessels was fitted with a technical provision to prevent incorrect hooking using sharp-ended hooks. However, this provision was not fitted to any other vessel because the shipping company decided that it would not increase safety, given the crew's response that they would then be able to operate the hatch crane alone.

*Photo 10: The hooks used on board with blunt end.*

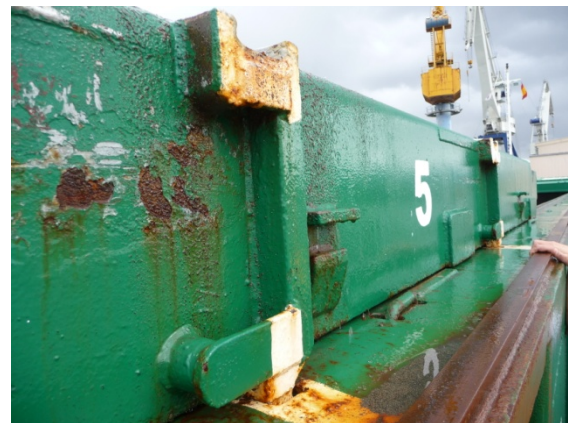
*Photo 11: Hatch with two attachment points with rounded profile.*

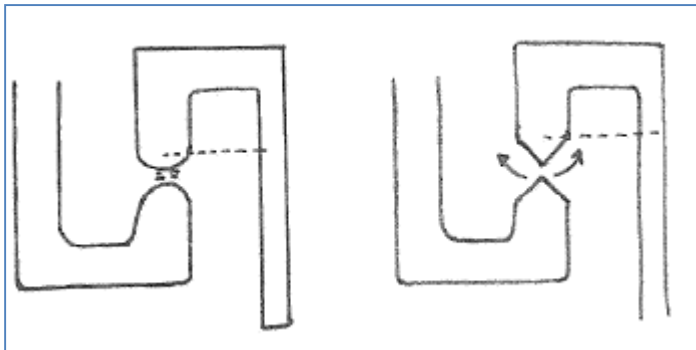
*Figure 1: Difference between blunt ended and sharp ended hook and attachment point.*

2. The use of sharp ended hooks and pockets, so that the hook cannot lift the hatch if not properly connected (see figure 1).

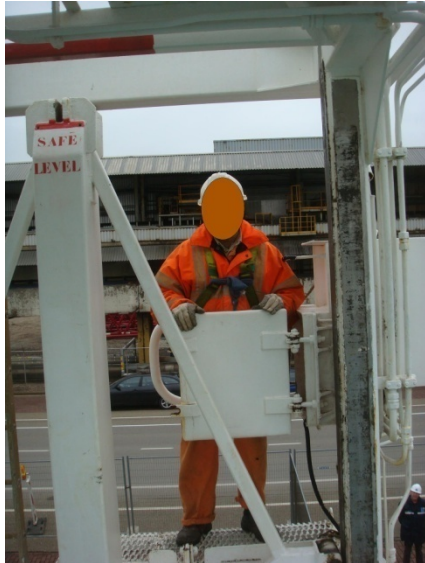
In combination with a correctly lowered spreader an anti-fall protection would seem adequate. (see picture attached - taken on board Arklow Sky in Sluiskil on 29/10/2010 with OVV representatives in attendance.

A footnote with the text of the legal framework applicable to the ship has been added to the text on page 10. The Board is of the opinion that the current outfitting of the crane offers insufficient protection against falling to the operator. When operating the hatch crane, either closing or opening the hatches, approximately half of the distance covered will be without a hatch attached to the hooks. The operator then will be unprotected exposed to a depth of approximately eight meters. Also in the case a hatch is being lifted of a pile of hatches and driven away (with obviously the hatch in elevated position before it can be lowered as required by the working orders), the operator will be exposed to the open hold.
